Magnolia Plantation
Gin Barn

Historic Structure Report

CANE RIVER CREOLE NATIONAL HISTORICAL PARK
MAGNOLIA PLANTATION

~ GIN BARN ~
HISTORIC STRUCTURE REPORT

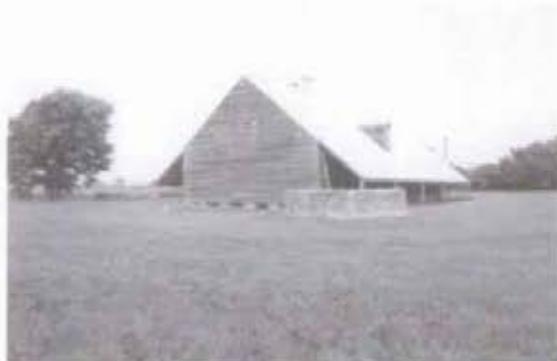
Figure 13 View of Gin Barn from northeast, with cistern visible in foreground. (NPS-SERO-CRS, 2001)

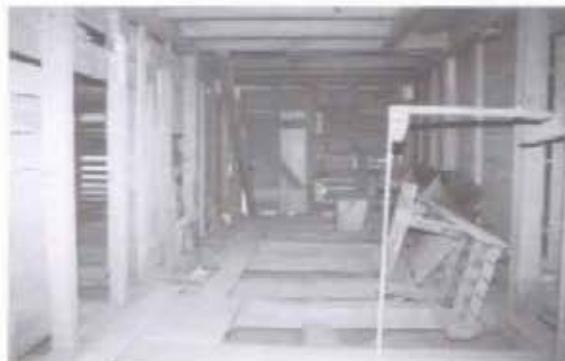
Figure 15 View north in center room, originally used as a lint room. (NPS-SERO-CRS, 2001)

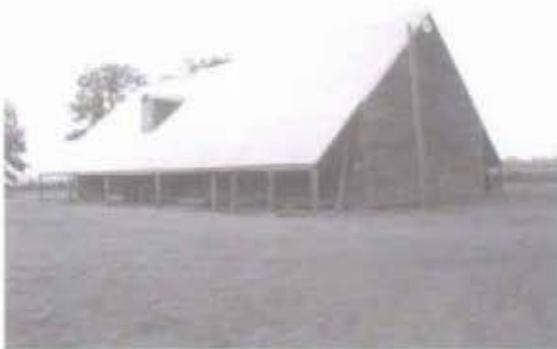
Figure 14 View of Gin Barn from southwest. (NPS-SERO-CRS, 2001)

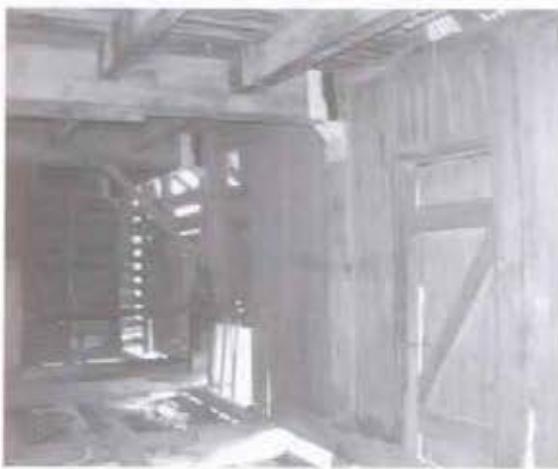
Figure 16 View southeast in machinery room, in probable location of original seed room. (NPS-SERO-CRS, 2001)

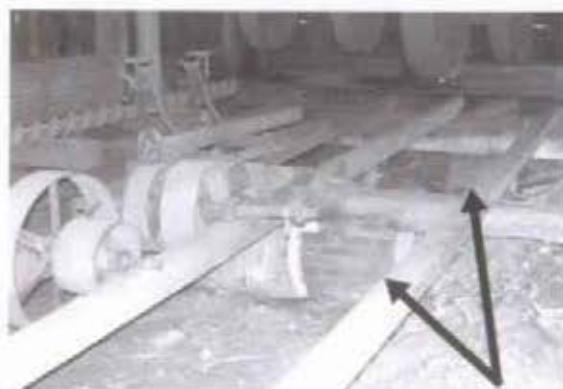
At the east end of the building is an older generation of piers that do not appear to relate to anything in the present building, although they might have been associated with the first cotton press or, perhaps, the first generation of steam equipment. Two of these piers are located near the center of the space. One is about 16" by 24", 12" high, and is lying on its side. The other, which is just behind the toppled pier, is about 12" by 24" with only two courses above grade. It is set at an angle that does not appear to relate to the present building. There may be other piers on the east side of the brick base to the steam press, but archeology will be necessary to confirm that. Curiously, the corners of both of the visible brick

Figure 17 View of early brick piers under machinery room floor. (NPS-SERO-CRS, 2001)

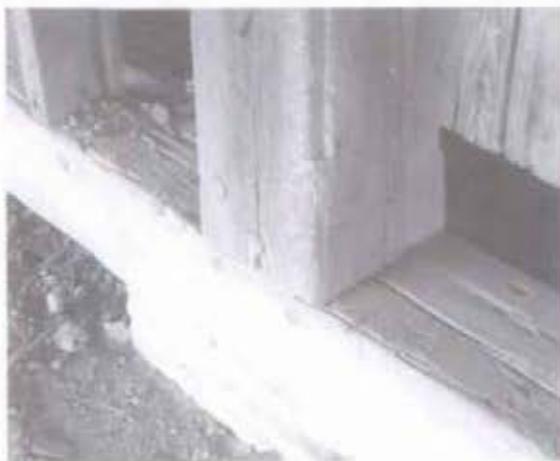
Figure 19 View of typical sill and post with historic splined connection intact. (NPS-SERO-CRS, 2001)

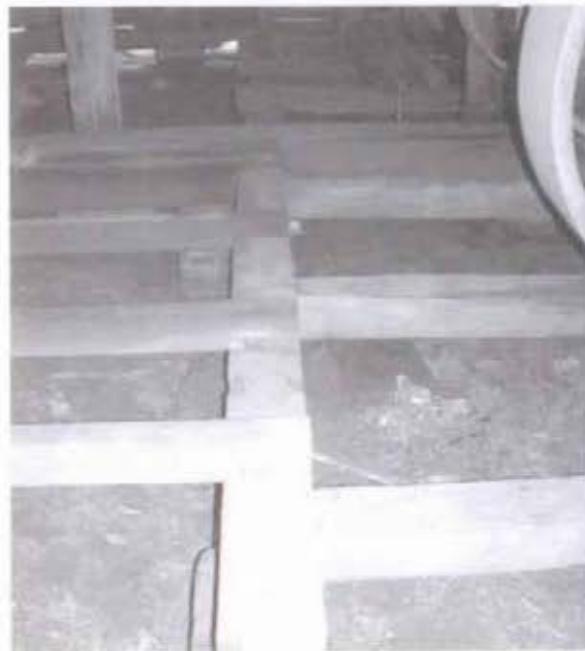
Figure 21 View of floor framing at east end of Gin Barn. (NPS-SERO-CRS, 2001)

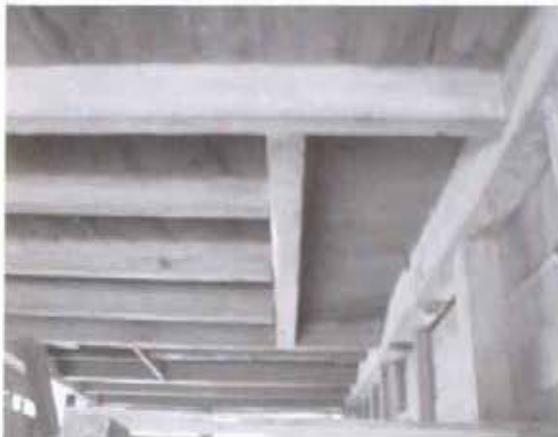
Figure 22 Ceiling in "lint room," showing framed opening for ginned cotton from first or second generation gin at second floor level. (NPS-SERO-CRS, 2001)

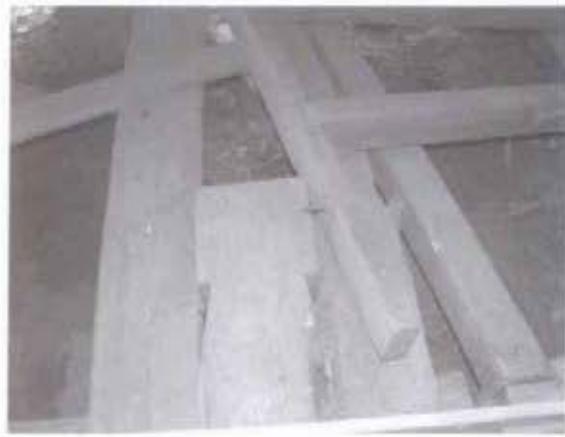
Figure 23 View of framing members in floor at east end of gin barn, with end of hewn beam visible at center, presumably from first cotton presss. (NPS-SERO-CRS, 2001)

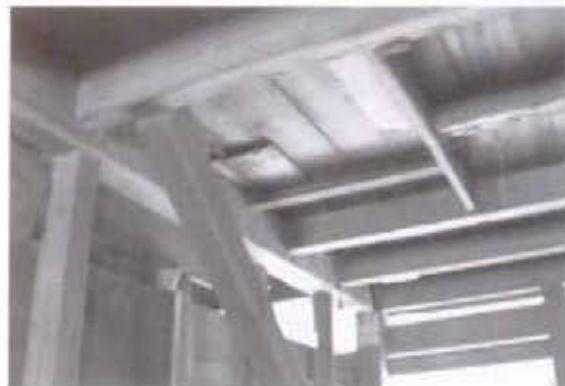
Figure 24 View of framing in lint room ceiling for cotton bale slide which was added along with new hydraulic press around 1900. (NPS-SERO-CRS, 2001)

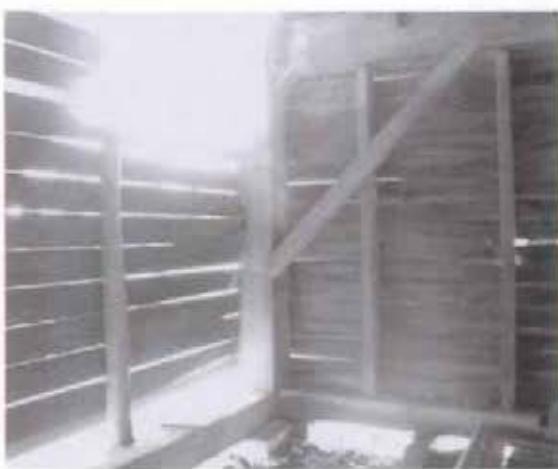
Figure 25 View of southwest corner of barn; wall at right was added in the late nineteenth or early twentieth century. (NPS-SERO-CRS, 2001)

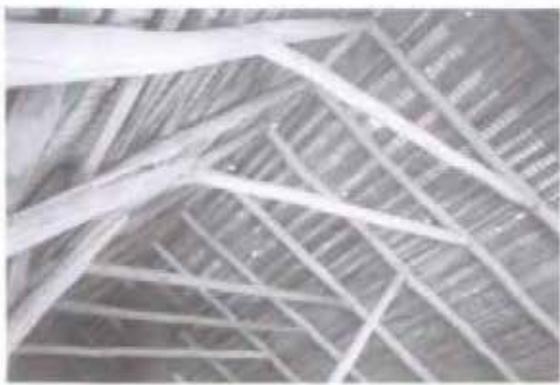
Figure 27 View of original pole-rafter roof in 1995. (NPS-SERO-Architecture, 1995)

The original roof was entirely removed in 1995, but photographs show that it was originally framed with twenty-nine pairs of pole rafters, set on centers approximately 36" apart. Betty Hertzog remembers these rafters being a combination of cypress and black locust.⁵⁹ In addition, two of the original pole rafters (both cypress), complete with lapped- and- pegged ridge connection, have been preserved by the park and, as noted in the previous section, offer important clues to the building's origins.

In 1995, the original pole rafters on the main roof were replaced by the existing rafters, which are 6" by 8", pressure-treated pine, set on centers 36" to 42" apart. Collar beams are the same size, with the connection reinforced by metal T-shaped plates. On the arcades, the rafters are 3" by 6" set on an outside beam 5½" by 7¼". Roofing is corrugated steel, specified as 18 gauge and attached with 1½" self-tapping, hex-head, galvanized wood screws with sealing washers. Only the framing and decking of the two dormer roofs appears not to have been replaced in 1995.

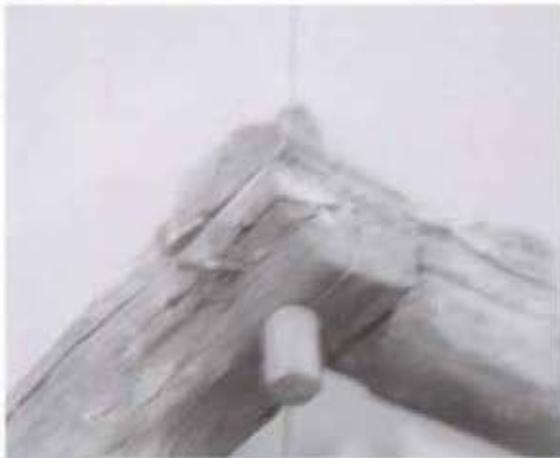
Figure 28 Detail of typical ridge connection in original roof, from partial rafters now in CARI Collection. (NPS-SERO-CRS, 2001)

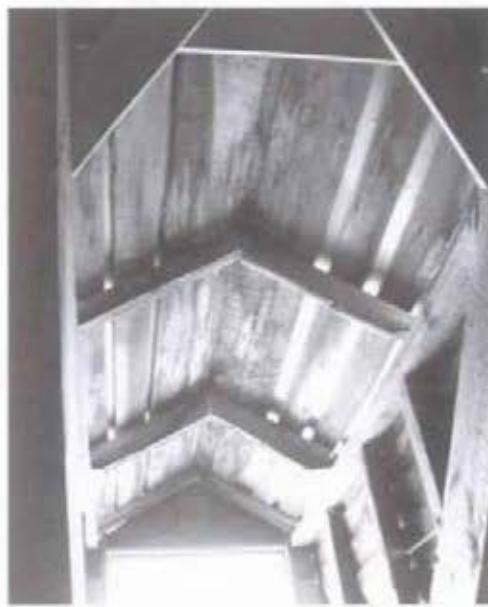
Figure 29 View of south dormer with original framing and decking intact. (NPS-SERO-CRS, 2001)

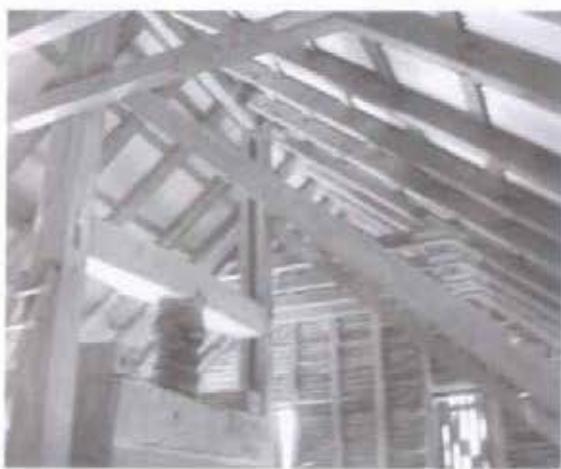
Figure 30 View southwest of roof framing installed in 1996. (NPS-SERO-CRS, 2001)

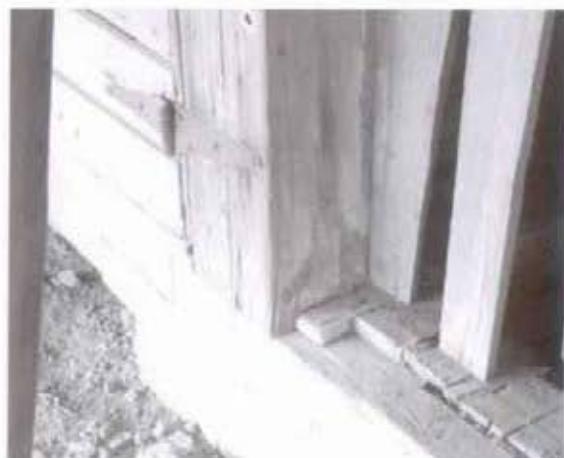
Figure 31 View of original flooring at south side of lint room. (NPS-SERO-CRS, 2001)

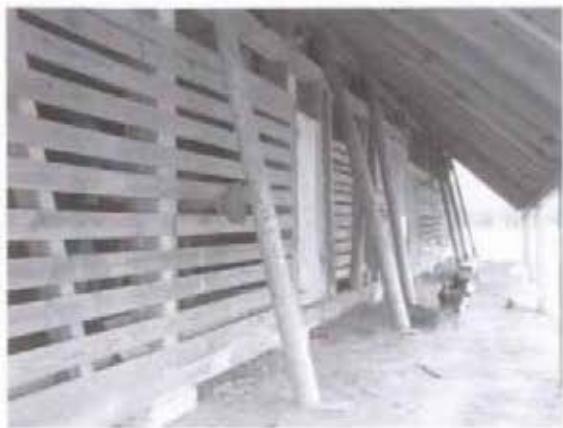
Figure 32 View of north side of building, showing typical open siding. Note that siding near center is attached to the interior face of the studs. (NPS-SERO-CRS, 2001)

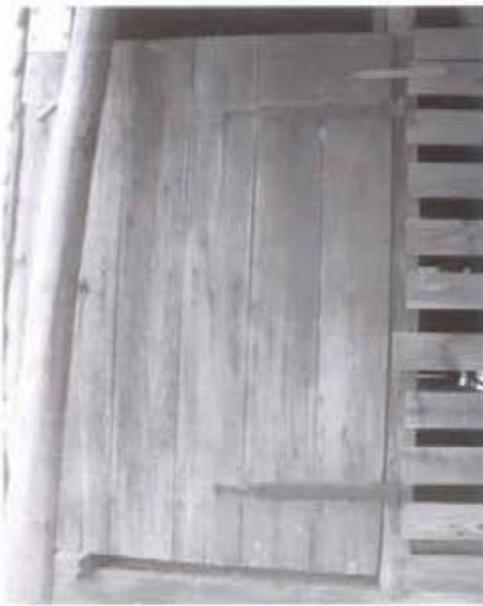
Figure 34 View of Door D, one of the oldest doors in the barn. (NPS-SERO-CRS, 2001)

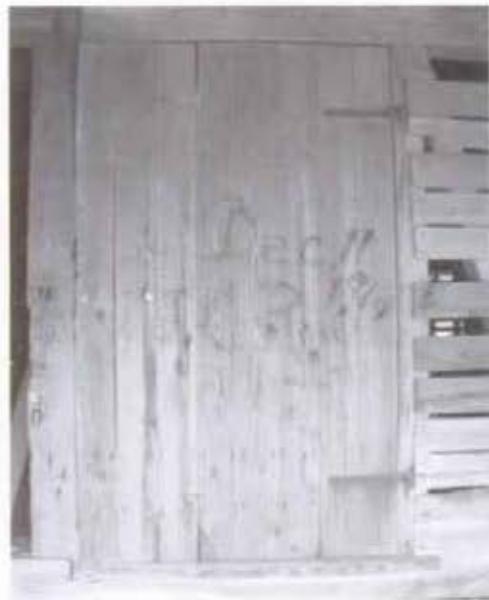
Figure 33 View of Door A, added to second floor around cotton press. (NPS-SERO-CRS, 2001)

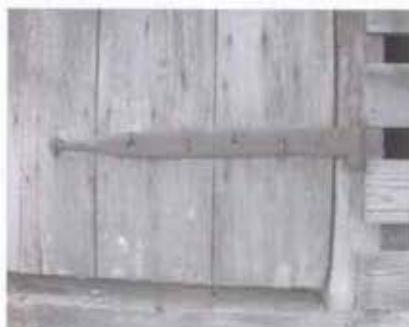
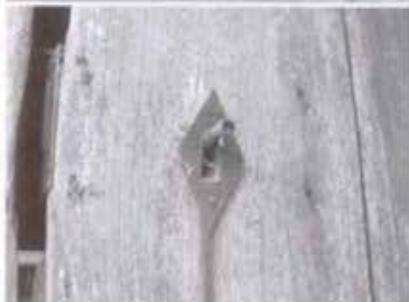
Figure 35 View of hinge and escutcheon on Door D. (NPS-SERO-CRS, 2001)

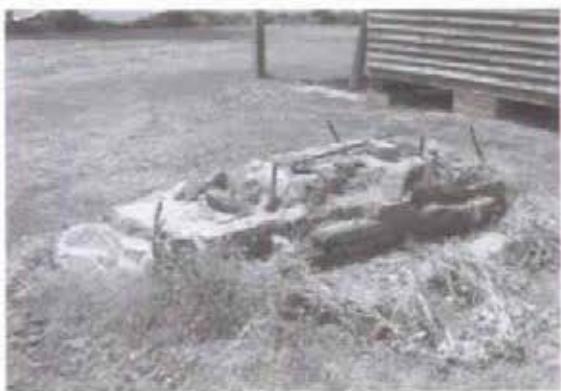
Figure 37 View to southwest of brick foundation for steam engine. (NPS-SERO-CRS, 2001)

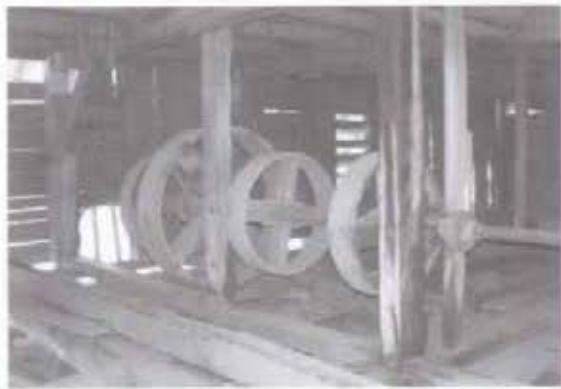
Figure 38 View of belt-driven flywheels at east end of barn, which would have been connected by leather belts to the engine outside the building and to the machinery inside. (NPS-SERO-CRS, 2001)

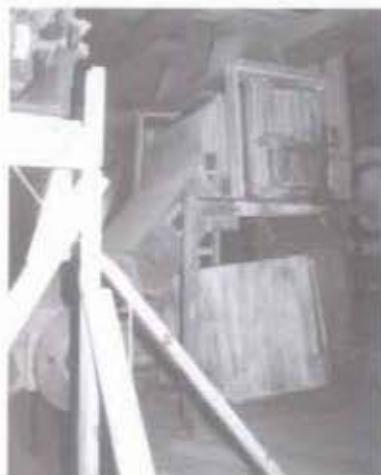
Figure 40 View of portion of Munger system gin machinery on second floor of barn. (NPS-SERO-CRS, 2001)

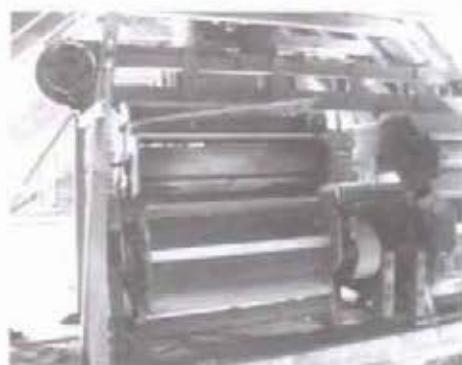
Figure 41 View of Continental gin stand on second floor. (NPS-SERO-CRS, 2001)

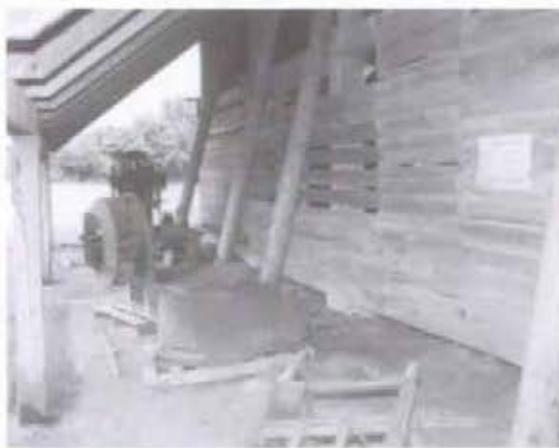
Figure 42 View west under south arcade, showing blowers and other equipment associated with c. 1900 system gin. (NPS-SERO-CRS, 2001)

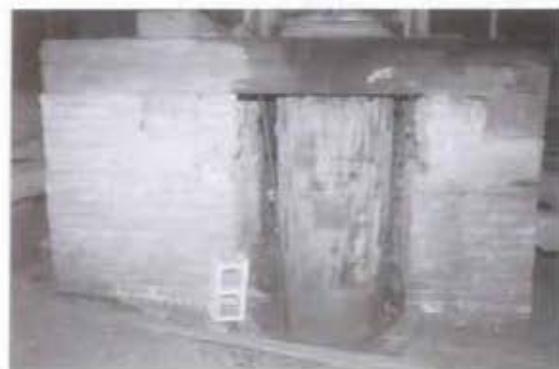
Figure 43 View of hydraulic cylinder and supporting brick piers for press. (NPS-SERO-CRS, 2001)

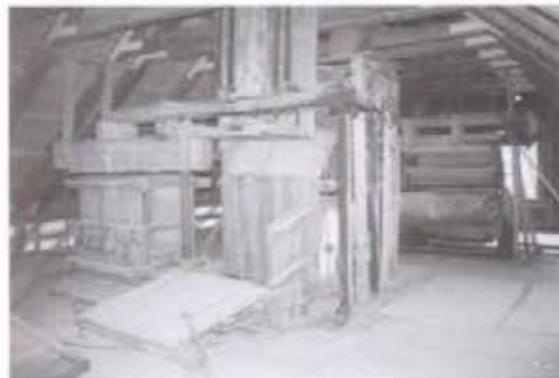
Figure 44 View east of dual-box, hydraulic press at second floor, with gin stand visible in background. (NPS-SERO-CRS, 2001)

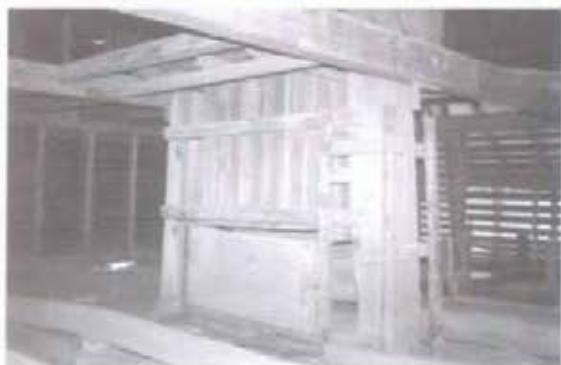
Figure 46 View of cotton press at ground level, showing door where finished bale was removed. (NPS-SERO-CRS, 2001)
