Condition Assessment and Treatment Plan for Libbey Memorial Physical Medicine Center

P R E - D E S I G N S E R V I C E S

June 30, 2022
NPS PMIS # 318915
NPS TIC #128-180181

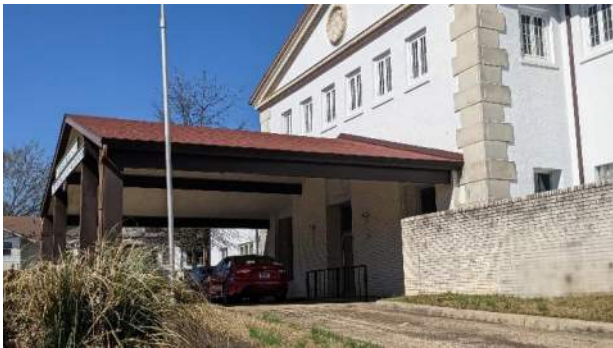
XC.3– Exterior at South. Porte cochere.

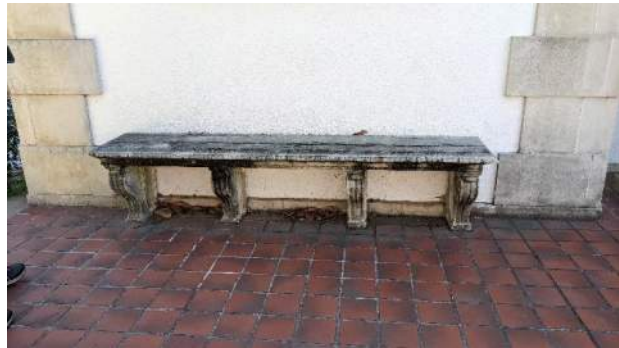
XAE.13 – Exterior at North. Bench with atmospheric and biological staining.

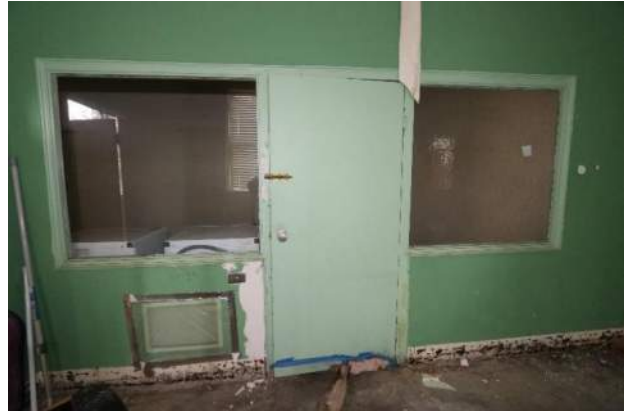
XAI.3 – Office 101. Historic interior window.

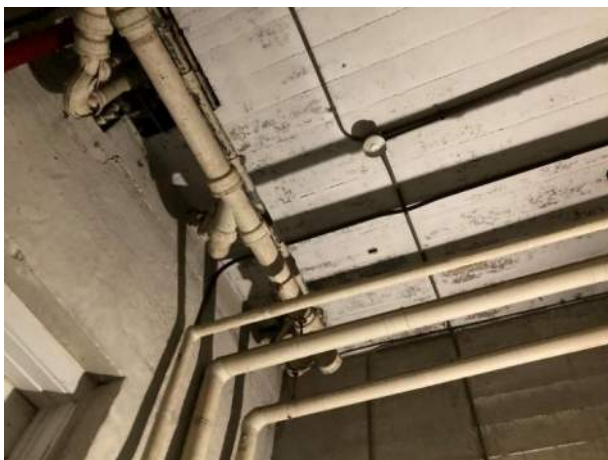
XAI.14 – Mechanical 106. Utility pipes anchored to the ceiling.

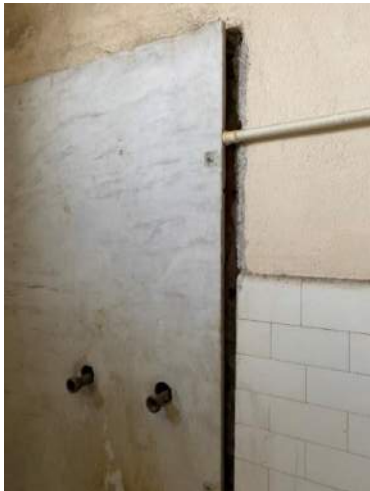
XAI.83 – Shower 220. Damaged shower marble wall.

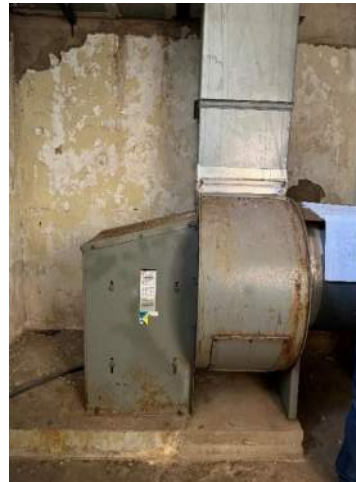
XM.7 Exhaust System

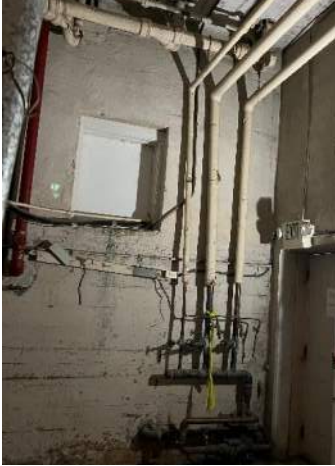
The existing 3" water service was installed in the 1956 building improvements. There is an existing 2" backflow preventer installed at the service entrance, but it is missing an air gap fitting and floor drain to collect any possible discharge.

XP.1 Water Service & Backflow Preventer

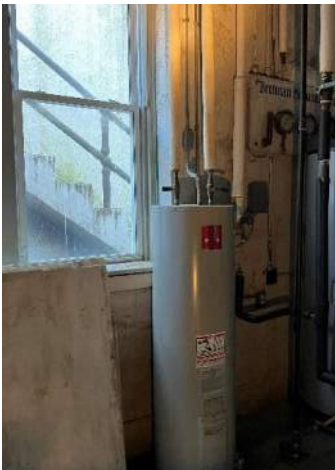
XP.2 Water Heaters

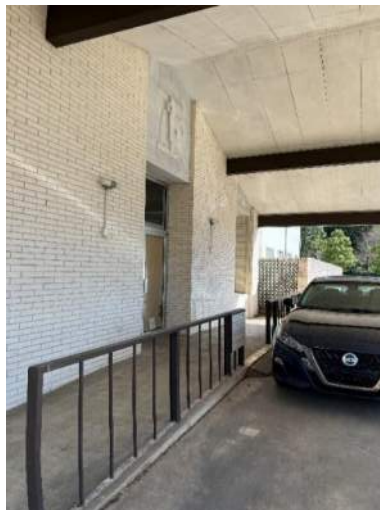
XE.2 Exterior Lighting

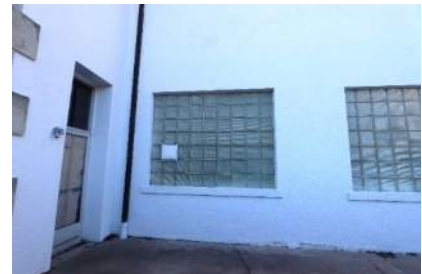
XE.3 Exterior Lighting

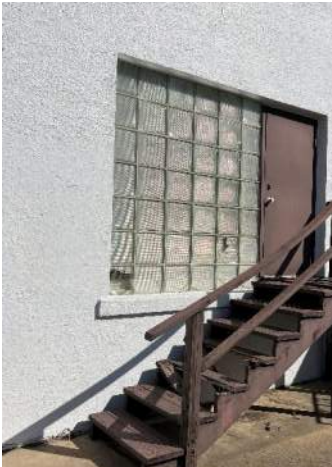
XE.4 Exterior Exit

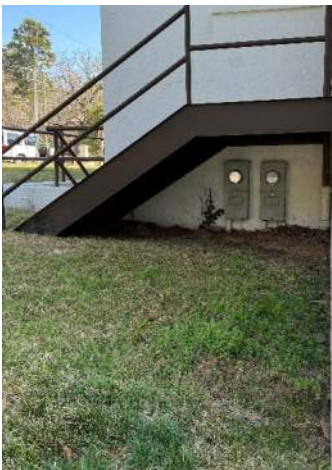
XE.5 Electrical Meters

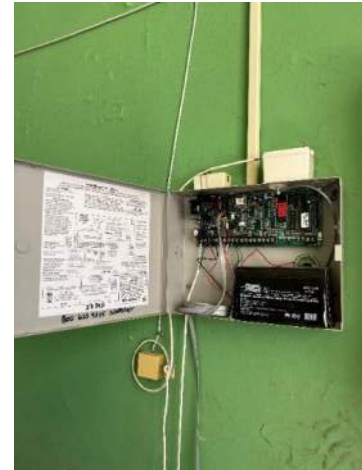
XE.11 Security System

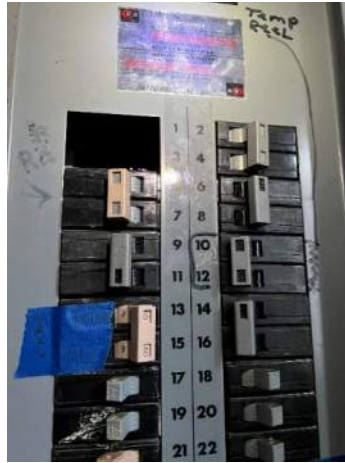
XE.25 Open Dead Front

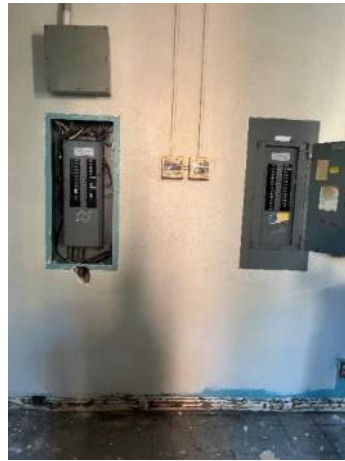
XE.26 Removed Dead Front

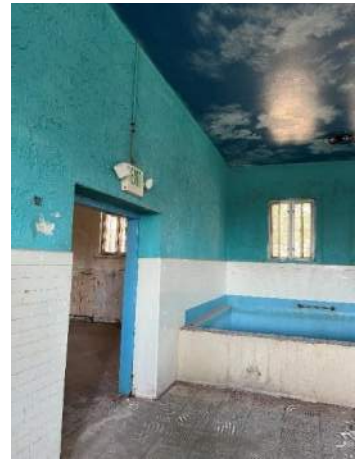
XE.29 Emergency Lighting

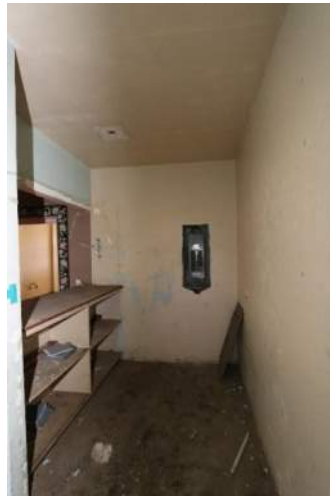
XE.27 Removed Dead Front
