GATEWAY ARCH Corrosion Investigation Part III

St. Louis, Missouri

Final Report

April 3, 2015

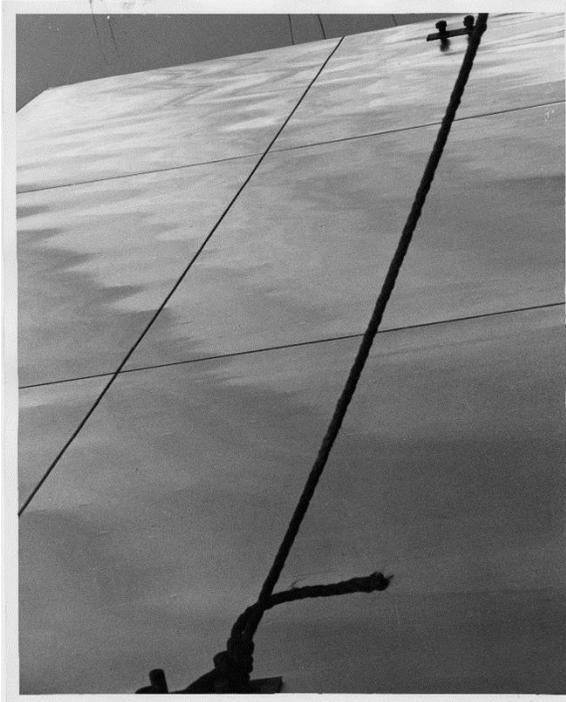
- b. Letter to MacDonald from JEFF Superintendent, dated January 10, 1964
26. Photographs of damaged stainless steel panels taken by an unknown person during construction of the Arch (two photographs included as Figure 13 and Figure 14)

*Figure 13. Damaged stainless steel panels.
Source: JEFF archives, unknown photographer,
unknown date.*

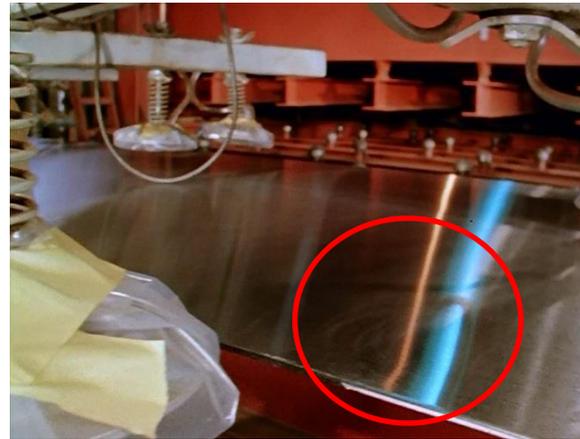
1. During handling in the PDM fabrication shops, suction cups were used to handle the stainless steel panels (Figure 15). The suction cups left circular marks on the panels (Figure 16), although it is not clear if the marks were removable or if they were scratches in the stainless steel finish.

Figure 16. Close-up of a suction cup marking (circled) on the stainless steel. Source: "Monument to the Dream" (03:31), courtesy Guggenheim Productions, Inc., 1967.

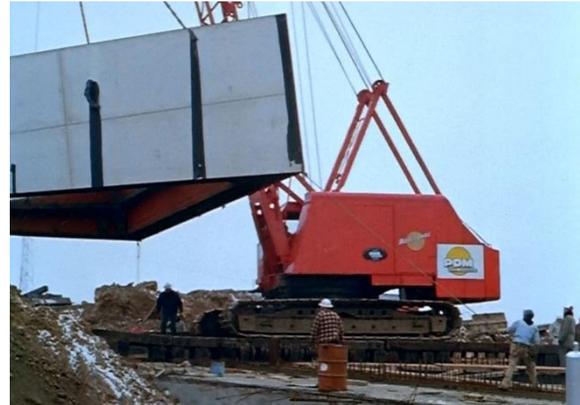
2. After the panels were constructed in the fabrication shops, they were transported to the jobsite on railcars (Figure 17 and Figure 18).
3. Black adhesive strips were visible on the stainless panels during lifting on site (Figure 19 and Figure 20). It is not known why or when the strips were applied to the panels. The adhesive material is unknown.

Figure 20. Lifting a section into place; note the black adhesive strips on the stainless steel. Source: "Monument to the Dream" (07:19), courtesy Guggenheim Productions, Inc., 1967.

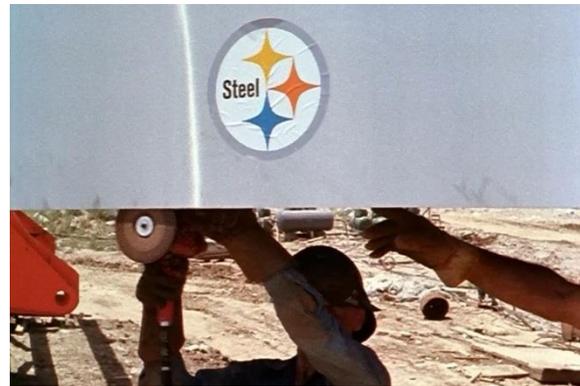
5. Adhesive marketing decals were observed on the stainless steel panels (Figure 22). The adhesive material is unknown.
6. The stainless steel panels required local handling for fit-up to adjacent panels (Figure 23), before on-site field welding could be completed (Figure 24).

Figure 22. Decal on the stainless steel during construction. Source: "Monument to the Dream" (08:03), courtesy Guggenheim Productions, Inc., 1967.

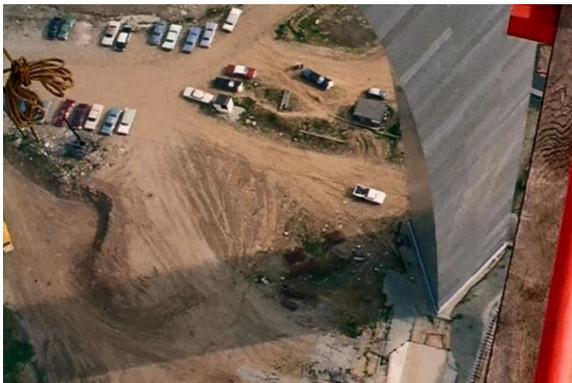
7. Bolts were installed on the extrados of the stations for attachment of the creeper derricks (Figure 25 and Figure 26).
8. An overall view of the Arch during construction shows a variety of finishes on the stainless steel panels (Figure 27).
9. Several overall views of the Arch during construction show streaking and staining on the stainless panels (Figure 28 to Figure 31).
10. The documentary did not describe or document the removal of the creeper derrick or the cleaning process at the end of the construction period.

Figure 27. Overview of Arch during construction; note the variety of finishes on the stainless steel panels. Source: "Monument to the Dream" (17:43), courtesy Guggenheim Productions, Inc., 1967.

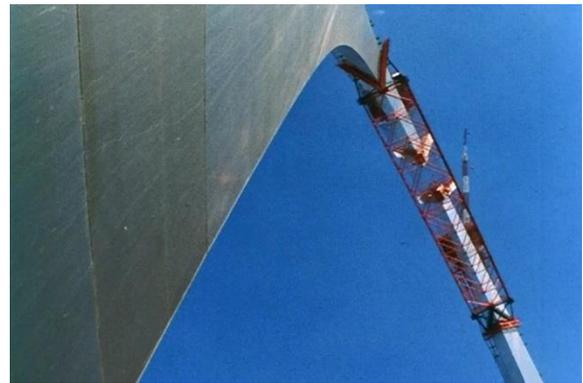
Figure 28. Streaking on the stainless steel panels during construction. Source: "Monument to the Dream" (18:32), courtesy Guggenheim Productions, Inc., 1967.

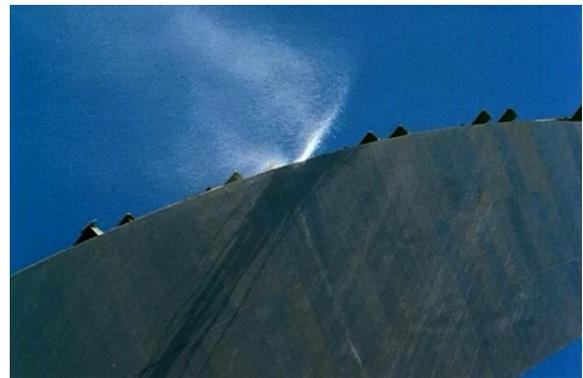
Figure 30. Water streaking on the stainless steel panels, during final station installation. Source: "Monument to the Dream" (23:08), courtesy Guggenheim Productions, Inc., 1967.

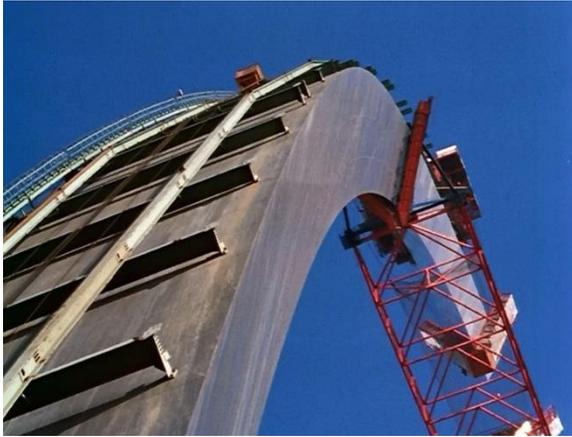
Figure 31. Streaking and debris on the stainless steel panels during construction. Source: "Monument to the Dream" (20:27), courtesy Guggenheim Productions, Inc., 1967.

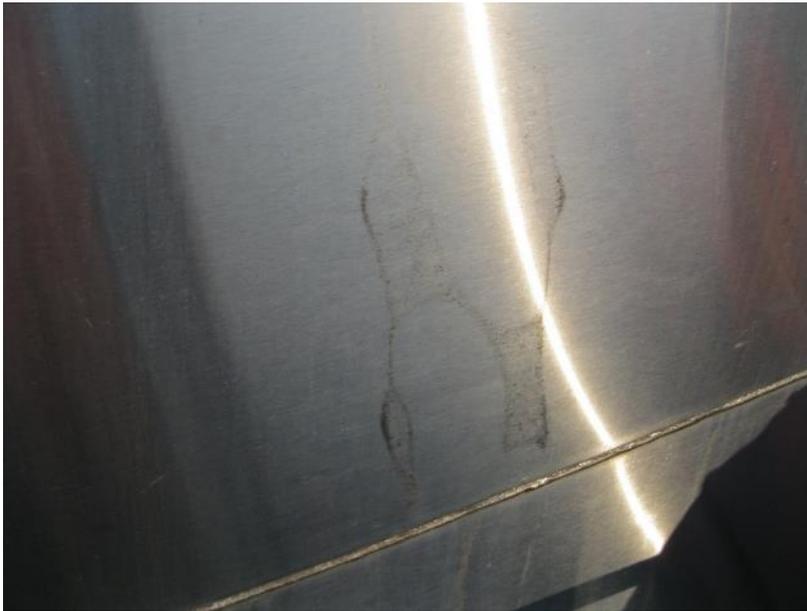
- a. Horizontal bands with a height of approximately one-third of the panel height (Figure 44)
 - b. Vertical blemishes with an approximate width of 8 to 10 inches, contained within a specific station, (Figure 45 and Figure 46)

Figure 46. Vertical blemish within panel. (Photo by authors, 2014)

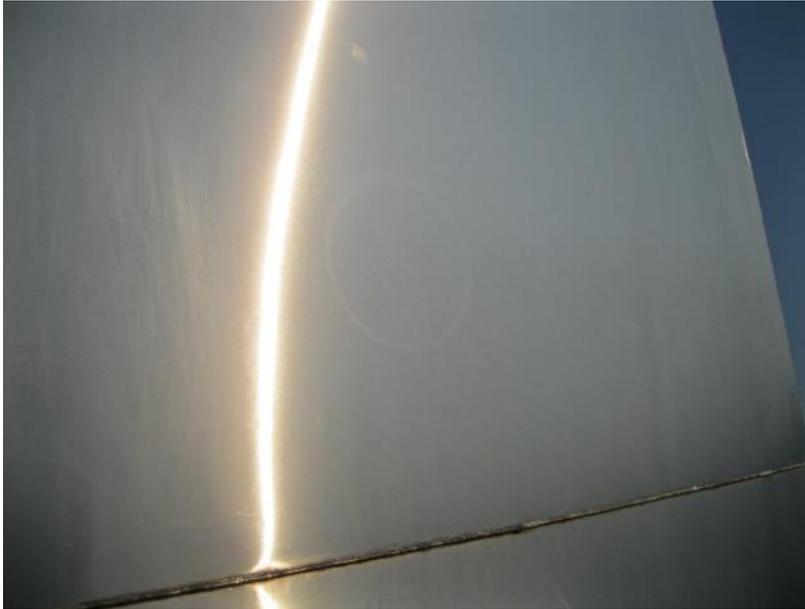
- c. Regular shaped blemishes (Figure 47, Figure 48 and Figure 49)
 - d. Circular blemish with diameter of approximately 10 or 18 inches (Figure 50)
 - e. Variations of dark and light vertical streaking patterns within the surface finish (Figure 51)

Figure 50. Large circle visible on panel surface. (Photo by authors, 2014)

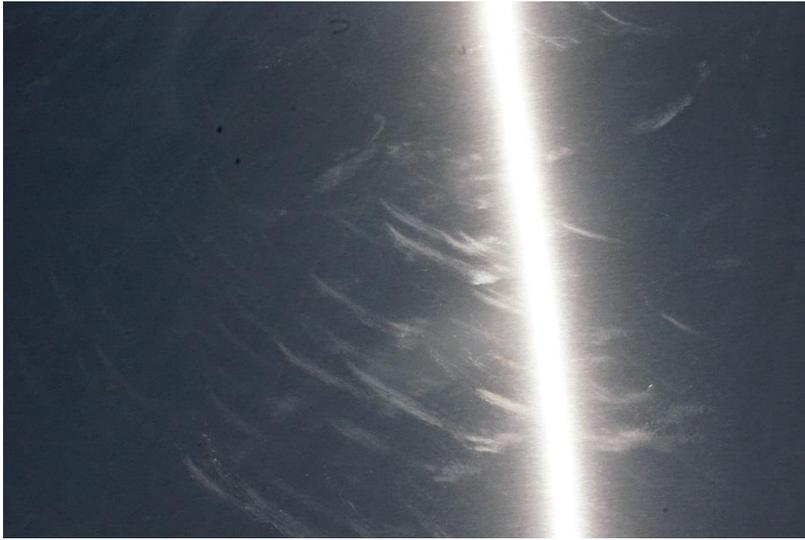
- f. Large arc-shaped blemishes caused by scratches (Figure 52)
6. Rectangular blemishes on the extrados that corresponded to the creeper derrick attachment (Figure 53)

Figure 52. Large arc-shaped blemishes. (Photo by authors, 2014)

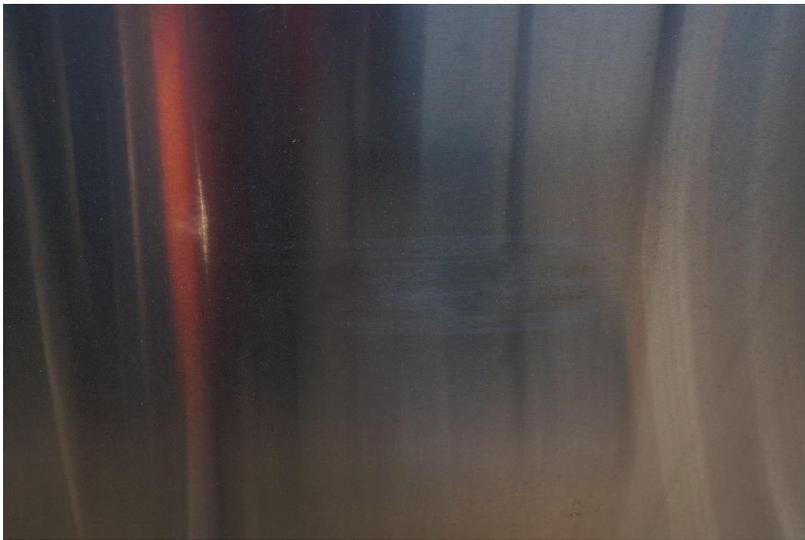
Figure 53. Blemish from field finish area after removing creeper derrick attachment. (Photo by authors, 2014)

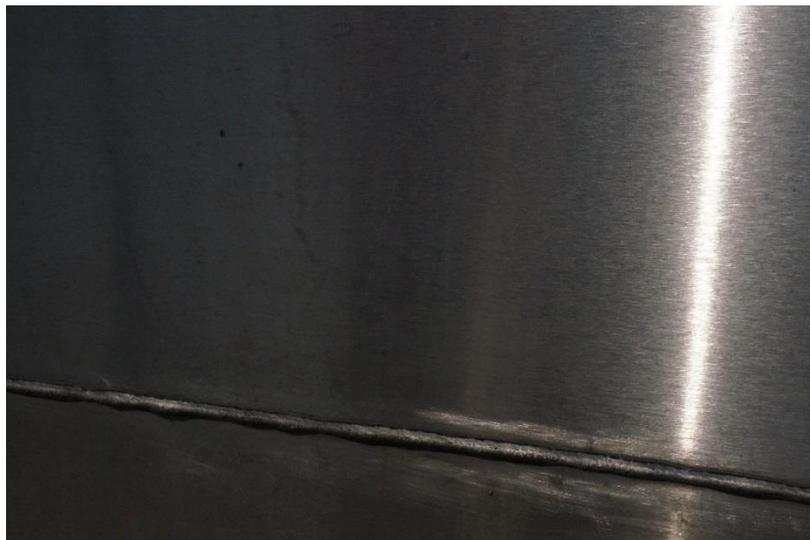
7. Brush marks adjacent to welds (Figure 54)
8. Field welds tended to be rougher with more weld spatter (Figure 55). Some field welds were irregular in shape (Figure 56). Some weld slag was also identified.

Figure 54. Brush marks adjacent to weld. (Photo by authors, 2014)

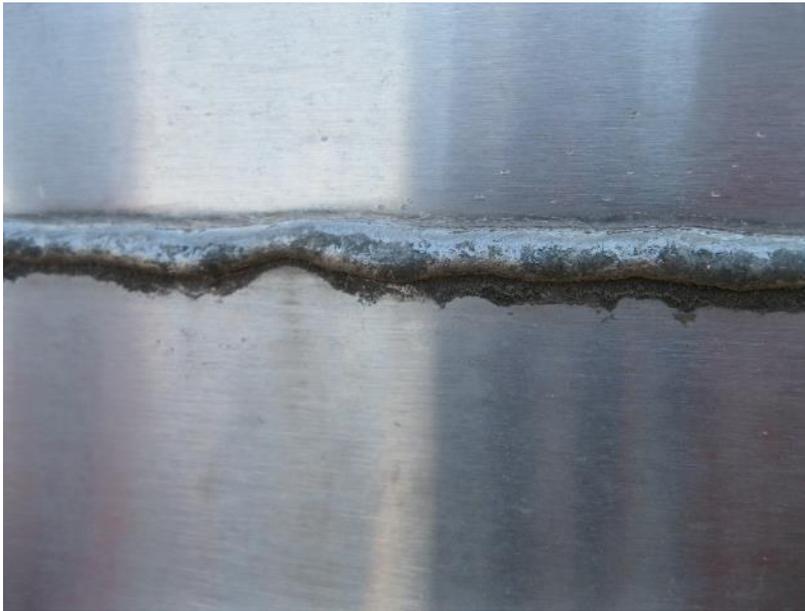
Figure 56. Irregular field weld. (Photo by authors, 2014)

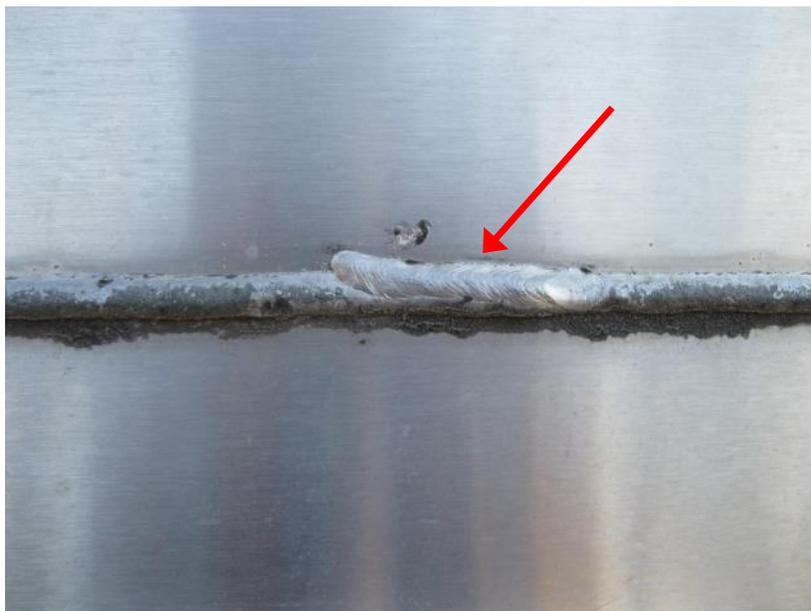
9. Welds that contained weld repairs that exhibited a shiny appearance (Figure 57 and Figure 58). These weld repairs occurred during installation to address weld gaps or porosity.

Figure 57. Weld repair along field weld. (Photo by authors, 2014)

Figure 58. Weld repair along field weld. (Photo by authors, 2014)

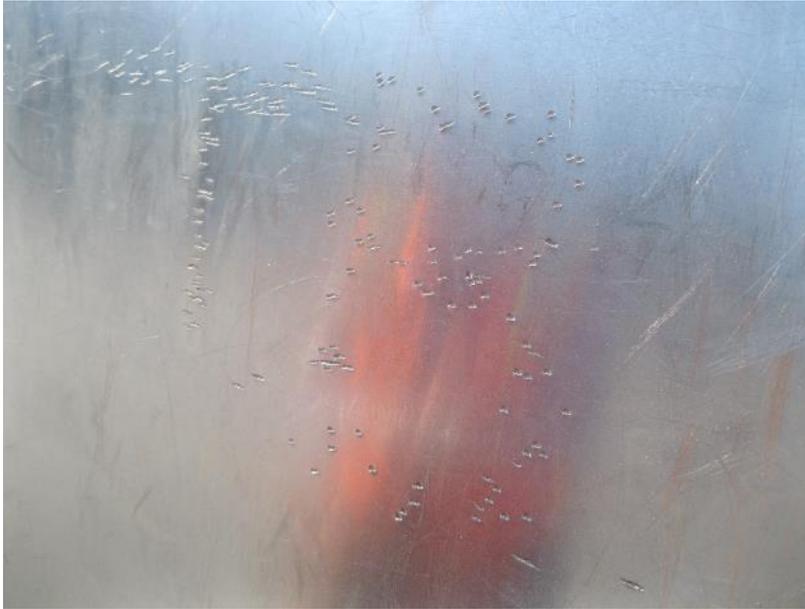
10. Minor pitting of the surface of the stainless steel was observed. The depth of the pit was negligible compared to the panel thickness.
11. Incised graffiti and impact damage blemishes, as typically observed in the two lowest panels at the base of the Arch (Figure 59). The depth of the damage ranged from superficial scratches to deep hammer indents (Figure 60). The depth of the incised graffiti was measured using a pit depth gauge (Figure 61). The incised surface graffiti was generally 1 to 5 mils (0.001 to 0.005 inch) deep. Circular (ball peen) hammer indents on the center section of the extrados (Figure 61) were approximately 6 to 11 mils deep. The deepest damage was observed at the half-moon hammer impact locations at the eastern side of the extrados, where dents were 25 to 35 mils deep. The most prominent damage on the western face near the south edge was generally near 8 to 15 mils deep.

Figure 60. Impact damage (extrados). (Photo by authors, 2014)

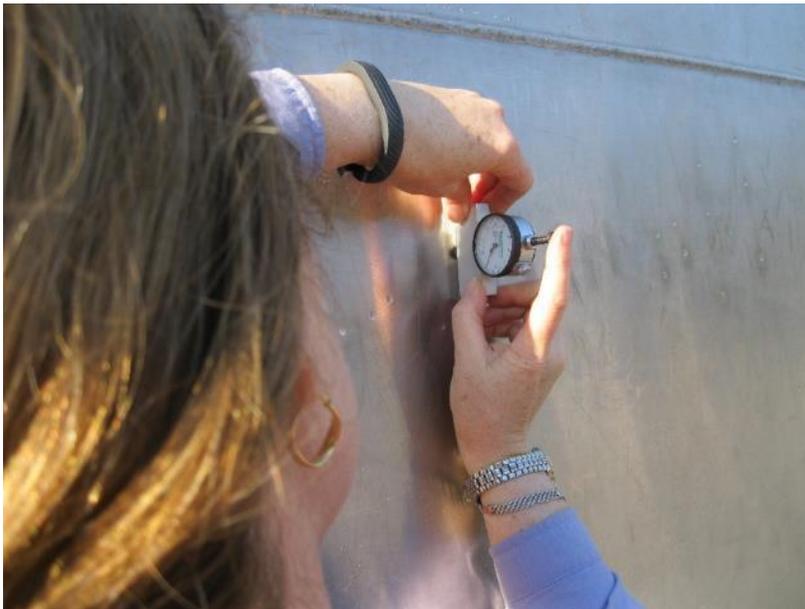
Figure 61. Using pit depth gauge to measure depth of incised graffiti. (Photo by authors, 2014)

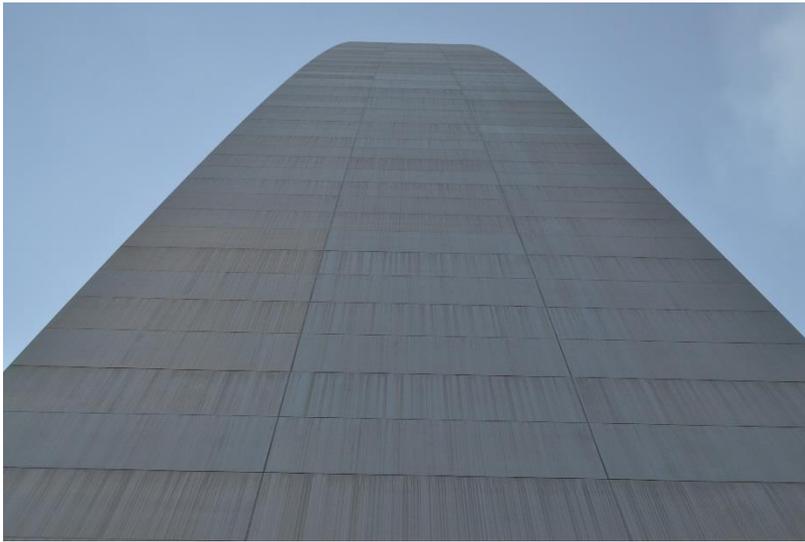
1. Surface deposits were common at many welds that were horizontal to grade.
 - a. The overall appearance tended to have dark vertical streaks and was more pronounced below the field welds (Figure 62 to Figure 64).
 - b. Upon closer inspection, the rougher welds and weld spatter collected more surface deposits below the welds (Figure 65 to Figure 67). The heaviest deposit build-up was observed at locations with more weld spatter.

Figure 62. Deposits from run off from horizontal welds. (Photo by authors, 2014)

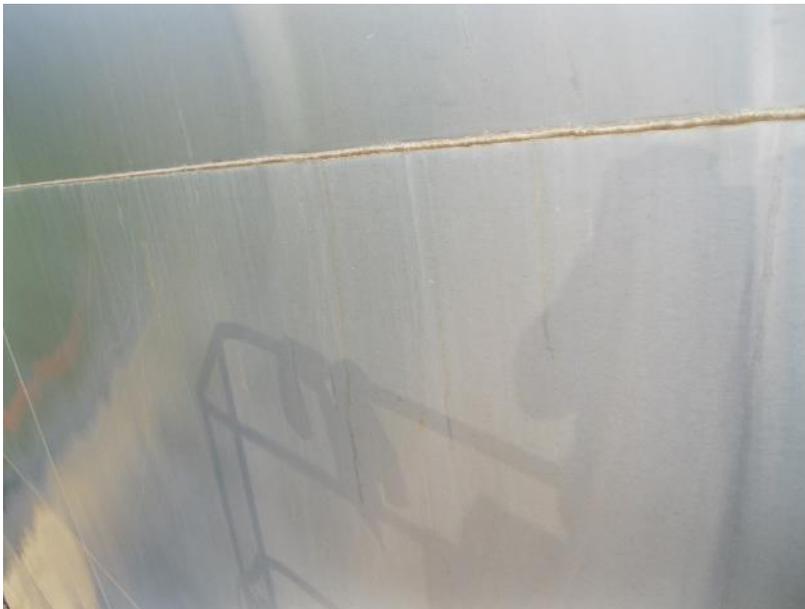
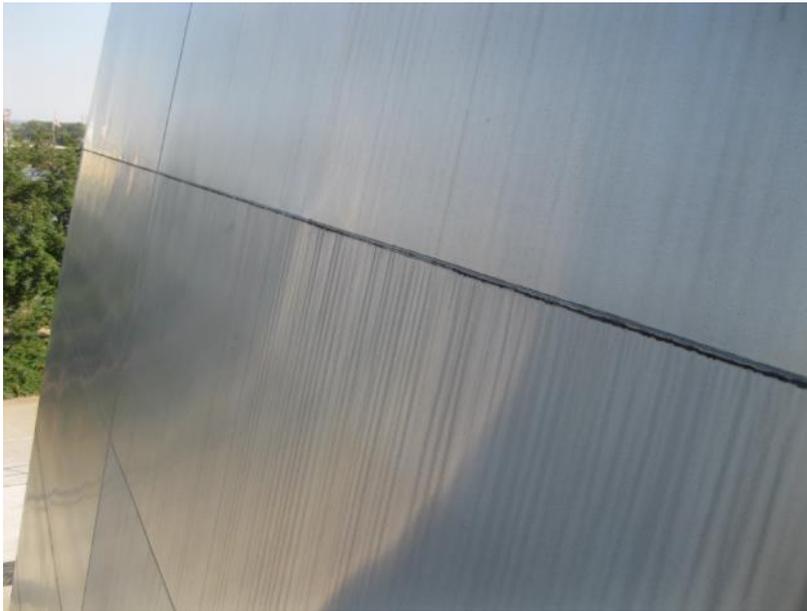
Figure 63. Deposits and blemishes below a field weld. (Photo by authors, 2014)

Figure 64. Deposits and blemishes below a field weld. (Photo by authors, 2014)

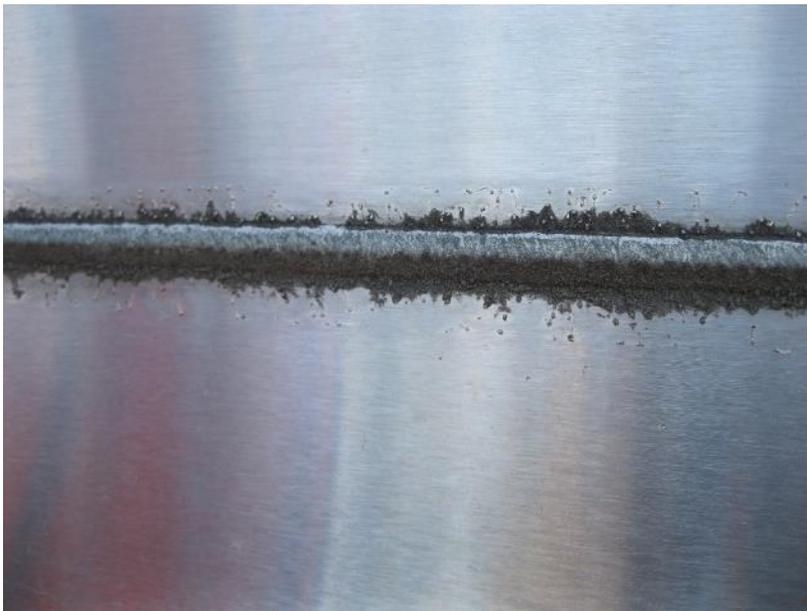
Figure 65. Weld spatter and dark deposits in weld area. (Photo by authors, 2014)

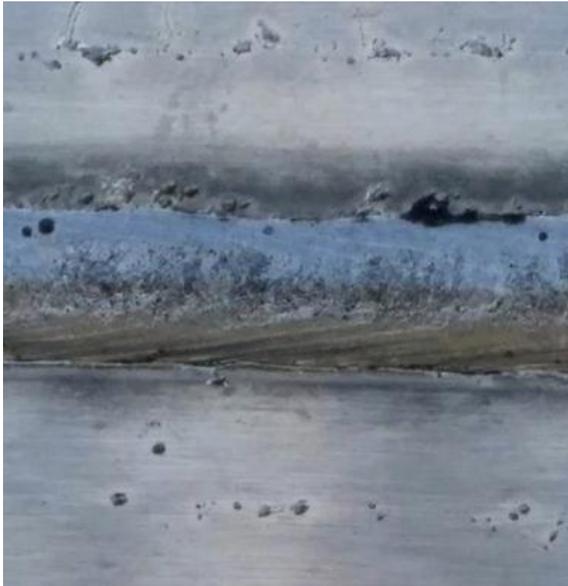
Figure 66. Light weld spatter with little surface deposits. (Photo by authors, 2014)

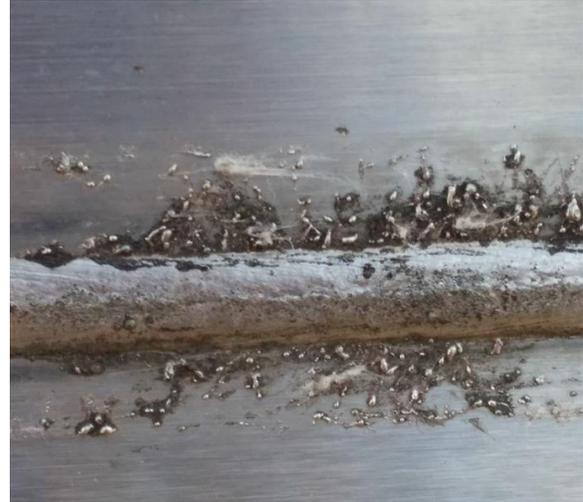
Figure 67. Heavier weld spatter with greater surface deposits. (Photo taken by authors, 2014)

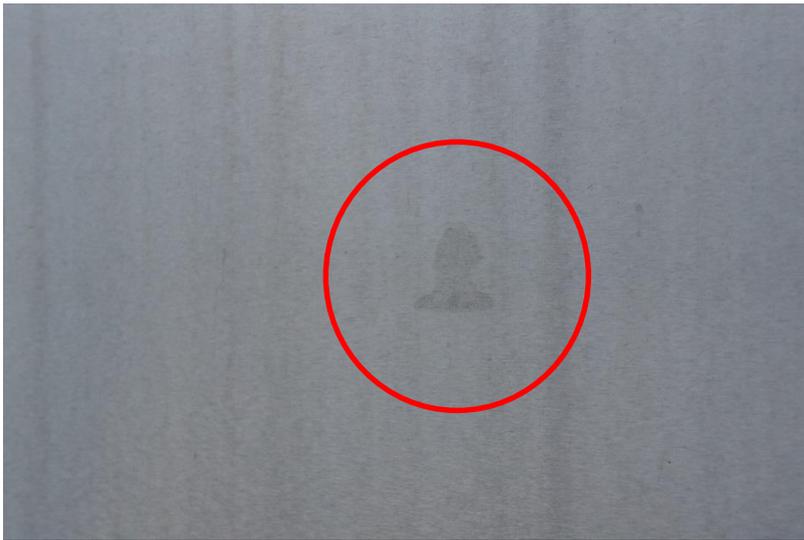
2. Irregularly shaped areas of an oily substance that collected deposits were observed (Figure 68). The deposits could be easily wiped off during the cleaning trials with a clean rag dipped in alcohol.
3. At the base of the Arch on the east face, the chloride content on the surface of the stainless steel was measured using a Chlor*Test as manufactured by Chlor*Rid International, Inc. Surface chloride content is estimated by flushing a known area with an extraction fluid, which is then checked for chloride using a titration tube reading in parts per million (ppm). A test was performed on the east face, 3 feet above grade. The chloride content was below the detection threshold (less than 1 ppm), which may be a result of low exposure or may indicate that the chloride contamination from deicing salts has been removed through rain washing.

Figure 68. Irregularly shaped deposit. (Photo by authors, 2014)

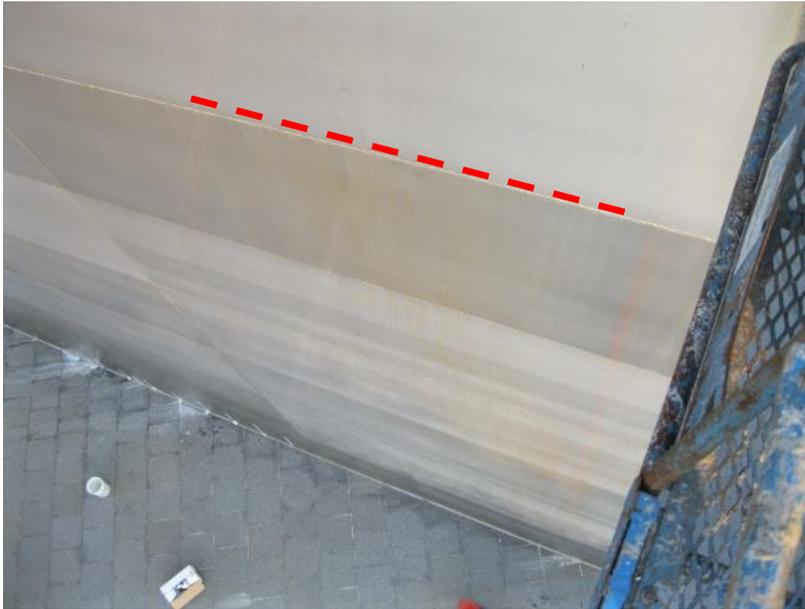
1. Heat tint, which is a dark halo along the length of the weld, was observed at some weld locations (Figure 69).
2. There are isolated areas of red-orange corrosion from iron particle staining below weld (Figure 70).
3. Overall superficial corrosion staining with a brownish-orange color was observed at the lowest five to eight panels (Figure 71).
4. At the base of the Arch in areas of incised graffiti and impact damage blemishes, corrosion staining with a red-orange hue was observed to be associated with incised graffiti at the lowest two panels (Figure 72).

Figure 71. Overall superficial corrosion staining with a brownish-orange color at the grade up to a height of the approximately the eight panels below the red dashed line. (Photo by authors, 2014)

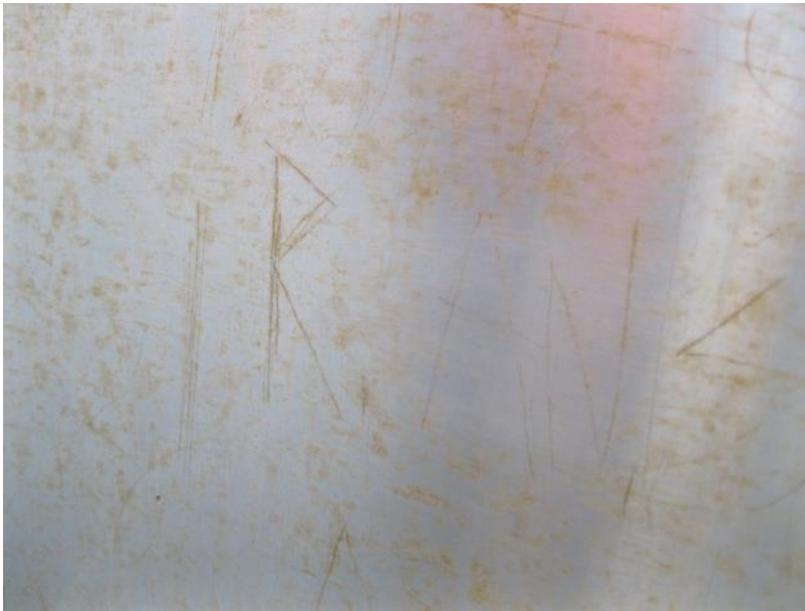
Figure 72. General superficial surface corrosion staining and incised graffiti. (Photo by authors, 2014)

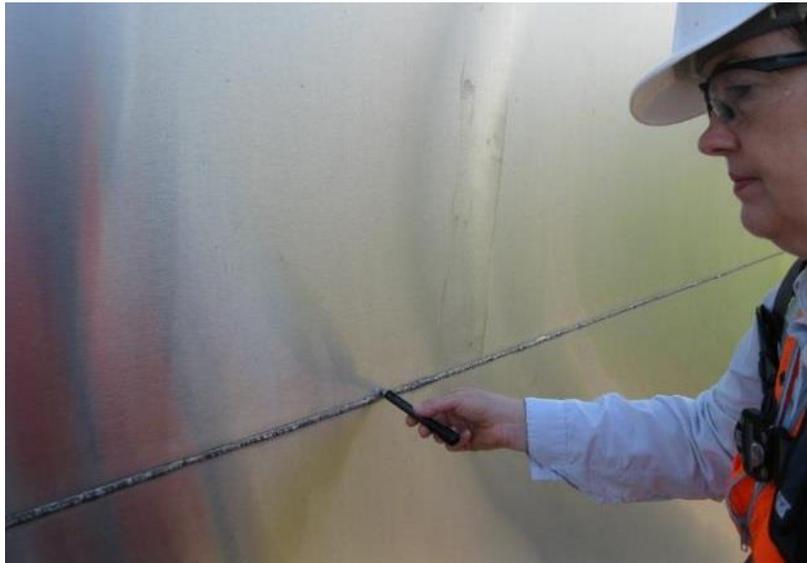
At several locations, a magnet that was part of a magnetic thickness gauge was used to assess the magnetism of the welds (Figure 73). The welds varied from being non-magnetic to being faintly magnetic.

Figure 73. Faintly magnetic weld. (Photo by authors, in 2014)

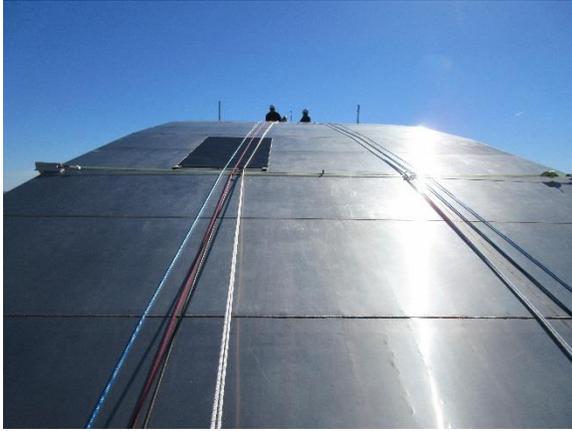
1. At the vent at Station 6:
 - a. Approximately half of the forty-two louver slats were observed with cracked welds, some of which were partially cracked at the attachment of the louver slats to the frame (Figure 74). There is one loose slat which was found to be the source of the tapping noise that can be heard from inside the observation deck during high winds (Figure 75).

*Figure 74. Overall view of vent at Station 6.
(Photo by authors, 2014)*

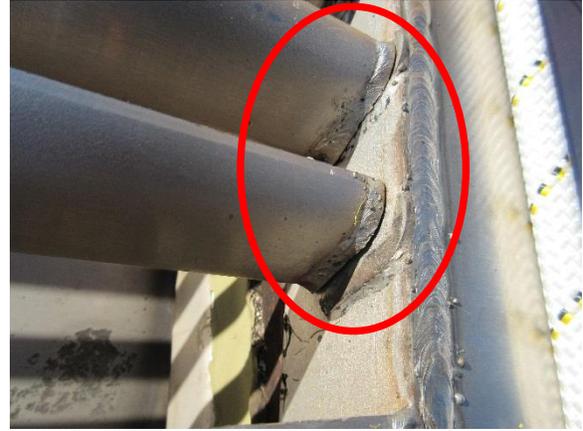
*Figure 75. Cracked weld at loose lower slat.
(Photo by authors, 2014)*

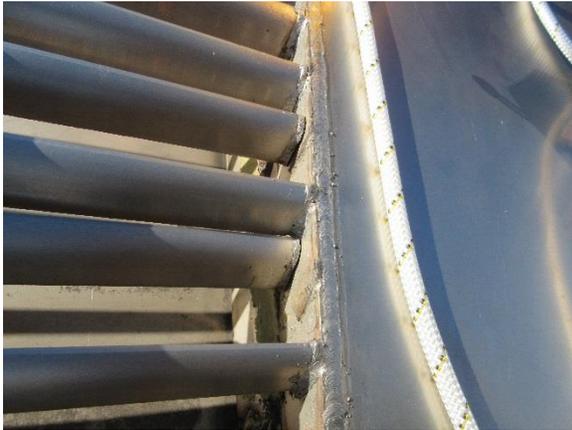
- b. Red-orange corrosion staining was visible between the slats (Figure 76). GSR Sample 14 was collected.
 - c. A black deposit was visible at the top of the vent (Figure 77). GSR Sample 13 was collected.

*Figure 76. Red-orange corrosion staining visible between the louver slats.
(Photo by authors, 2014)*

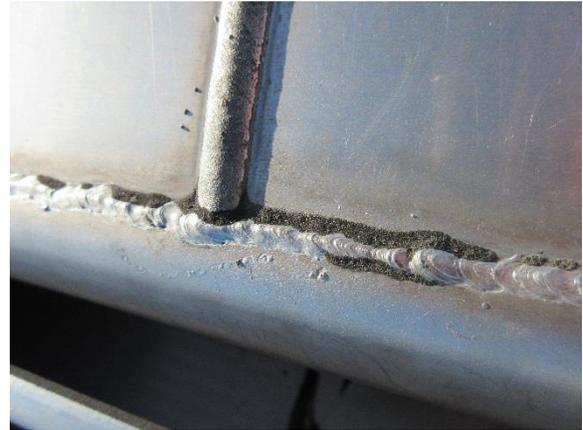
*Figure 77. Black deposits visible at the top of the vent.
(Photo by authors, 2014)*

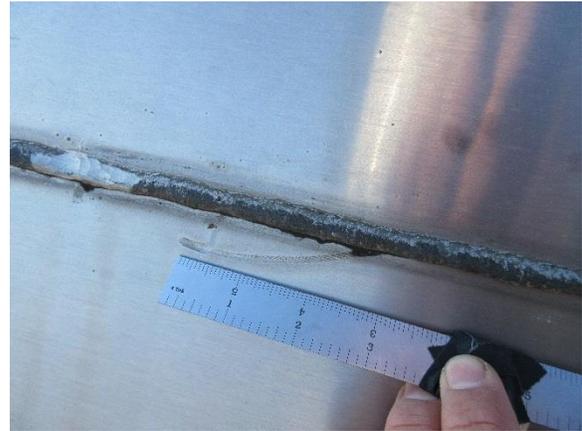
2. At Station 14, a repair at a previous creeper derrick attachment was observed (Figure 78 and Figure 79). No distress was observed.
3. At Station 20, a typical weld profile was documented (Figure 80), and a gouge with a depth of approximately 1/32 inch was observed in the stainless steel panel (Figure 81). No corrosion was observed in the gouge.

Figure 81. Gouge with a depth of approximately 1/32 inch gauge at stainless steel panel at Station 20. (Photo by authors, 2014)

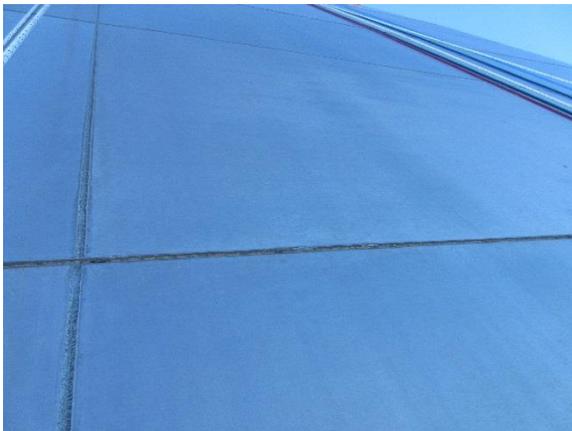
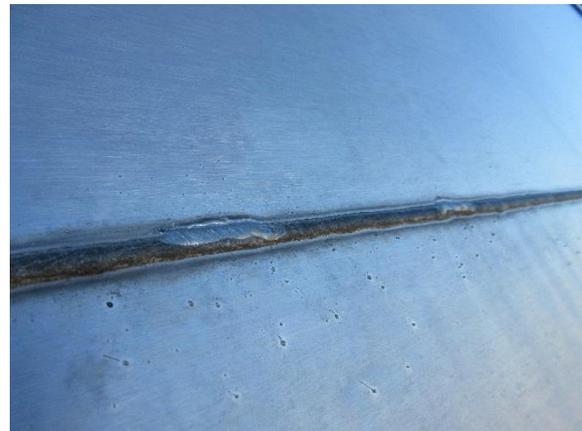
4. At Station 24, a typical weld was found to be faintly magnetic (Figure 82 and Figure 83).
5. At Station 31:
 - a. A blemish was observed in the finish of the stainless steel panel (Figure 84 and Figure 85).

Figure 82. Typical weld repair. (Photo by authors, 2014)

Figure 83. Close up of typical weld repair. (Photo by authors, 2014)

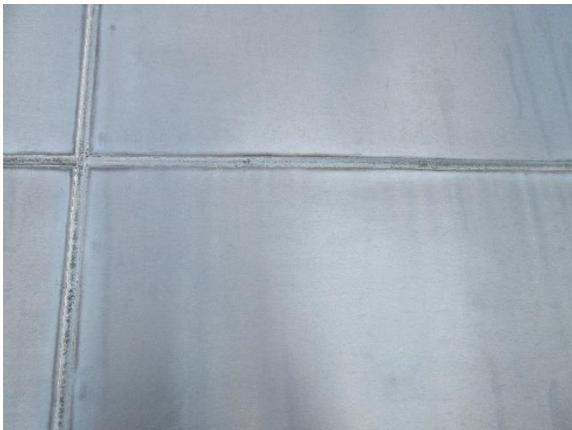
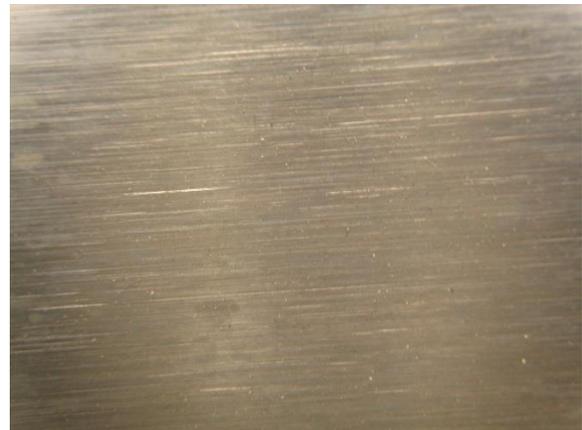
Figure 84. Variation in stainless steel finish at Station 31. (Photo by authors, 2014)

Figure 85. Close-up of the variation in the stainless steel finish. (Photo by authors, 2014)

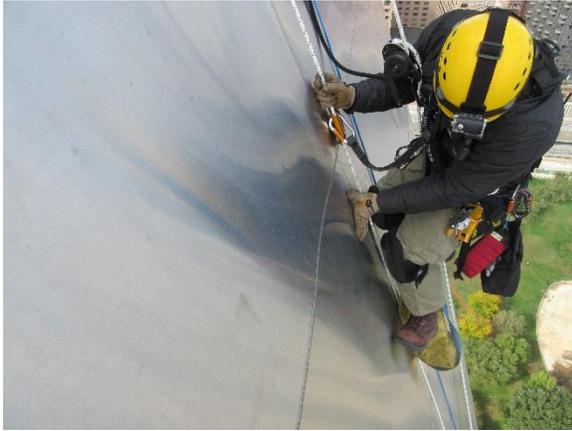
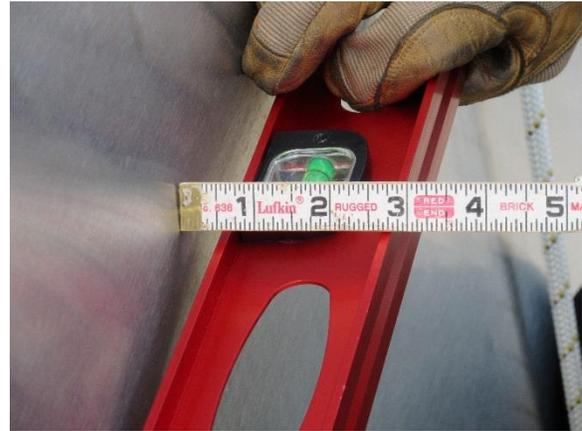
- b. Typical black deposits were visible at welds. GSR Sample 4 was collected.
6. At Station 35, a dent was observed in the stainless steel panel. The dent was measured to have plan dimensions of approximately 24 inches horizontally by two panels vertically, and a depth of 1/2 inch (Figure 86 and Figure 87).

Figure 86. Dent observed at Station 35. (Photo by authors, 2014)

Figure 87. Close up of dent with a ruler at the location of maximum deformation. (Photo by authors, 2014)

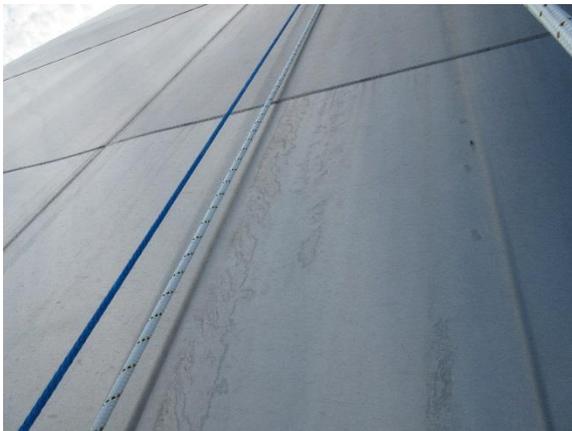
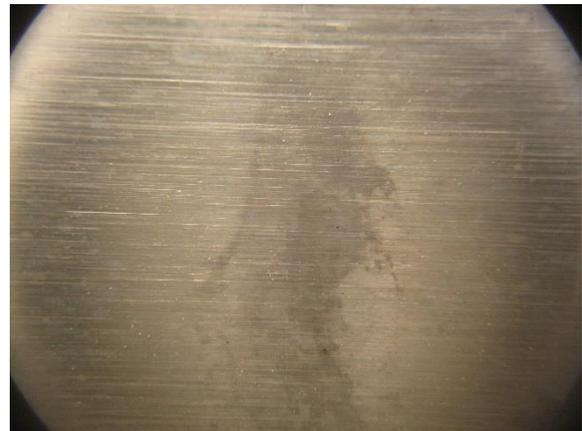
7. At Station 36, a blemish was observed in the finish of the stainless steel panel (Figure 88 and Figure 89).
8. At Station 43 and Station 49, heat tint was observed at welds (Figure 90 and Figure 91). One of the welds was faintly magnetic.

Figure 88. Variation in stainless steel finish at Station 36. (Photo by authors, 2014)

Figure 89. Close-up of the variation in the stainless steel finish. (Photo by authors, 2014)

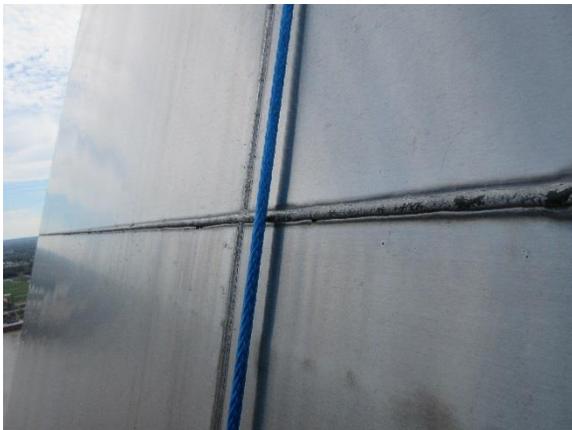
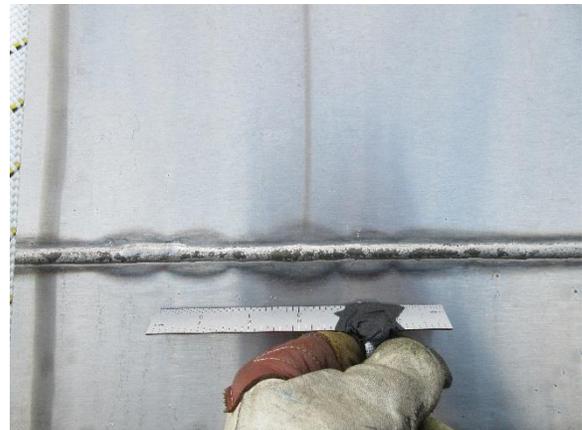
Figure 90. Heat tint observed just above and below weld at Station 43. (Photo by authors, 2014)

Figure 91. Close up of heat tint that may have been partially cleaned. (Photo by authors, 2014)

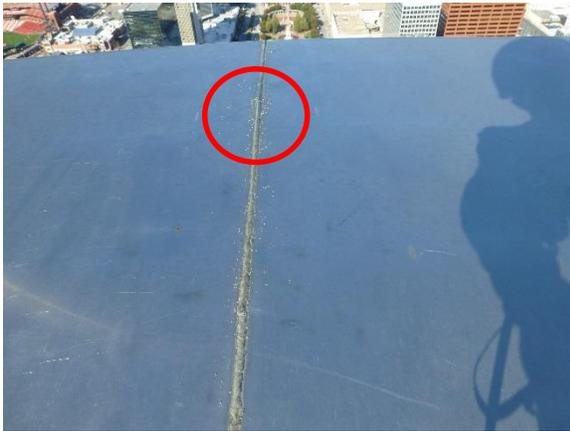
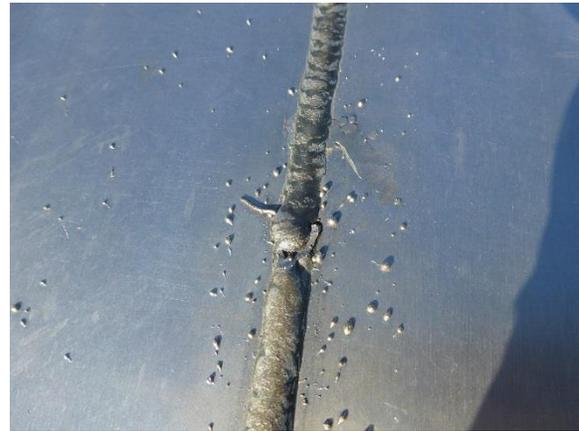
1. At one weld location northwest of the access hatch, a portion of the weld is irregular (Figure 92 and Figure 93). No distress or deterioration was observed at the weld locations. No cracked welds were observed.
2. The chloride content on the surface of the Arch west face was measured using a Chlor*Test kit. The test location was accessed from a window. The chloride content was below the detection threshold (less than 1 ppm).

Figure 92. Overall view of weld with irregular weld (circle). (Photo by authors, 2014)

Figure 93. Close up of irregular weld with no crack observed. (Photo by authors, 2014)

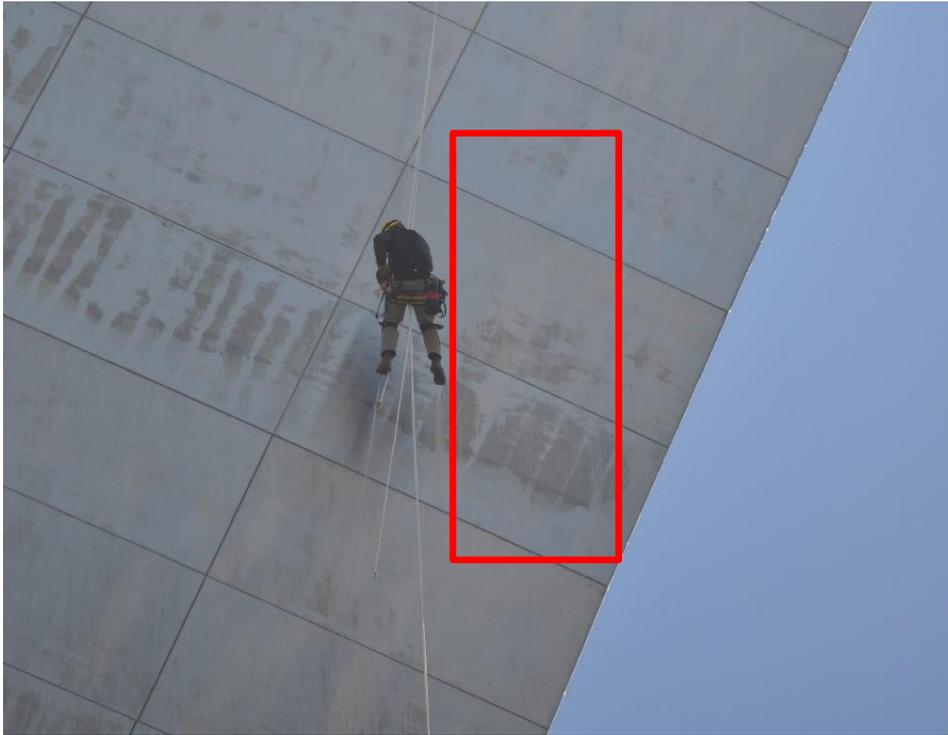
- b. Staining, parallel to station marks, was red in hue.
 - c. Staining, perpendicular to station marks, was violet in hue.
 - d. Vertical streaking appeared similar to patterns that could be attributed to water running down the face of the steel panels. The vertical streaking was visible from grade (Figure 96).

Figure 96. Vertical streaking visible from grade at Station 35 (rectangle). (Photo by authors, 2014)

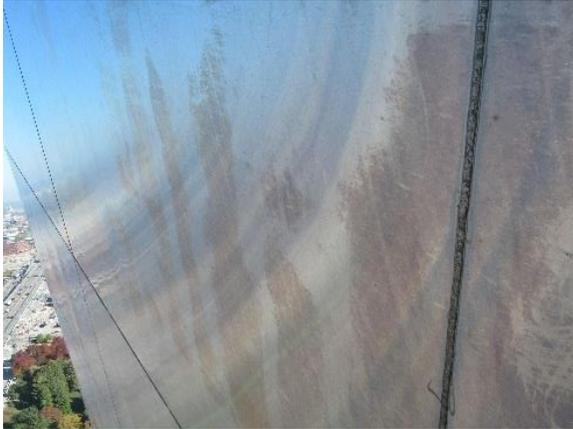
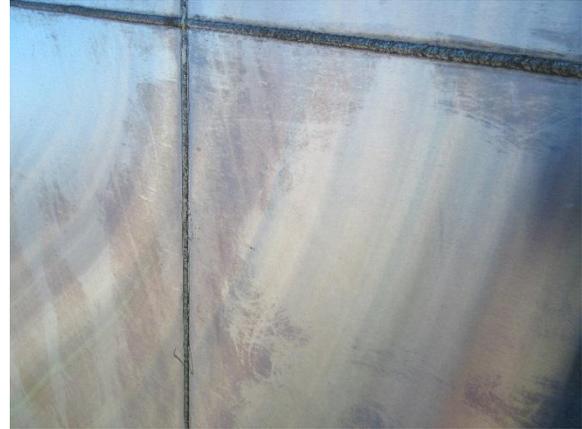
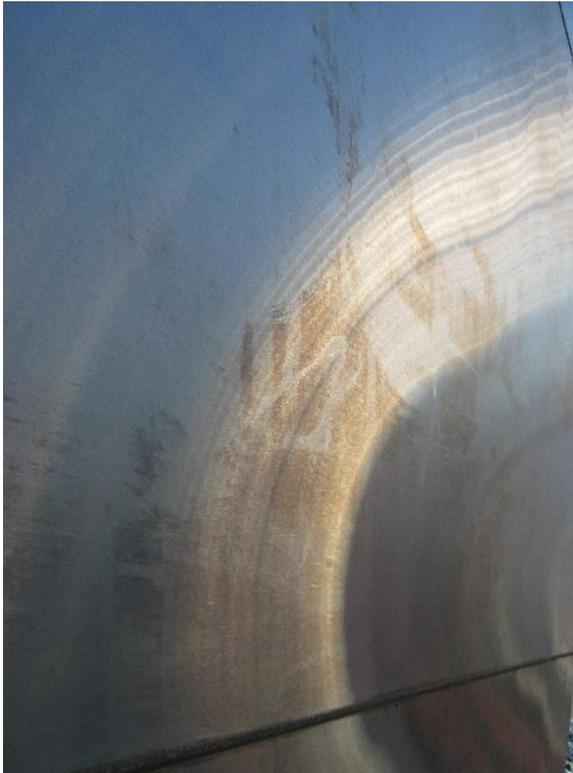
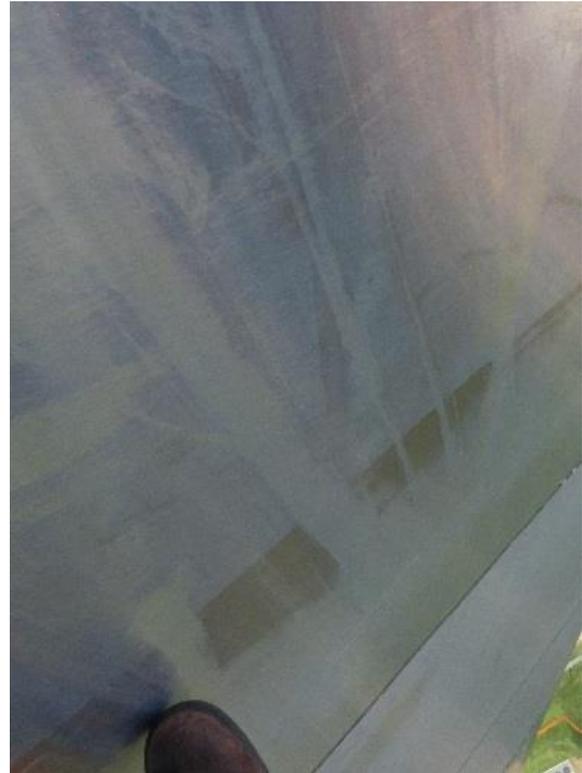
1. Overall photos of the stainless steel at Station 35 are provided as Figure 96 through Figure 101. General observations included:
 - a. The discoloration was located in an area which appeared to have had a chemical applied (intentionally or unintentionally) and of not being removed, as it was at adjacent unstained areas.

Figure 98. Overall view of stainless steel at Station 35. (Photo by authors, 2014)

Figure 99. Overall view of stainless steel at Station 35. (Photo by authors, 2014)

Figure 100. Overall view of discoloration of stainless steel at Station 35. (Photo by authors, 2014)

Figure 101. Overall view of discoloration of stainless steel at Station 35. (Photo by authors, 2014)

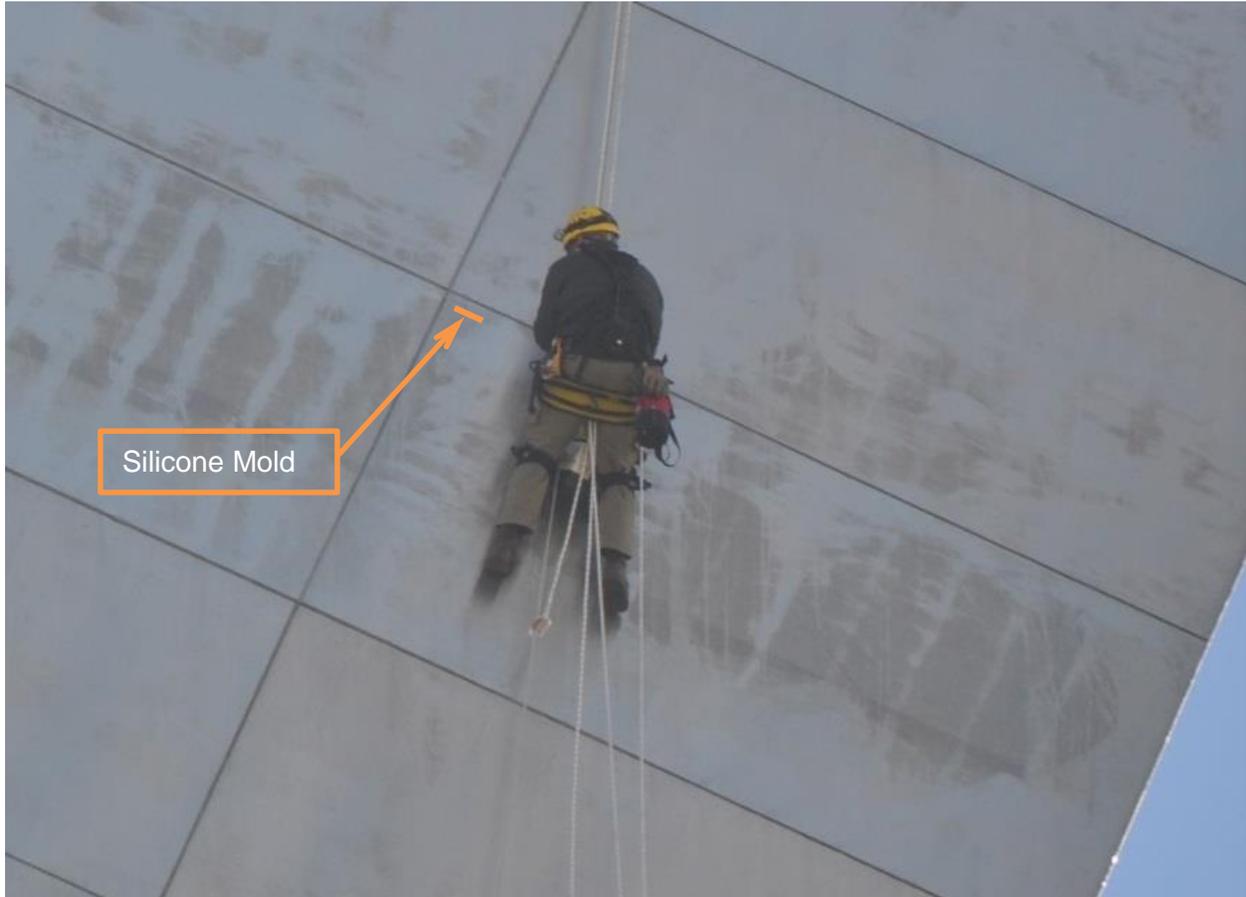
Sample	Location
1	Location of blemish consisting of dark and light vertical streaking patterns within the surface finish on extrados from the lift at Station 69 (similar to Figure 51) (Figure 107)
2	Location of blemish at stainless steel below weld on intrados at Station 35 (Figure 104)
3	Shop weld at top of Arch near access hatch (Figure 105)
4	Field weld at top of Arch near access hatch (Figure 106)
5	Typical surface at top of Arch near access hatch

Figure 104. Close-up view of hands-on inspection location noting location of silicone mold. See Figure 95 for an overall view of Station 35. (Photo by authors, 2014)

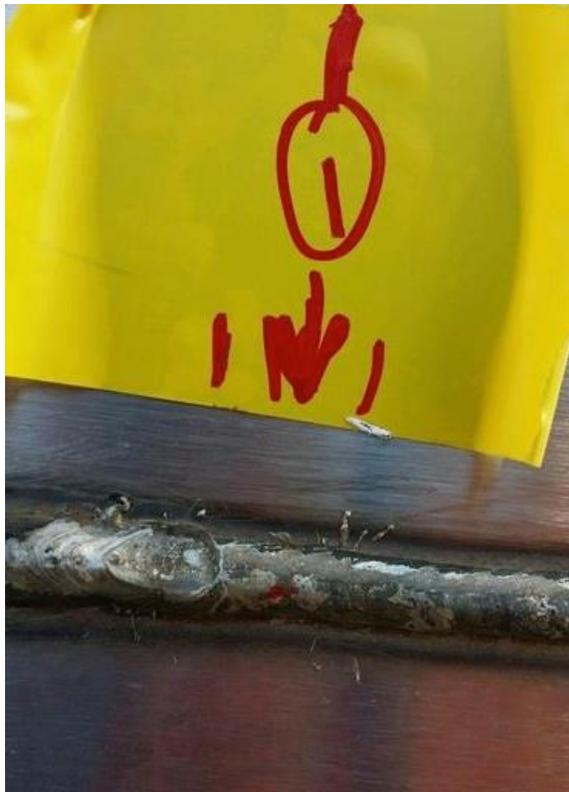
Figure 116. Weld Sample 1 (shop weld), prior to removal. (Photo by authors, 2014)

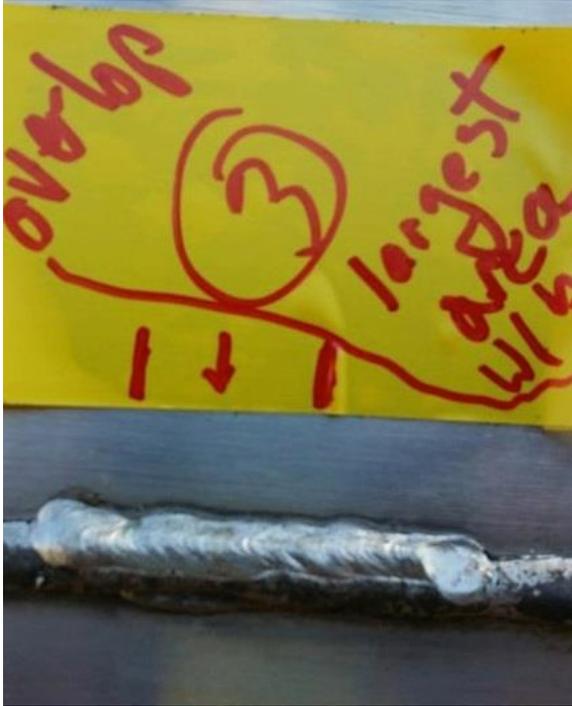
Figure 118. Weld Sample 3 (field weld), prior to removal. (Photo by authors, 2014)
