GATEWAY ARCH Corrosion Investigation Part III

St. Louis, Missouri

Final Report

April 3, 2015

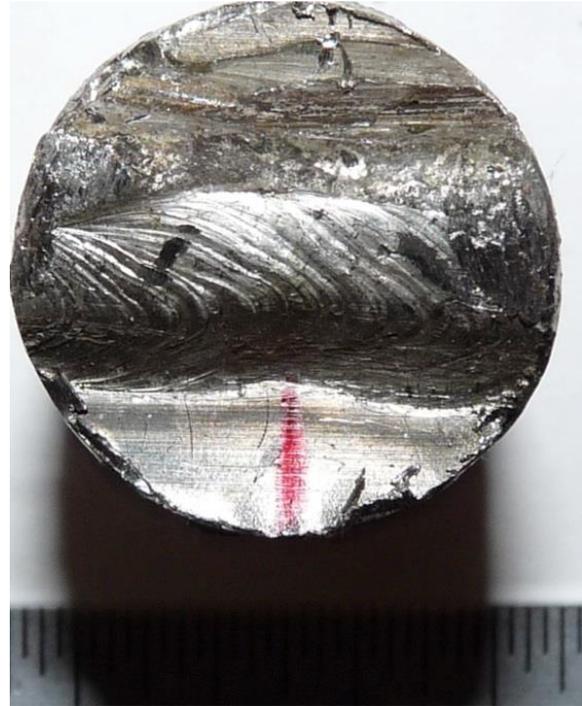
Figure 119. Weld Sample 3 (field weld), as-received condition. (Photo by authors, 2014)

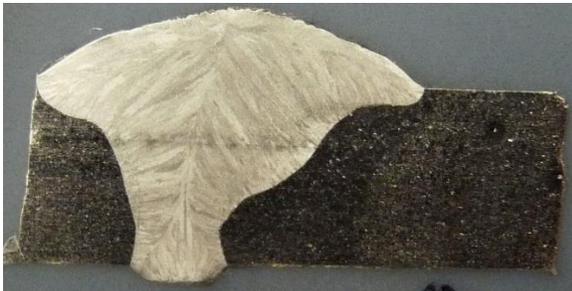
1. The welds in each sample were full penetration (Figure 120 and Figure 121).
2. Varying amounts of weld porosity were noted in all of the sectioned welds (Figure 122). The largest weld metal void was noted in Sample 4, with a diameter of approximately 0.04 inch (Figure 123). Sample 5 contained a void with an approximate diameter of 0.024 inch (Figure 124).

Figure 120. Macrograph cross-section of weld Sample 1 in the etched condition. (Photo by authors, 2014)

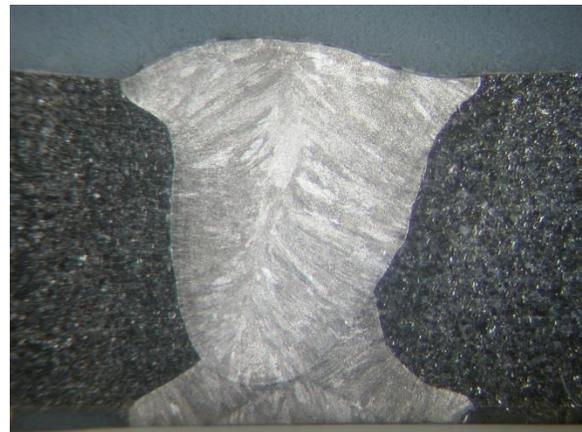
Figure 121. Macrograph cross-section of weld Sample 2 in the etched condition. (Photo by authors, 2014)

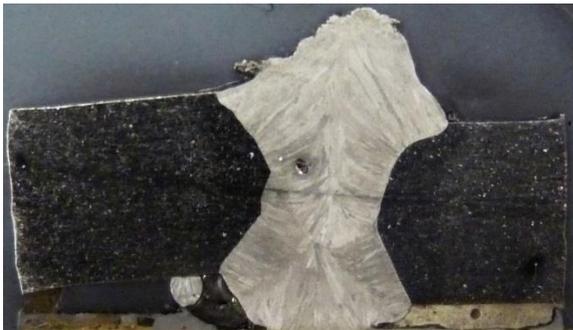
Figure 124. Macrograph cross-section of weld Sample 5 in the etched condition showing porosity. (Photo by authors, 2014)

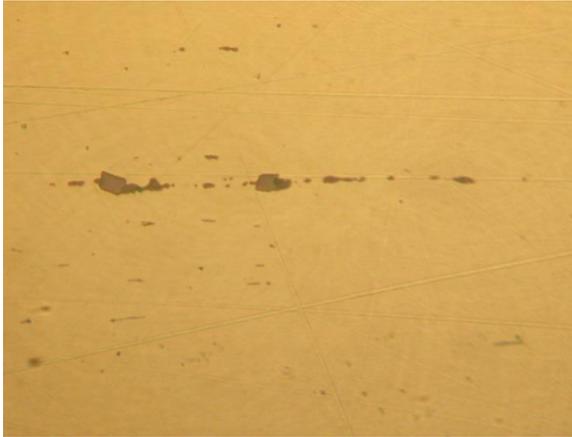
5. Slag contamination was observed at the weld in Sample 5 (Figure 128 and Figure 129).
6. Magnesium sulfide inclusions in the stainless steel plate were observed in Samples 1 and 3 (Figure 130 through Figure 132).

Figure 130. Micrograph of plate inclusion, Sample 1, as-polished condition (517x). (Photo by authors, 2014)

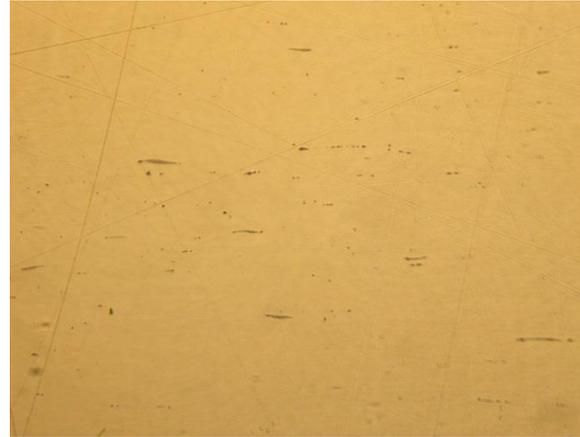
Figure 131. Micrograph of manganese sulfide stringers in the plate, Sample 1, as-polished condition (256x). (Photo by authors, 2014)

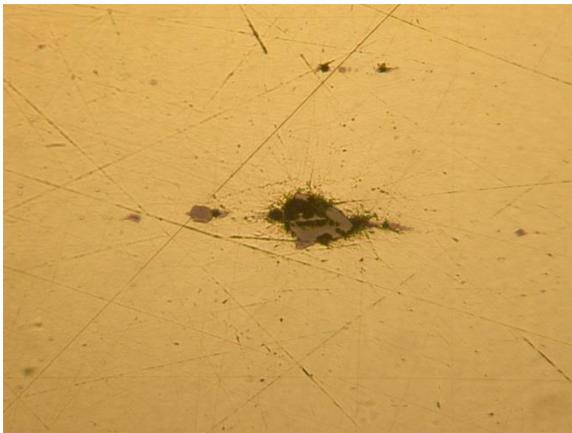
Figure 132. Micrograph, Sample 3, plate inclusion, as-polished condition (256x). (Photo by authors, 2014)

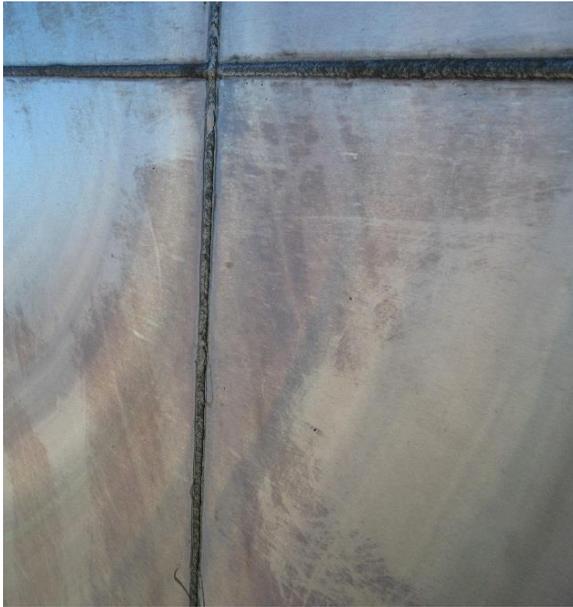
Figure 143. Location of discoloration on intrados at Station 35. (Photo by authors, 2014.)

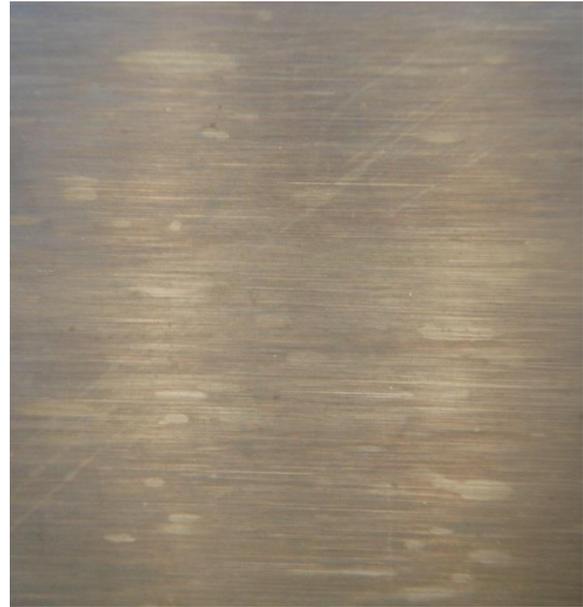
Figure 144. Photomicrograph of discoloration at residue Sample 1. (Photo by authors, 2014.)

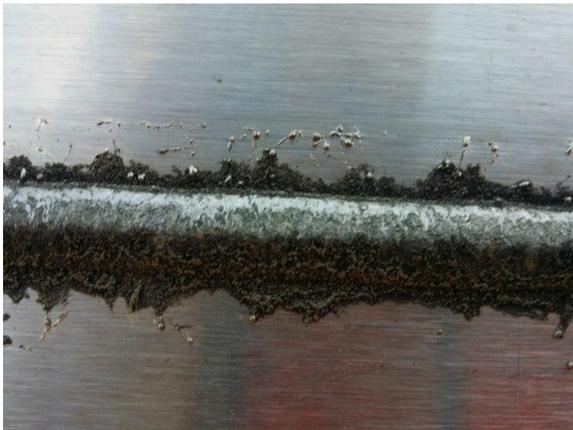
Figure 145. Sample 2B collection location, which appeared to have the same type of deposits as Sample 2A. (Photo by authors, 2014.)

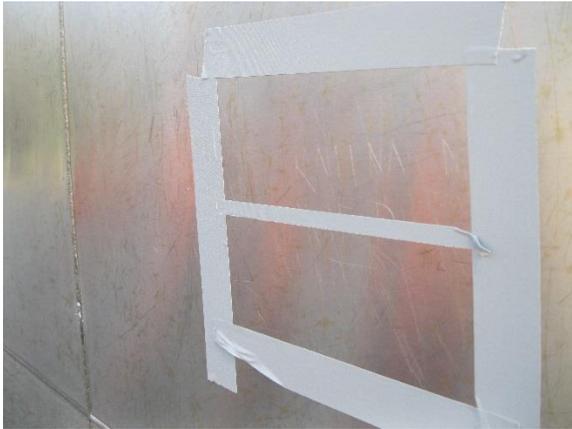
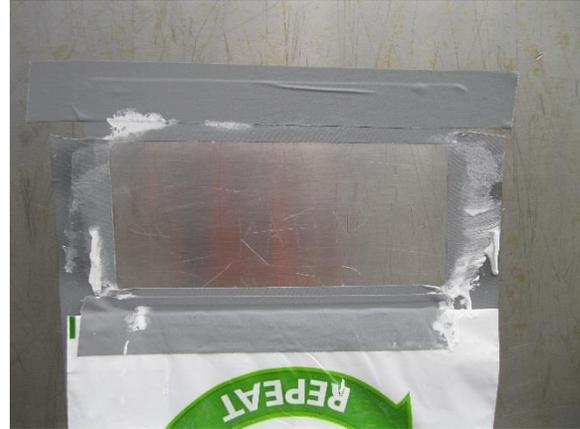
3. A cleaning trial, which was labeled M, was performed at a severe incised graffiti location on the west face of the north leg (Figure 153 and Figure 154).

5. The cleaning at trial area M dramatically changed the surface appearance, but resulted in a very coarse and rough surface that did not acceptably simulate the original surface finish (Figure 153 and Figure 154).

Figure 153. Cleaning Trial M before. (Photo by authors, 2014.)

Figure 154. Cleaning Trial M after. (Photo by authors, 2014.)

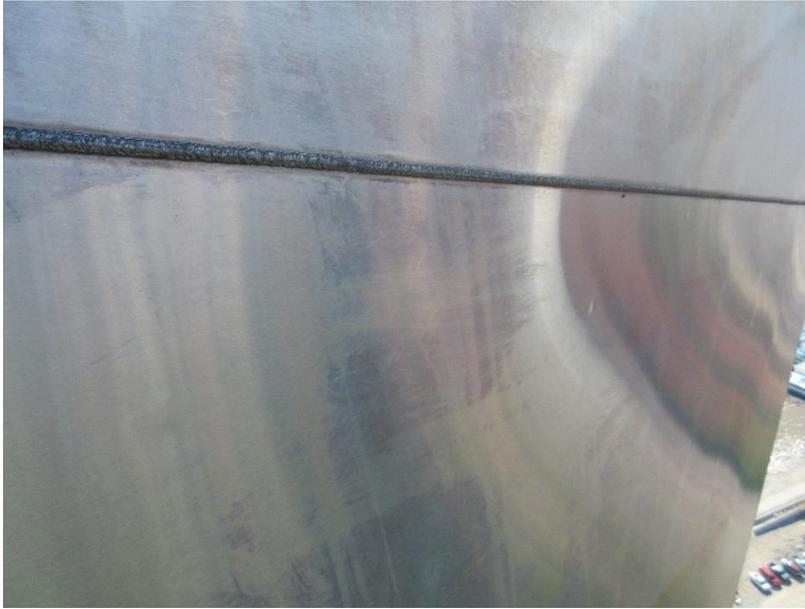
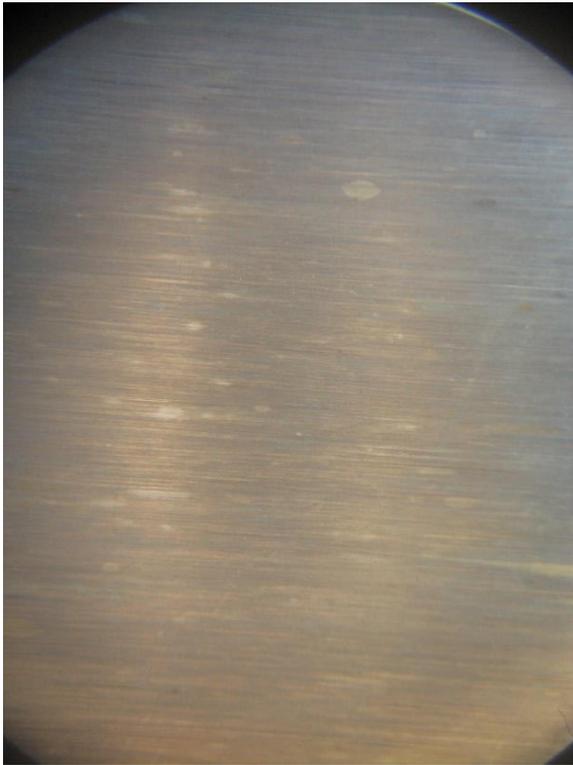
7. During all the trials at the intrados at Station 35 (Figure 155 through Figure 158), light atmospheric deposits were removed, although the removals were too slight to be visually noticeable from grade when viewed with the spotter scope. The discoloration became noticeably less visible when all the

Figure 156. Overall of location of cleaning Trials 2 through 4 before cleaning. (Photo by authors, 2014.)

Figure 157. Photomicrograph before cleaning at trial areas 2 through 4. (Photo by authors, 2014.)

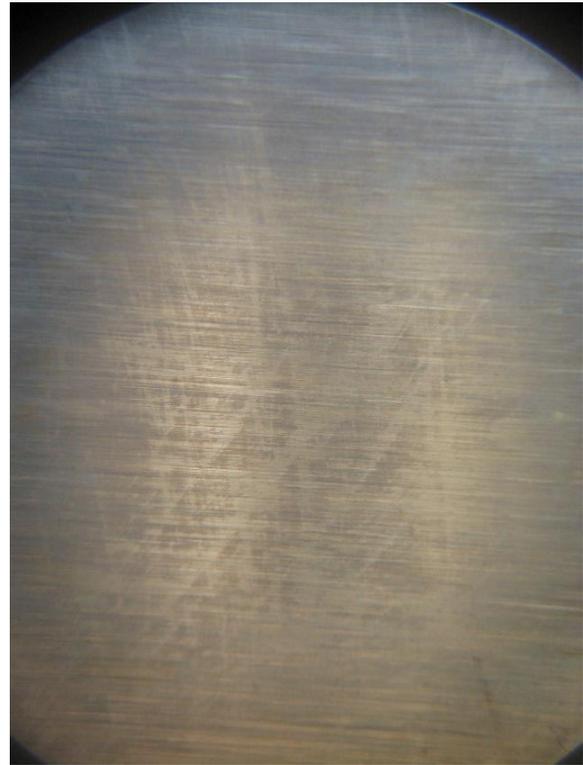
Figure 158. Photomicrograph before cleaning at trial areas 2 through 4. (Photo by authors, 2014.)

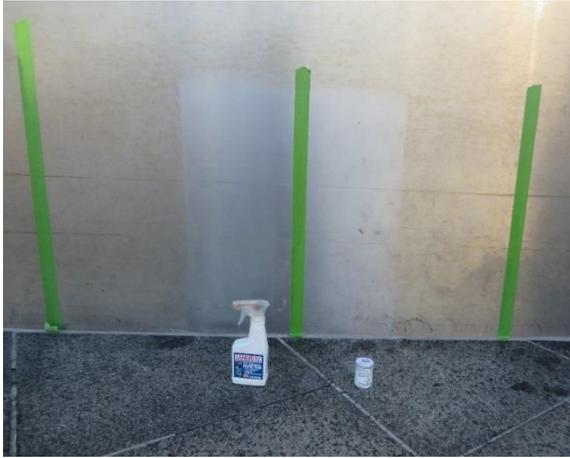
8. The chemical cleaners alone did not change the surface profile, but when combined with the abrasive pads, some alteration to the surface profile was noted. The Norton Ultra Fine pad caused the most significant change to the surface profile.
9. While initially Trials L, N, and O appeared to remove the dark streaks while the surface was wet, the streaks reappeared when the surface dried.
10. Trial P successfully removed the oily deposit.
11. The wax resulted in minimal visual change to the stainless steel, while the lanolin created a darker and glossier appearance with a slight orange tint (Figure 159 and Figure 160).

Figure 159. Wax and lanolin trials before

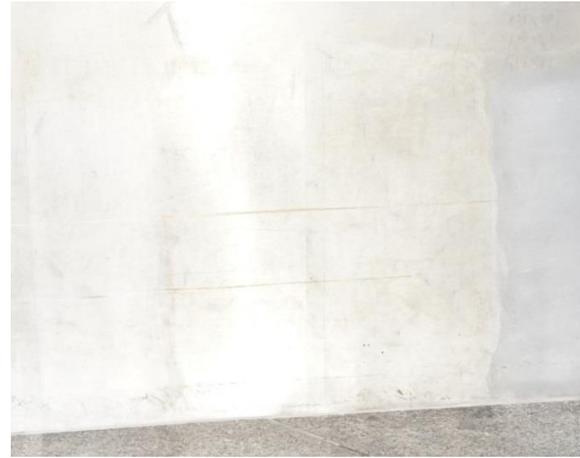
Figure 160. Wax and lanolin trials after

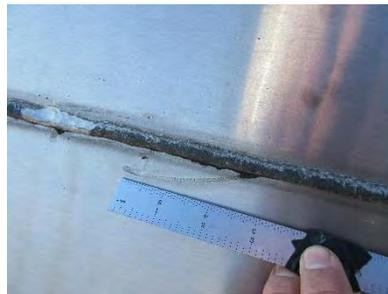
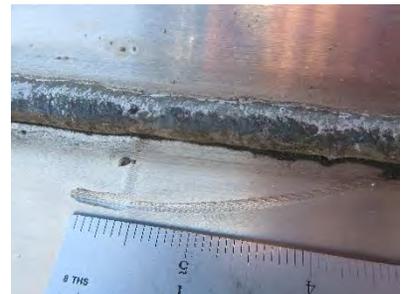
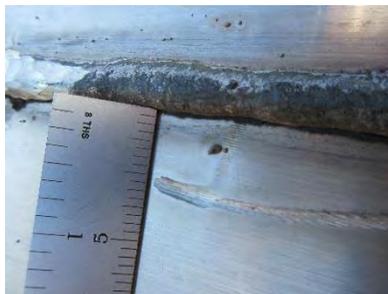
St.	Weld	Location Comments	Pictures		Notes During Inspection per A. Sterns
		CMF Notes	A. Sterns	iLoupe	
18	36				
	37				Derrick crane attachment observed without distress
19	38				
	39				
20	40		0178 - 0183		Typical weld profile
	41		0184 - 0187		1/32 inch removed at grinding location; no corrosion observed
21	42				
	43				
22	44	Stabilizing bridge; proper texture not restored (ST 22 and 23) based on archival research			
	45	Water froze on surface during construction causing staining (ST 22 to 30) based on archival research			
23	46				
	47				
24	48				
	49		0188 - 0191		Slightly magnetic; light repairs at welds
25	50				
	51				
26	52				
	53				
27	54	1-1/8 inch out of camber (ST 27) based on archival research			
	55				
28	56				
	57				
29	58				
	59				
30	60				
	61		0192 - 0198		Typical photos
31	62				
	63		0199 - 0205	0073 - 0081	Different finish at panels; black residue with GSR (#4) at center panel
32	64

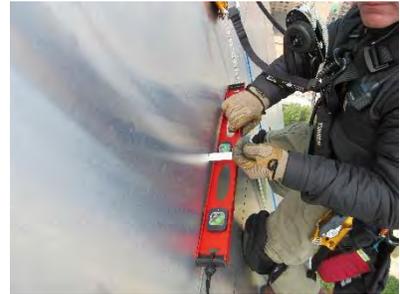
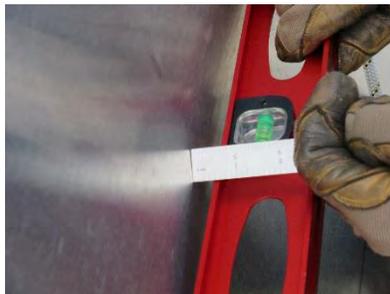
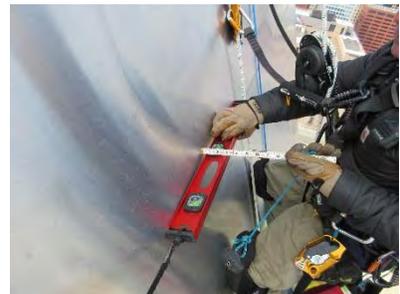
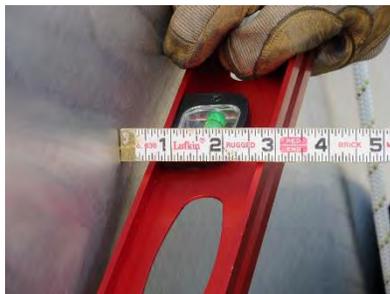
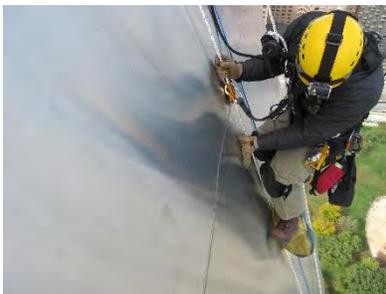
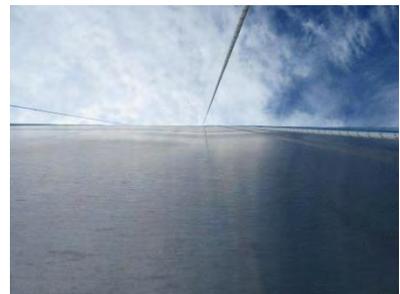
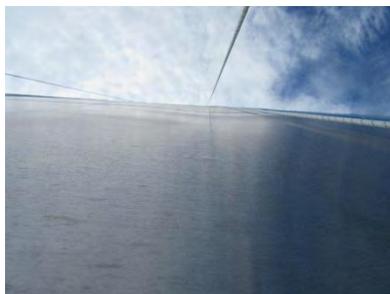
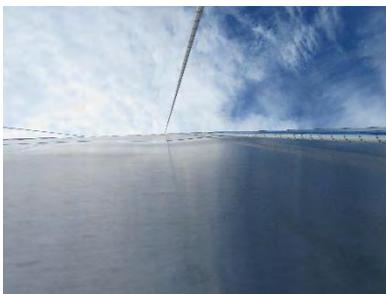
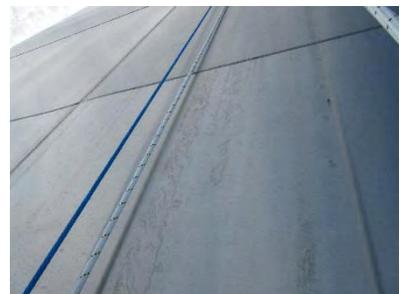
65				
33	66				
	67				
34	68				
	69				
35	70		0206 - 0215		Dent (1/2x2 panels vertical x 24 inches wide) centered on one stiffener; no scratches observed
	71

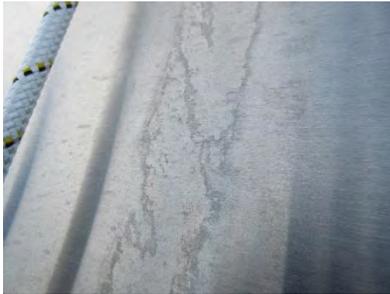
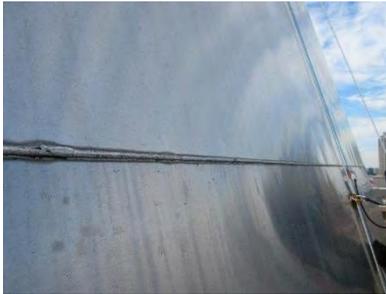
St.	Weld	Location Comments	Pictures		Notes During Inspection per A. Sterns
		CMF Notes	A. Sterns	iLoupe	
36	72		0216 - 0217	0082 - 0084	Different finish at stainless steel
	73	Significant deflections during construction (ST 36 and 37) based on archival research			
37	74				
	75				
38	76				
	77				
39	78				
	79				
40	80	Surface damage and carbon staining noted during construction based on archival research			
	81				Confirmed 'oil canning' typically at 1/8 inch depth
41	82				
	83				
42	84				Confirmed black residue is typical
	85				
43	86	End of concrete fill	0218 - 0223		Some magnetism; heat time observed at weld
	87		0224 - 0225		
44	88	Jacking during construction (ST 44 and 45) based on archival research			
	89				
45	90				
	91				
46	92				
	93				
47	94				
	95				
48	96				
	97				
49	98				
	99				Black residue with GSR (#15)
50	100		0226 - 0227		Overheated area with more heat tint
	101				
51	102				
	103

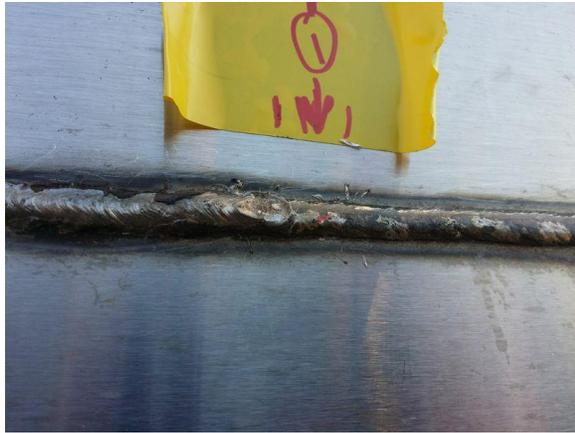
Figure 1. Sample 1 before

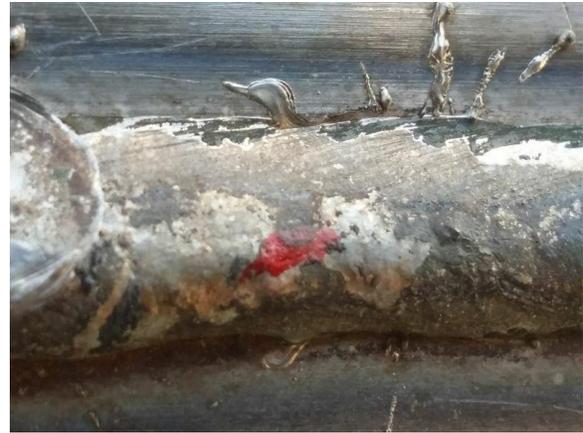
Figure 2. Sample 1 before

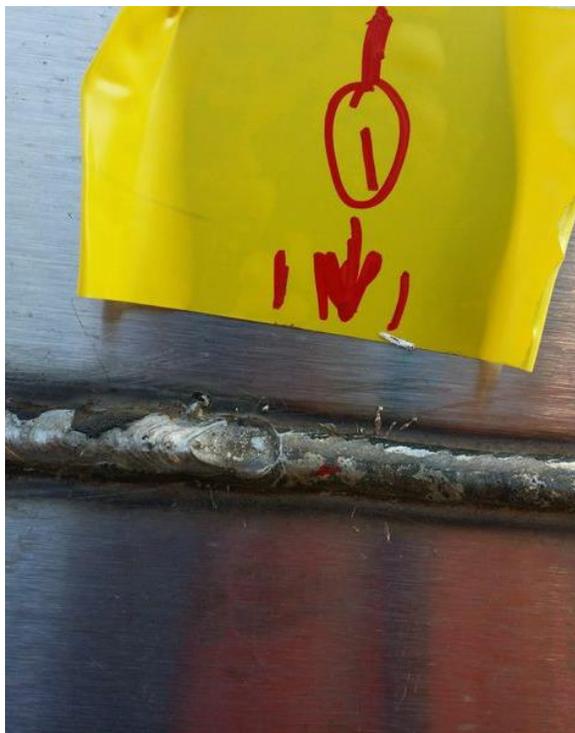
Figure 3. Sample 1 before

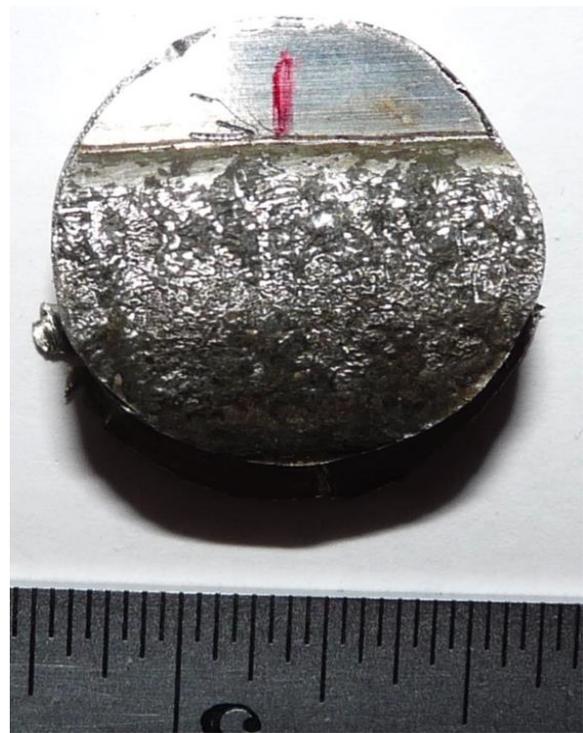
Figure 4. Sample 1 (Scale=1/32")

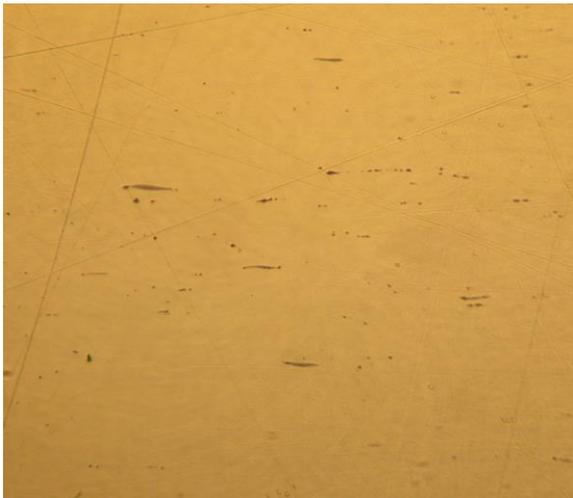
Figure 14. Optical micrograph of polished plate inclusion (517x)

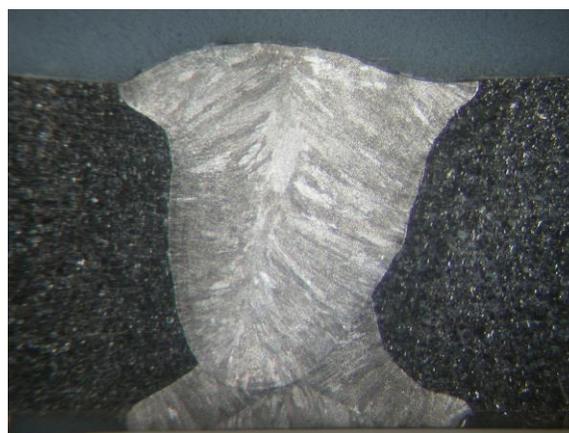
Figure 76. Etched cross section

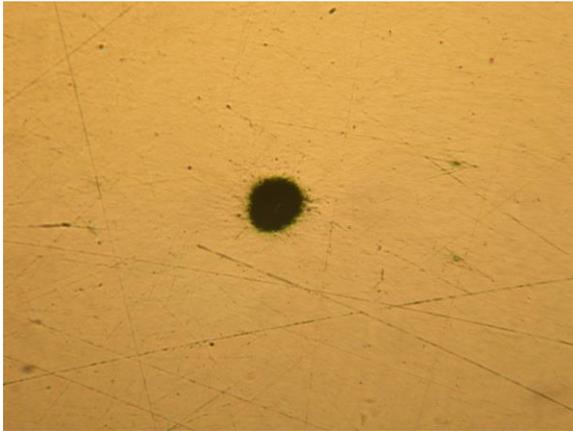
Figure 103. Optical micrograph, plate inclusion, as-polished condition (256x)

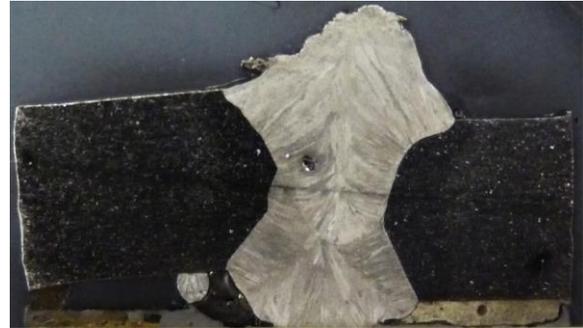
Figure 150. Etched cross section

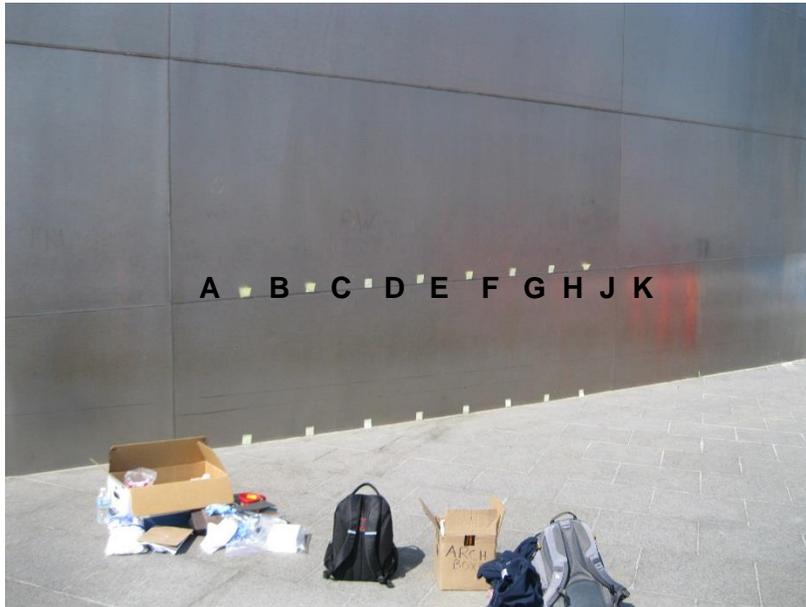
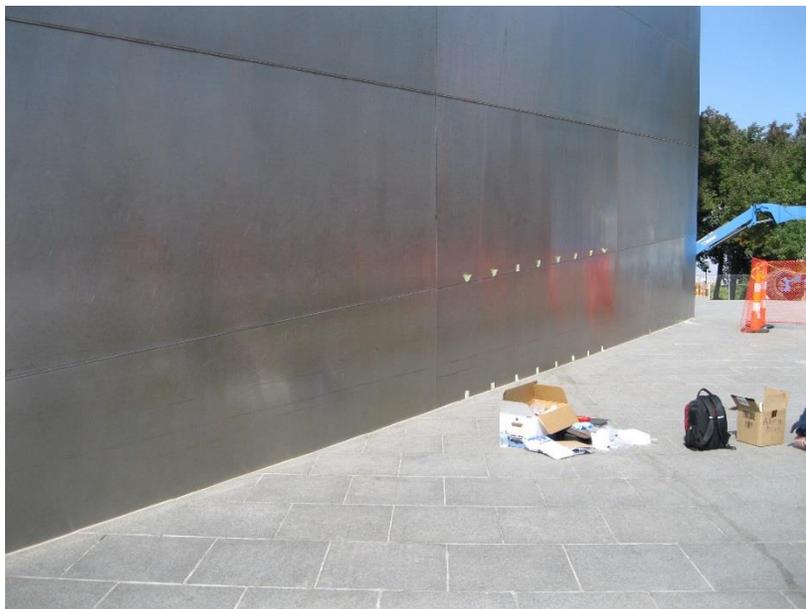
Figure 1. Overall Cleaning trials A through K before

Figure 2. Overall Cleaning trials A through K before

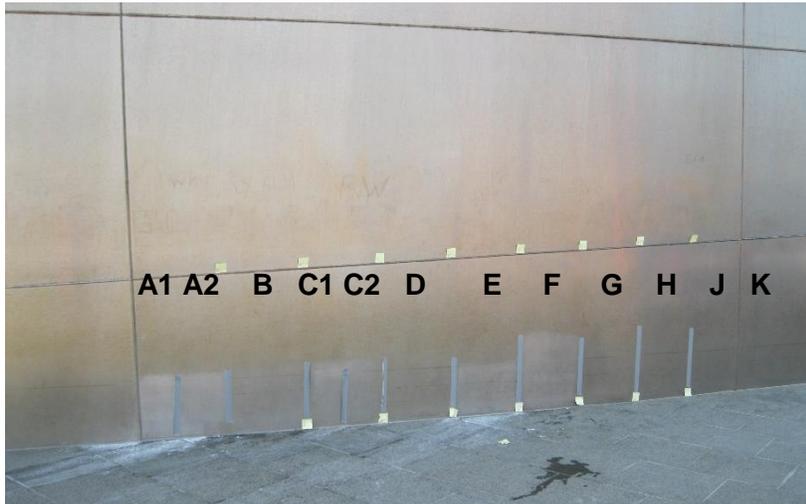
Figure 3. Overall Cleaning trials A through K after

Figure 4. Overall Cleaning trials A through K after

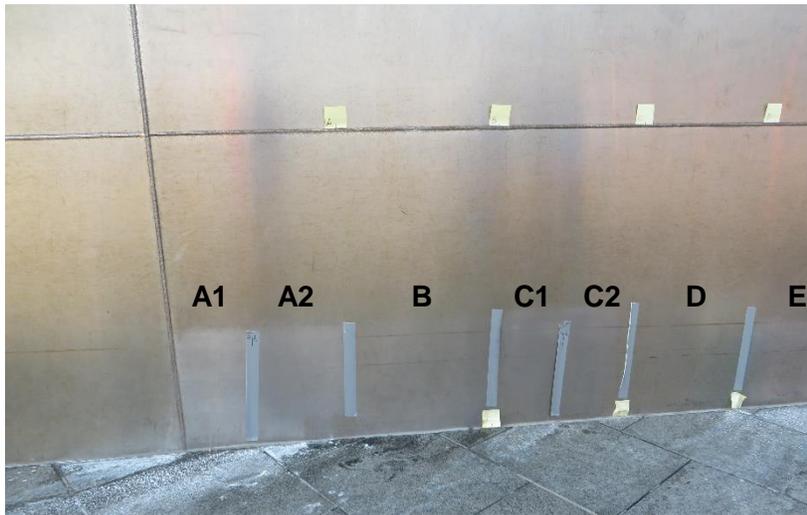
Figure 10. Overall Cleaning trials A through E after

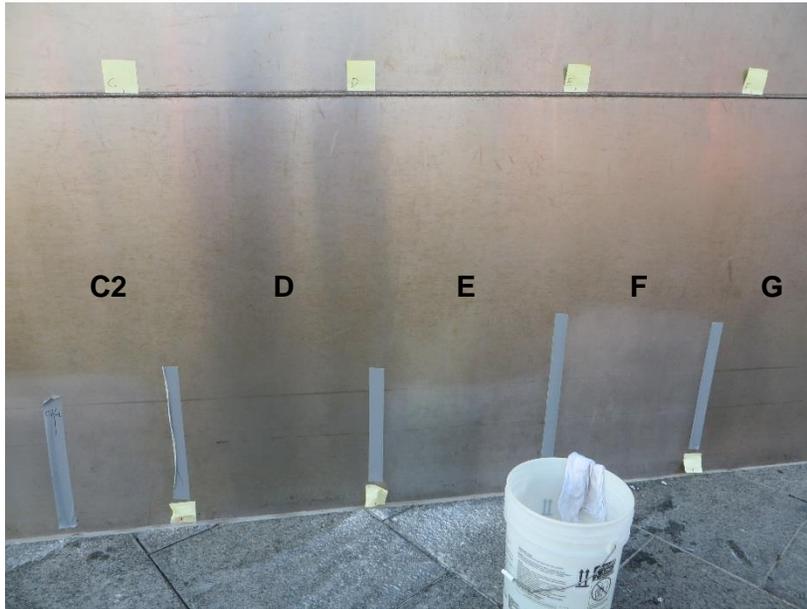
Figure 12. Overall Cleaning trials C2 through G after

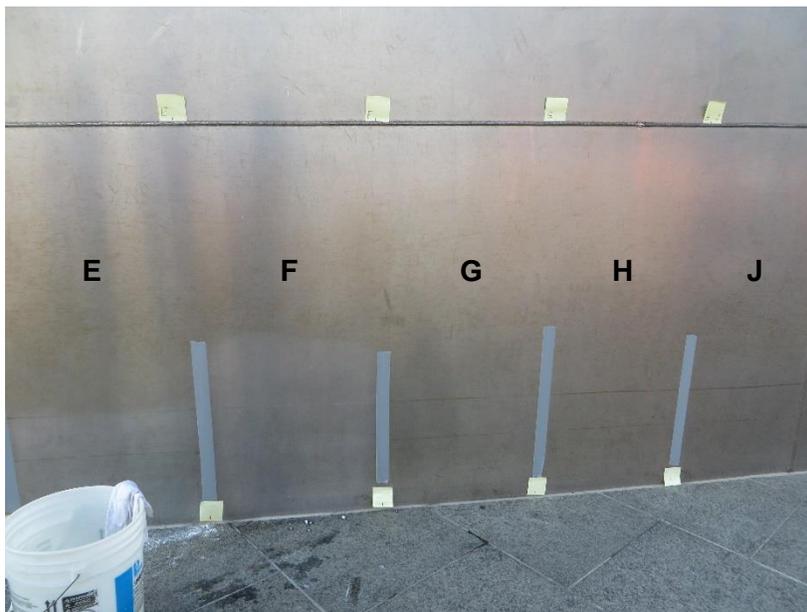
Figure 13. Overall Cleaning trials E through J after

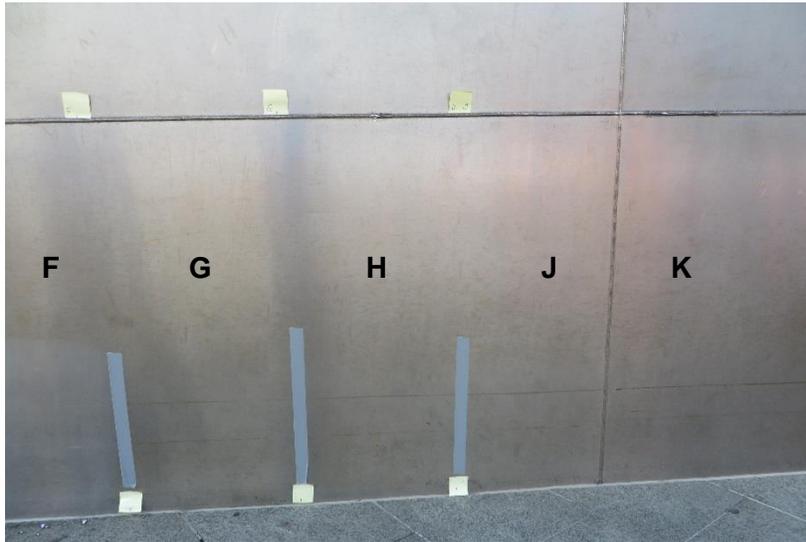
Figure 14. Overall Cleaning trials F through K after

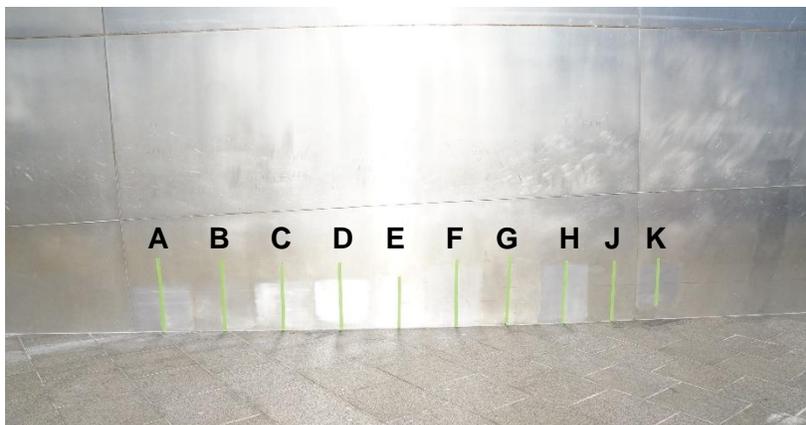
Figure 15. Overall Cleaning trials A through K after—note tape divides each sample in half

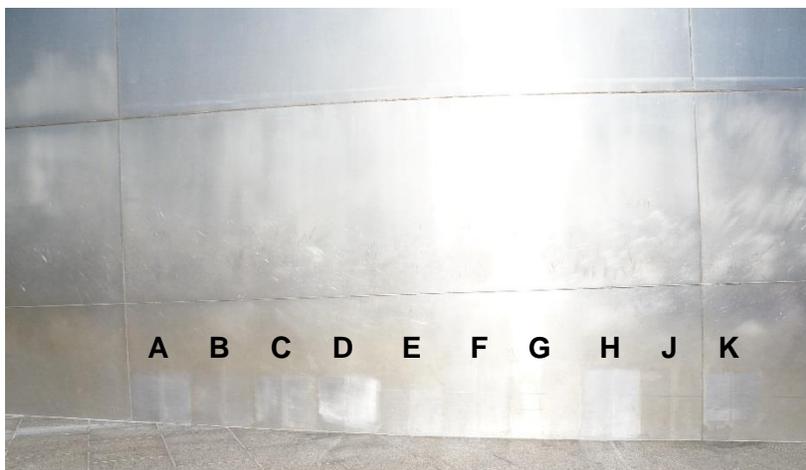
Figure 16. Overall Cleaning trials A through K after

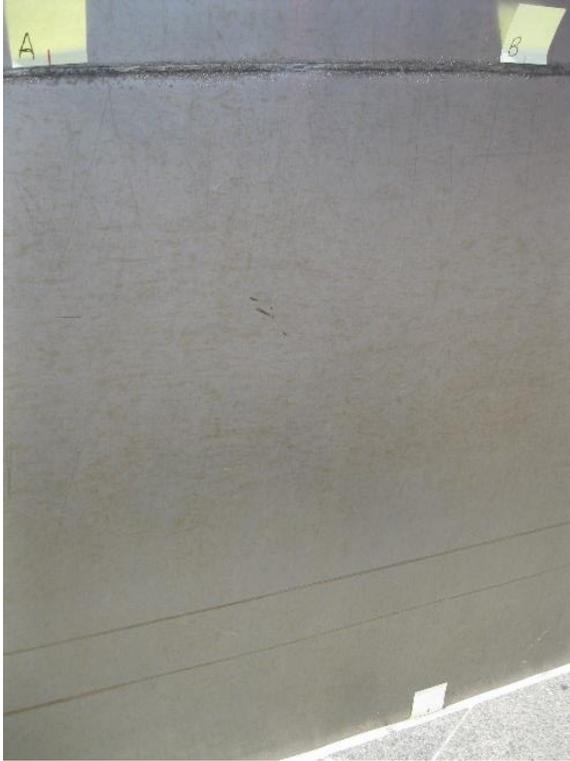
Figure 17. Trial A before

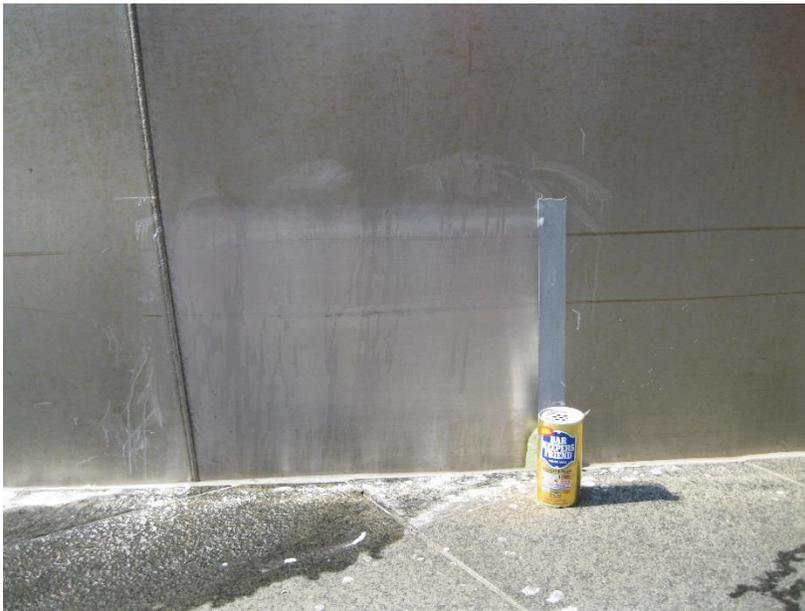
Figure 18. Trial A during

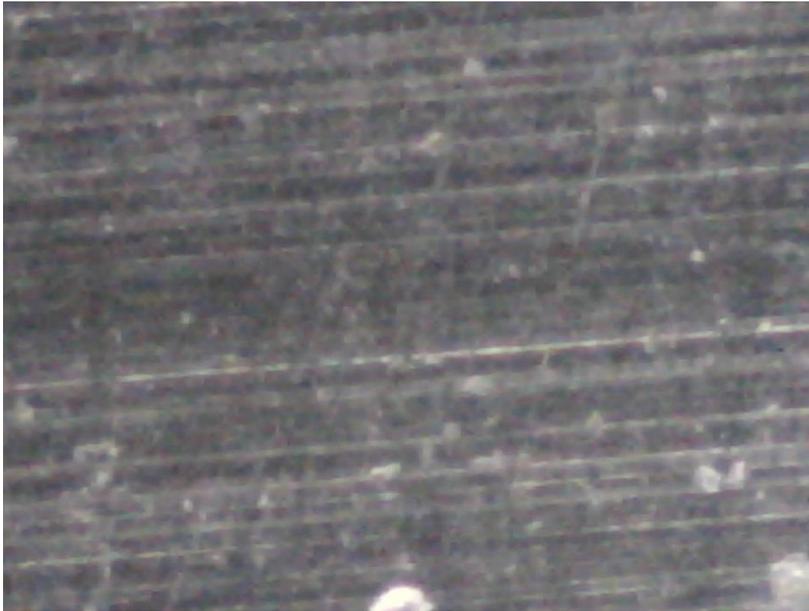
Figure 23. Photomicrograph Trial A after

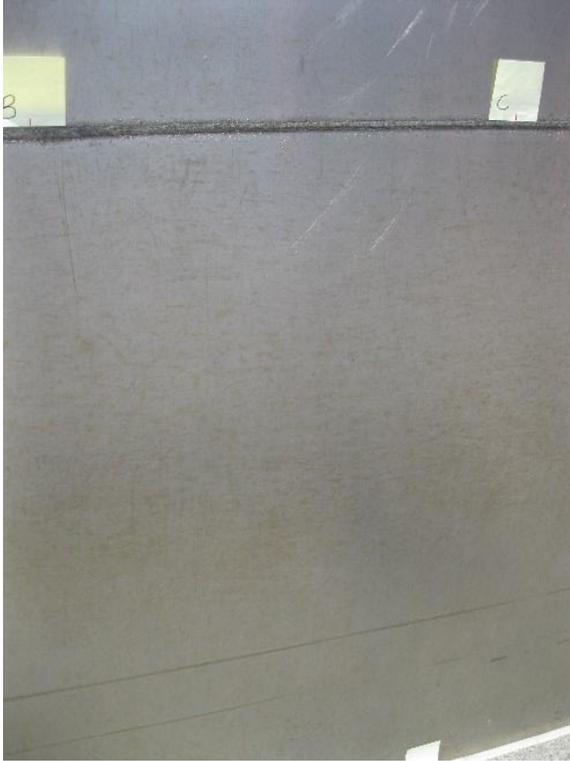
Figure 25. Trial B before

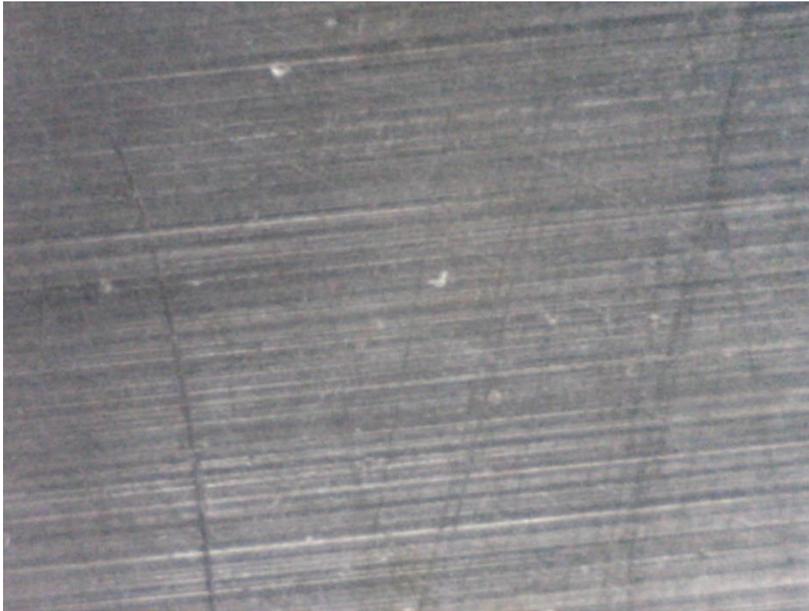
Figure 27. Photomicrograph Trial B

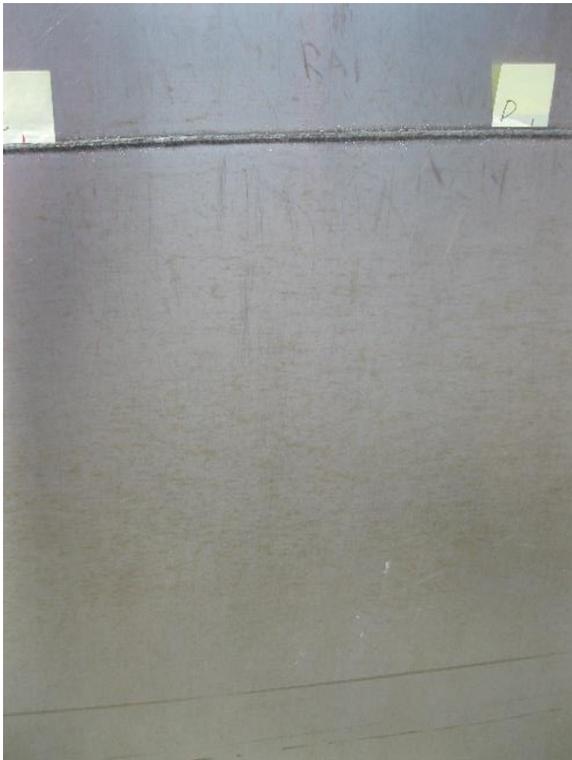
Figure 28. Trial C Before

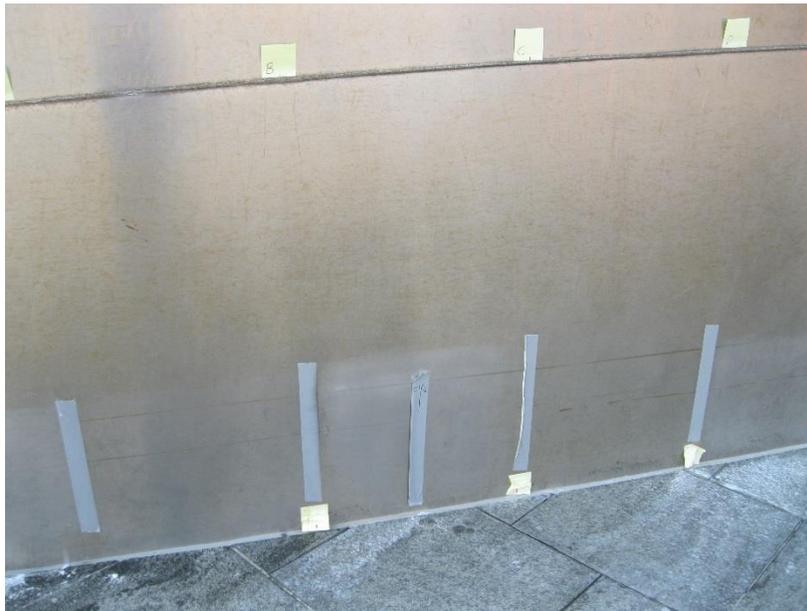
Figure 30. Trial C after

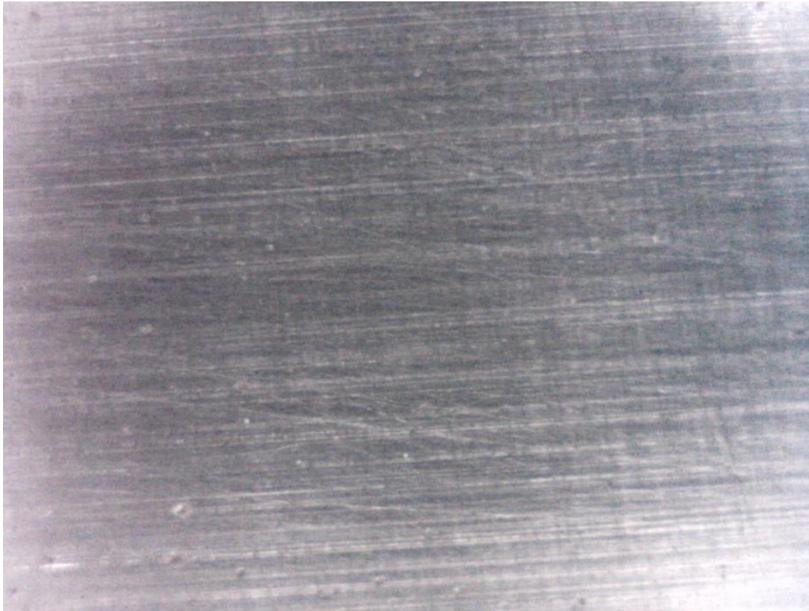
Figure 31. Photomicrograph Trial C after

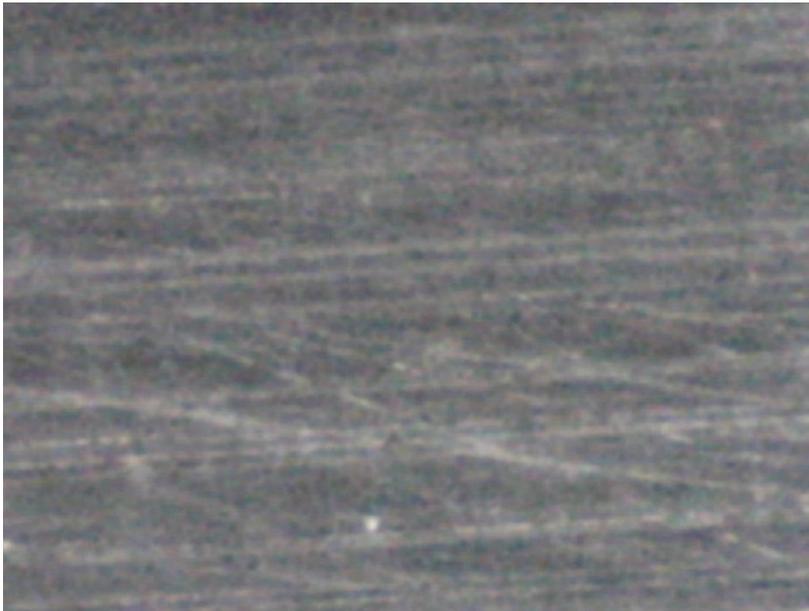
Figure 32. Photomicrograph Trial C after

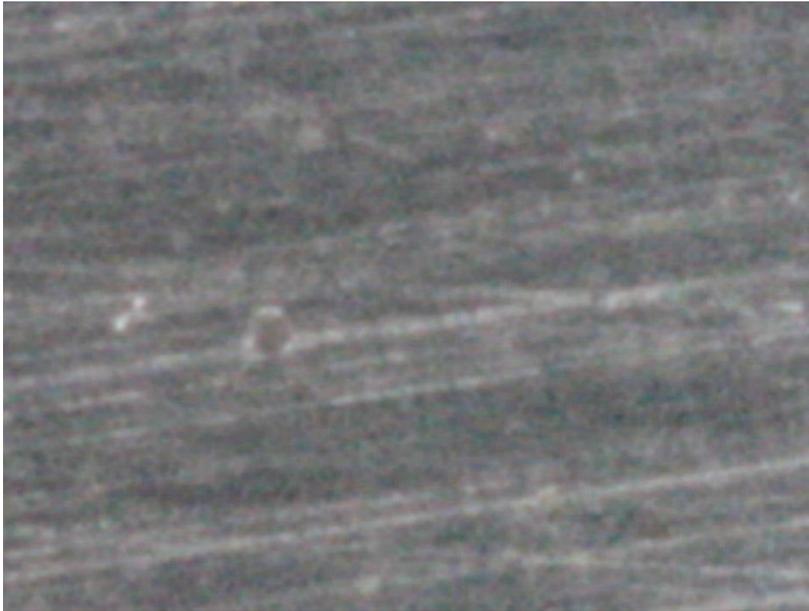
Figure 33. Photomicrograph Trial C after

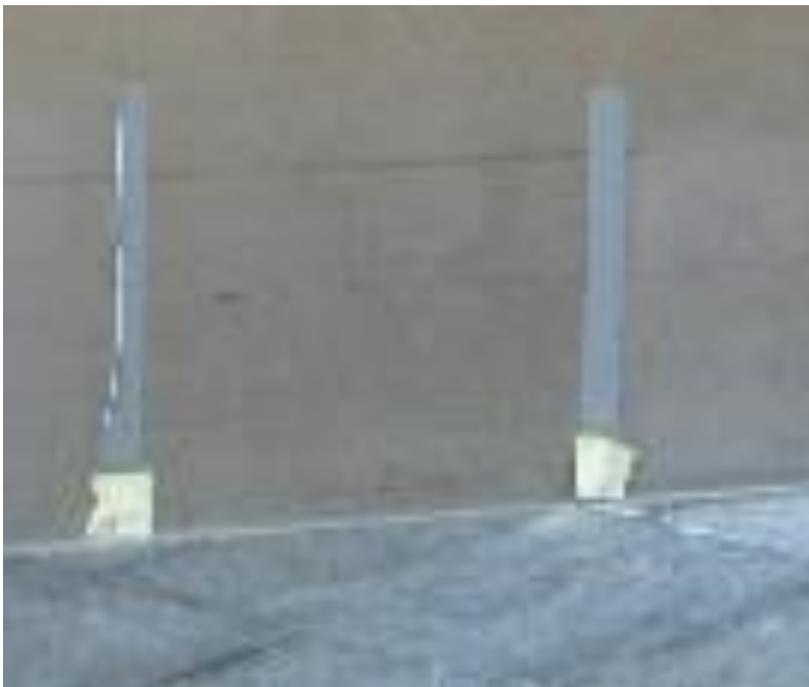
Figure 34. Trial D after

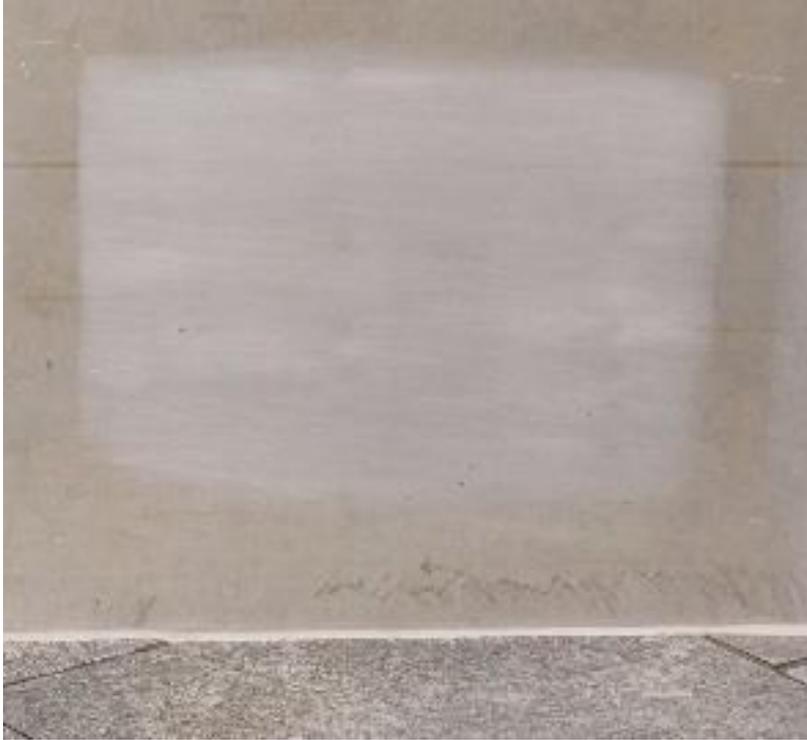
Figure 35. Trial D2 after

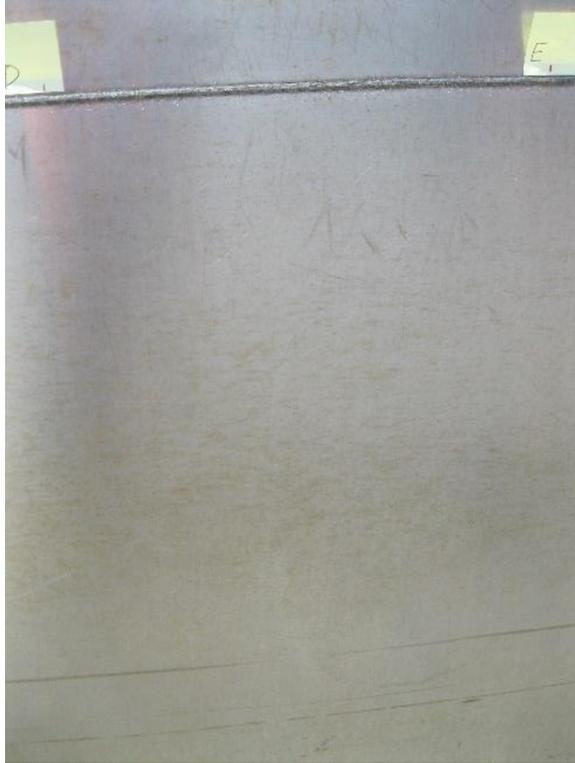
Figure 39. Trial E before

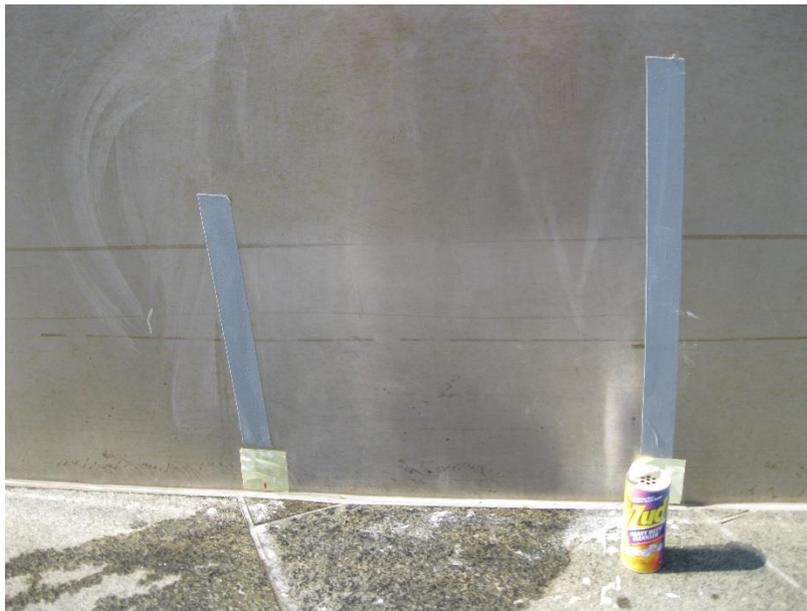
Figure 40. Trial E during

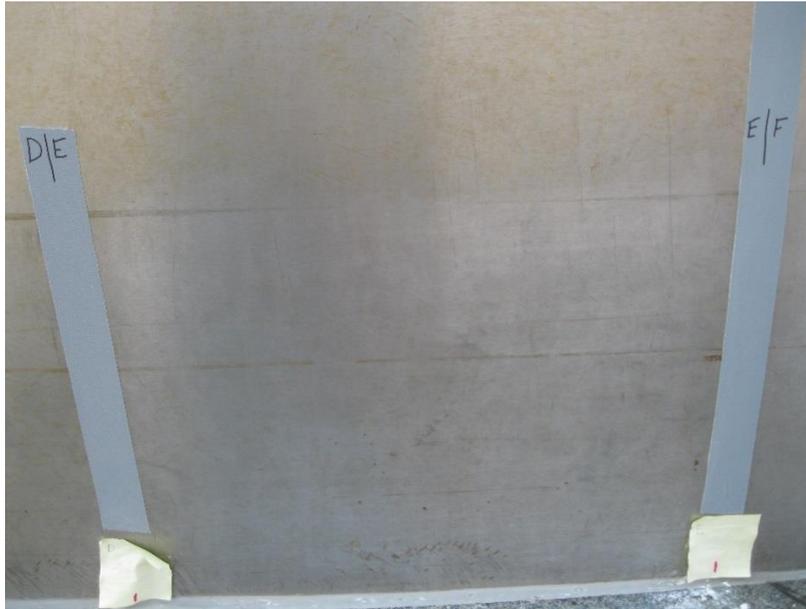
Figure 41. Trial E after

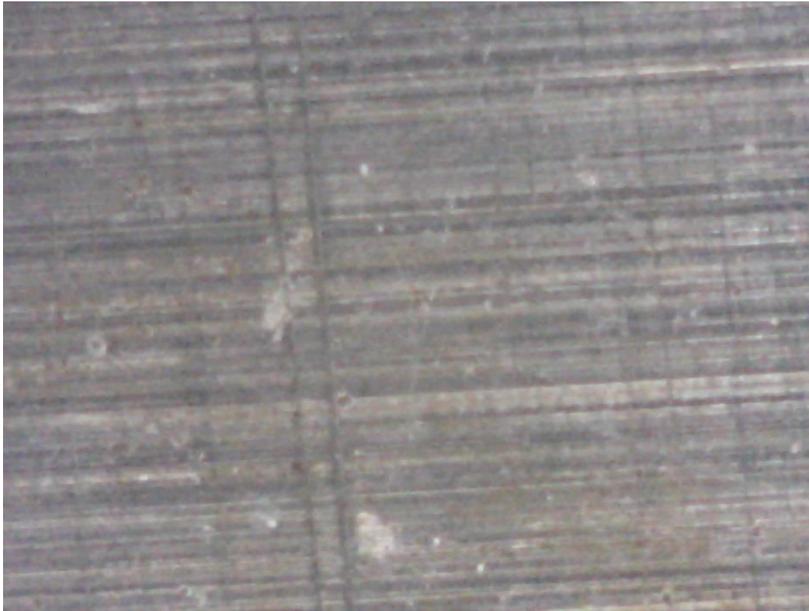
Figure 43. Photomicrograph Trial E after
