GATEWAY ARCH Corrosion Investigation Part III

St. Louis, Missouri

Final Report

April 3, 2015

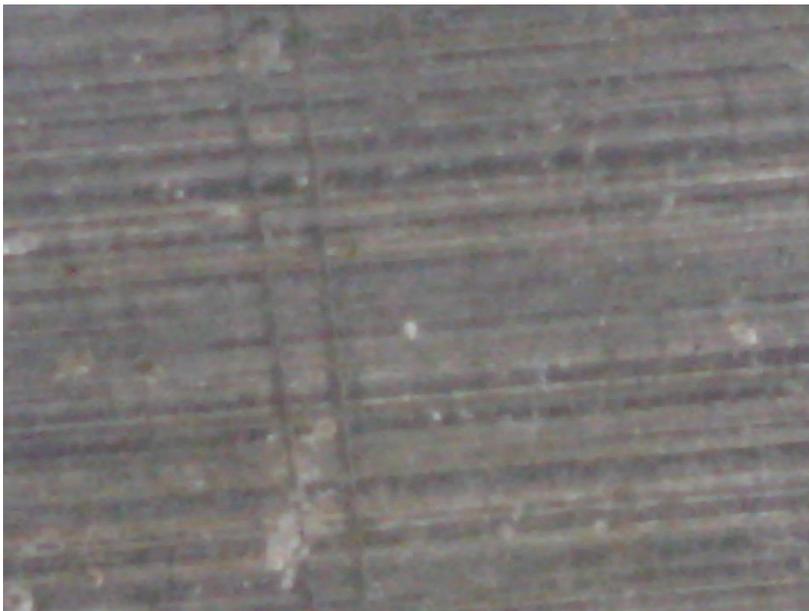
Figure 44. Photomicrograph Trial E after

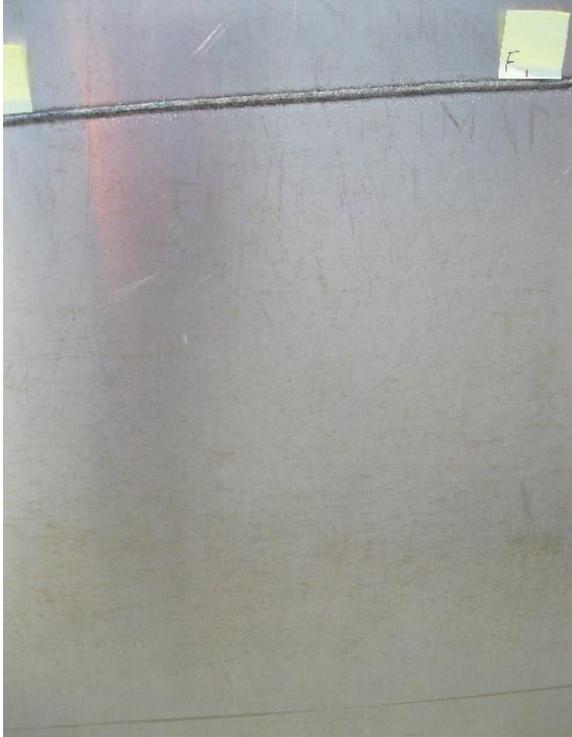
Figure 45. Trial F before

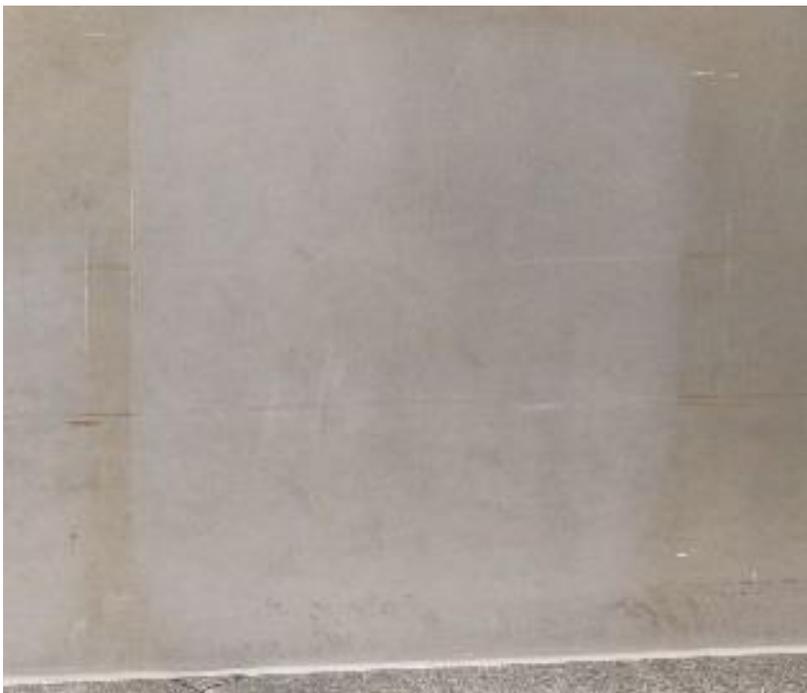
Figure 46. Trial F after

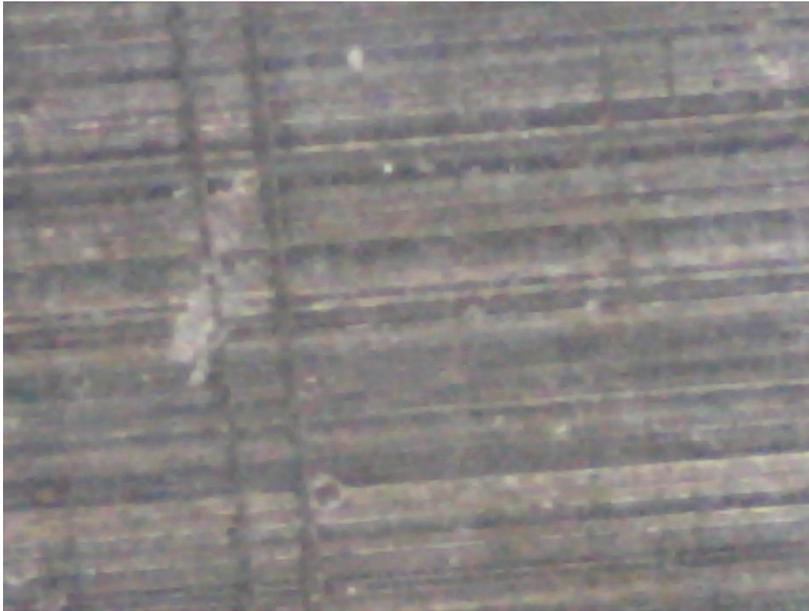
Figure 47. Photomicrograph Trial F after

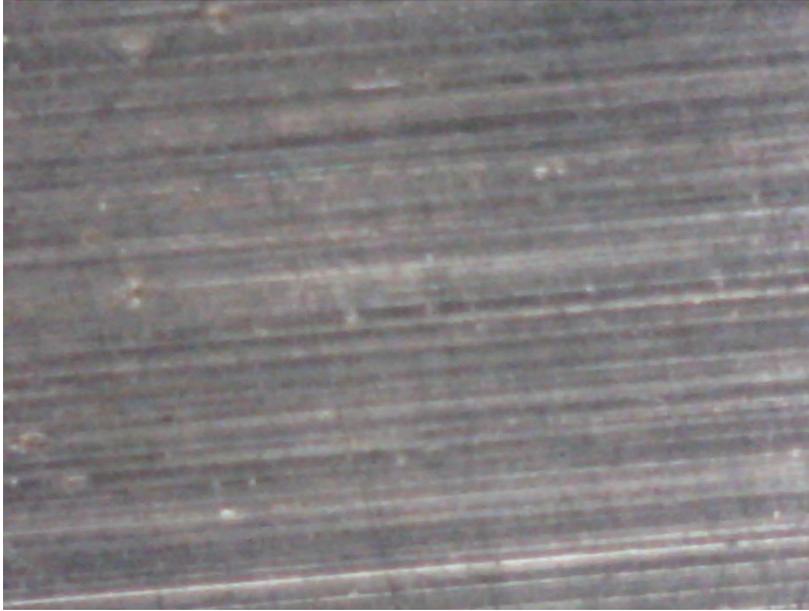
Figure 49. Photomicrograph Trial F after

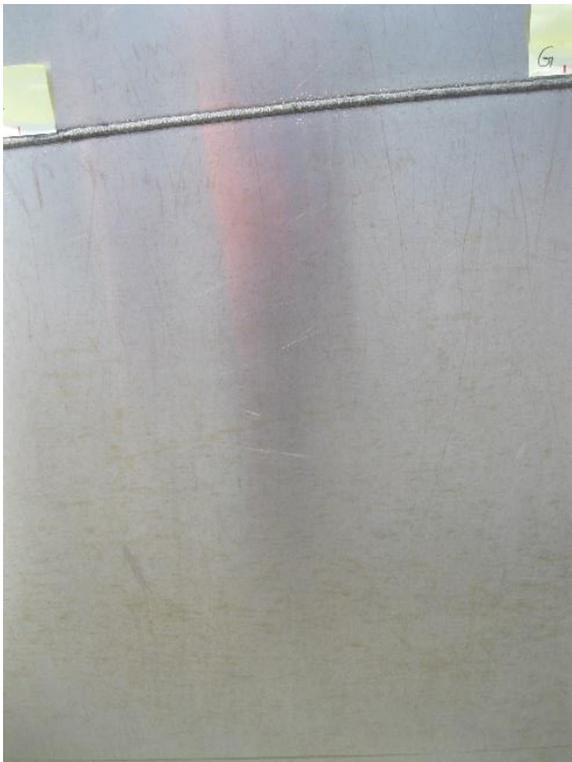
Figure 50. Trial G before

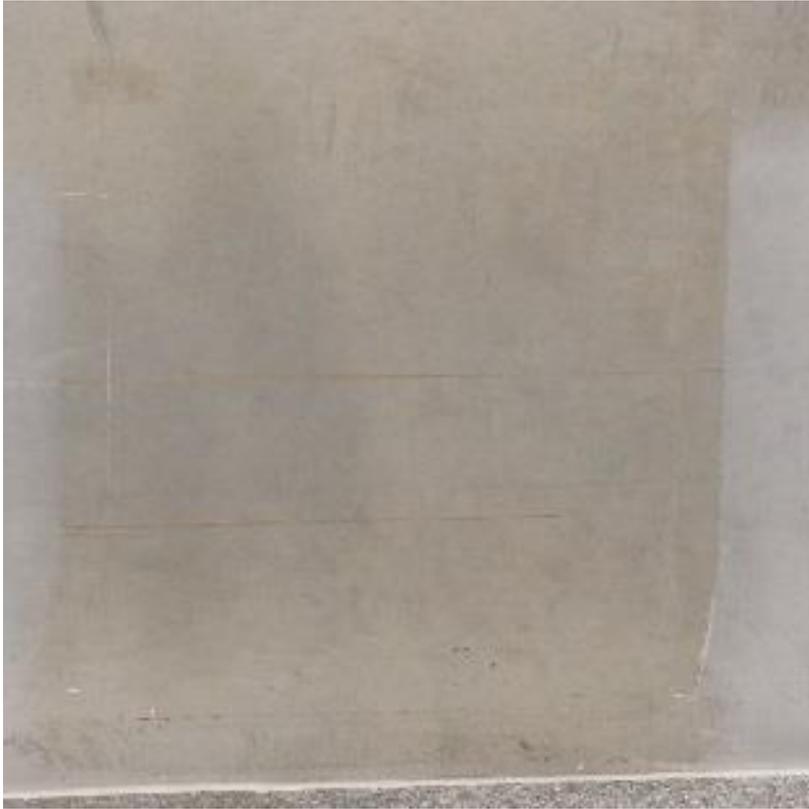
Figure 51. Trial G after

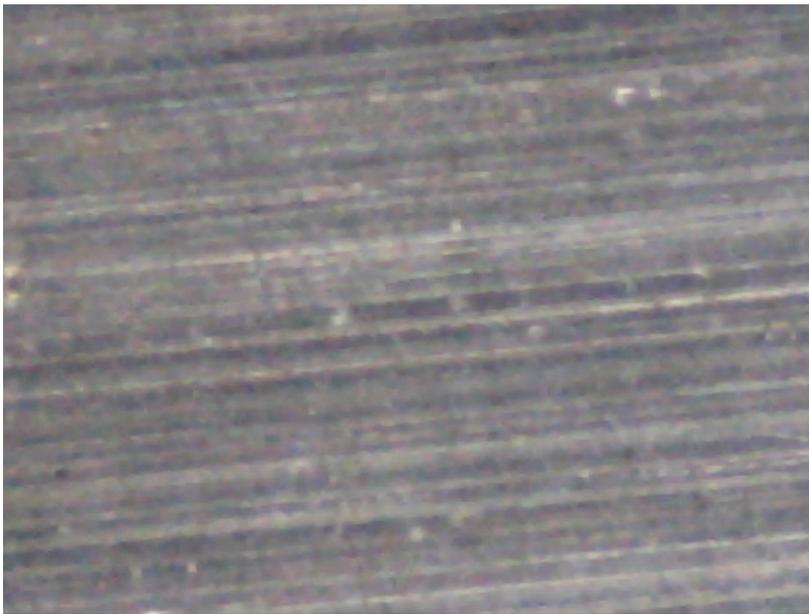
Figure 52. Photomicrograph Trial G after

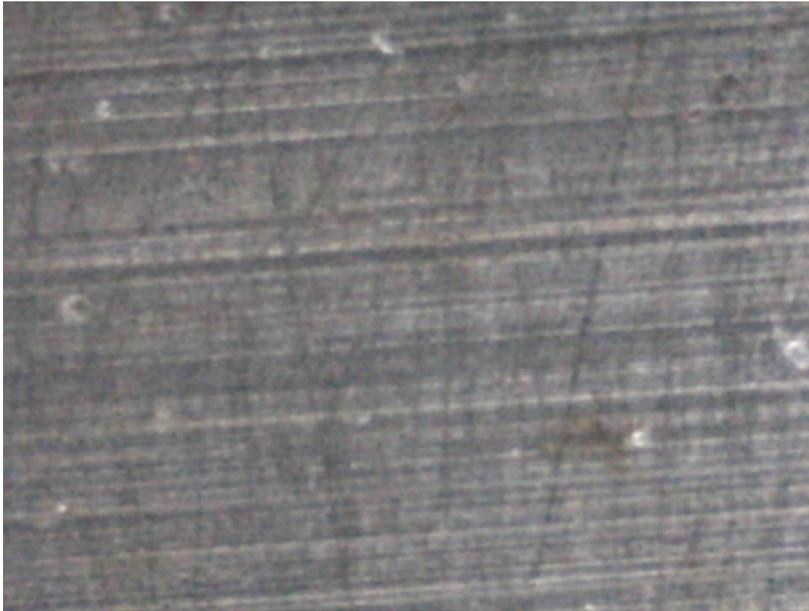
Figure 53. Photomicrograph Trial G after

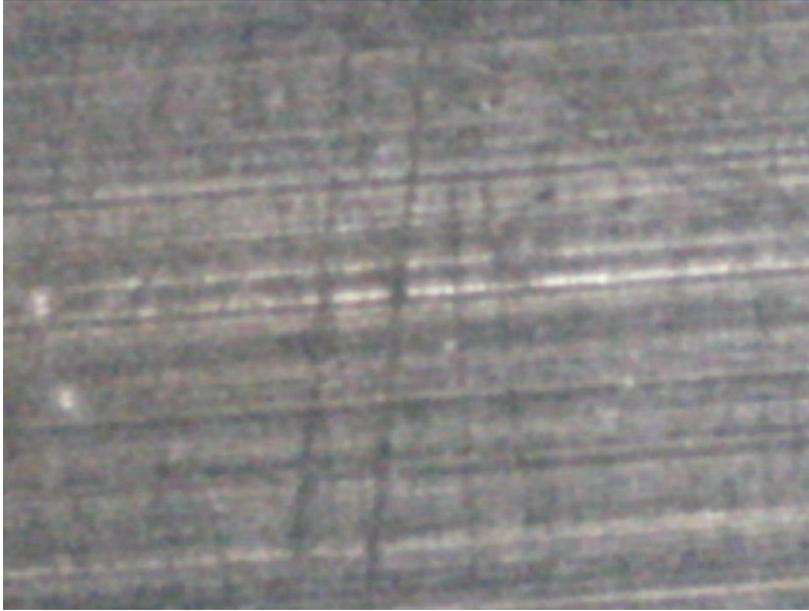
Figure 55. Photomicrograph Trial G after

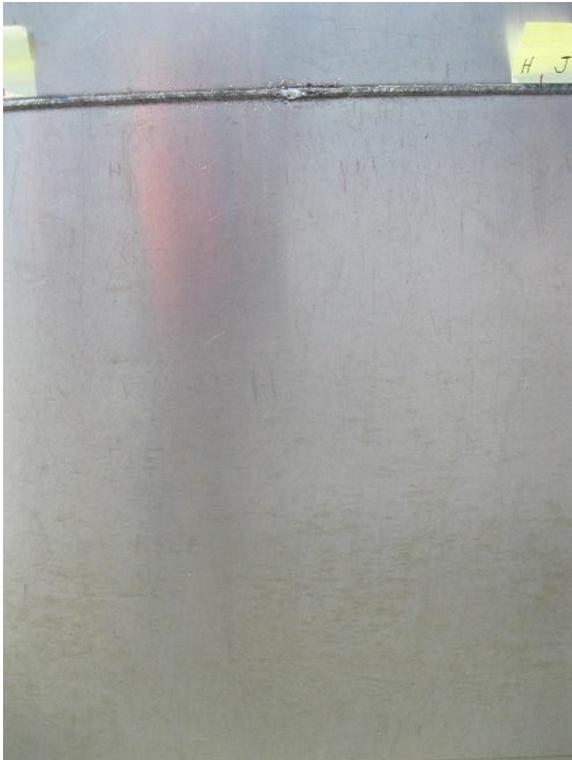
Figure 56. Trial H before

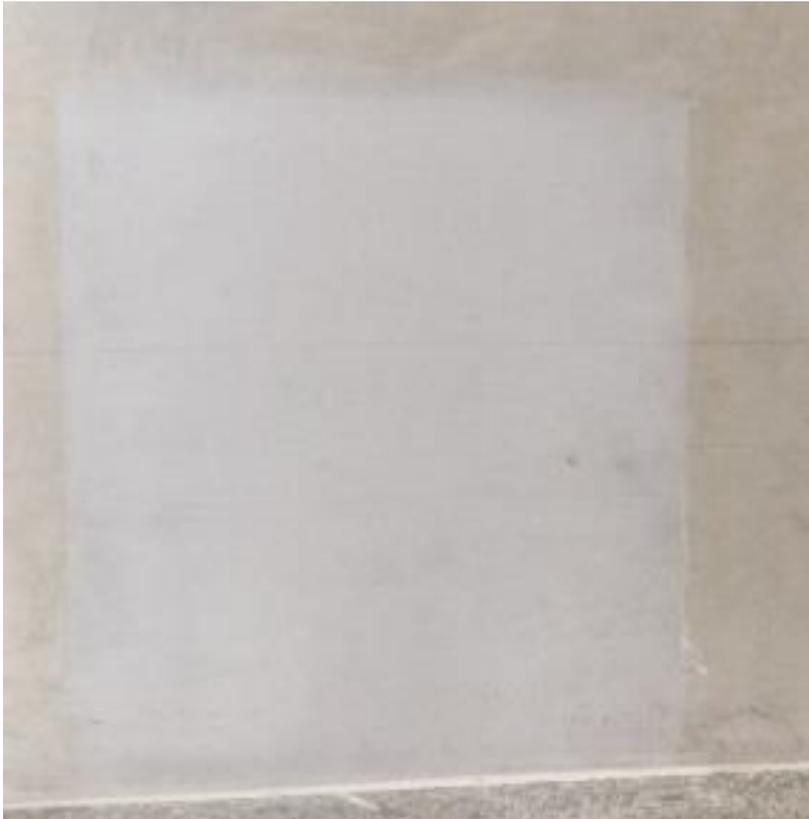
Figure 57. Trial H after

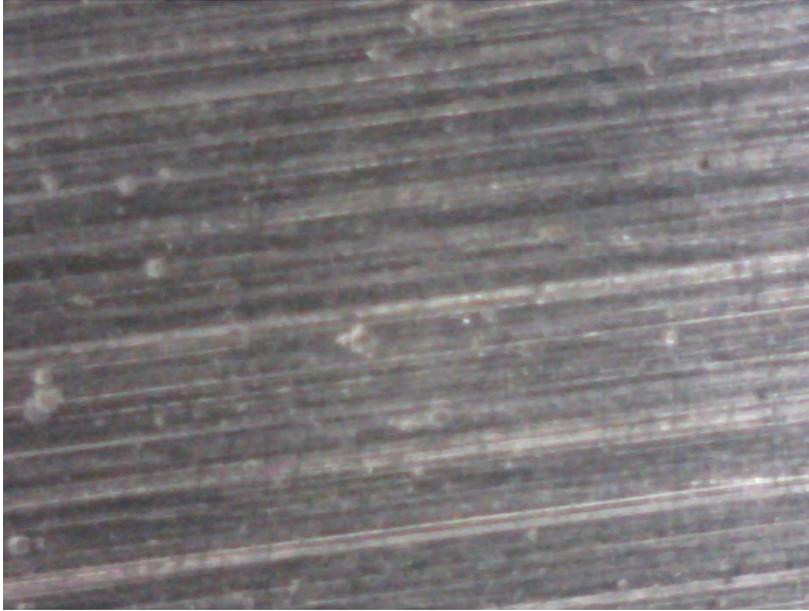
Figure 59. Photomicrograph Trial H after

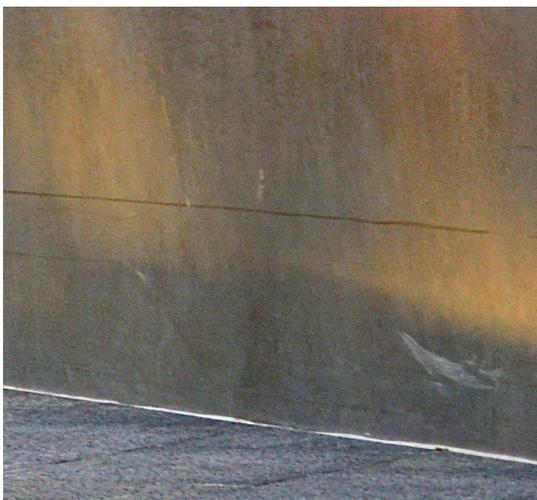
This iron surface contamination should be removed, particularly from the long deep scratches, because the corrosion product from this deposit creates a crevice and does not allow oxygen to reach the surface. Corrosion of the stainless steel under the carbon steel corrosion product deposit will continue. Crevice corrosion can occur when the surrounding exposed stainless does not corrode and the rate of corrosion is higher. The exposure of these areas to deicing salt will increase the corrosion rate.

Figure 1: Embedded carbon steel, probably from a snow plow blade (Photo taken by authors in 2014)

Over time, this linear, concentrated increased thickness loss due to corrosion could lead to thickness loss that presents a concern and weld repair might then become necessary. That is easily avoided. Removal of the contamination should be with stainless steel pickling paste painted on to these localized areas with a small artists brush in accordance with ASTM A380 followed by chemical passivation to improve the corrosion resistance within the scratch. Pickling will dull the finish locally but careful limited application should not make it noticeable since it is so close to the ground. These strong acids should only be used in compliance with manufacturers recommendations to ensure operator safety and to prevent damage to surrounding materials.

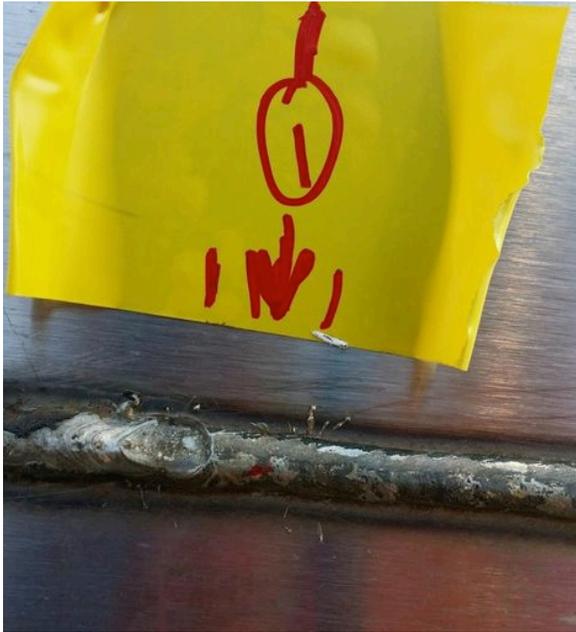
Figure A1: W1, prior to removal (Photo taken by authors in 2014)

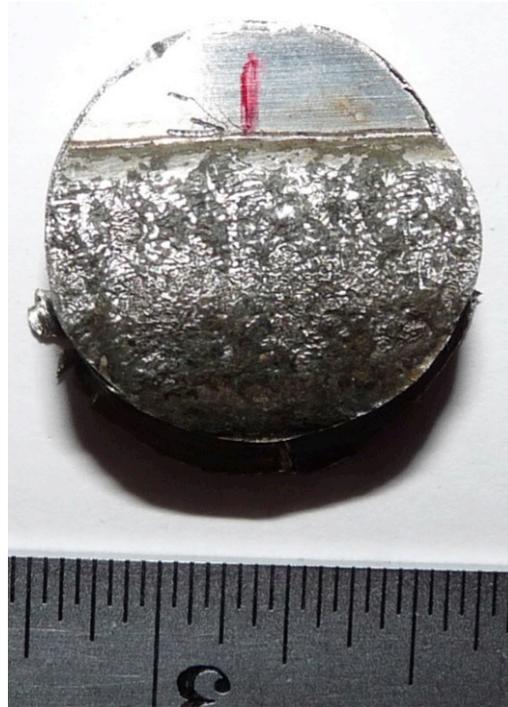
Figure A2: W 1 as-received condition.
(Scale=1/32") (Photo taken by authors in 2014)

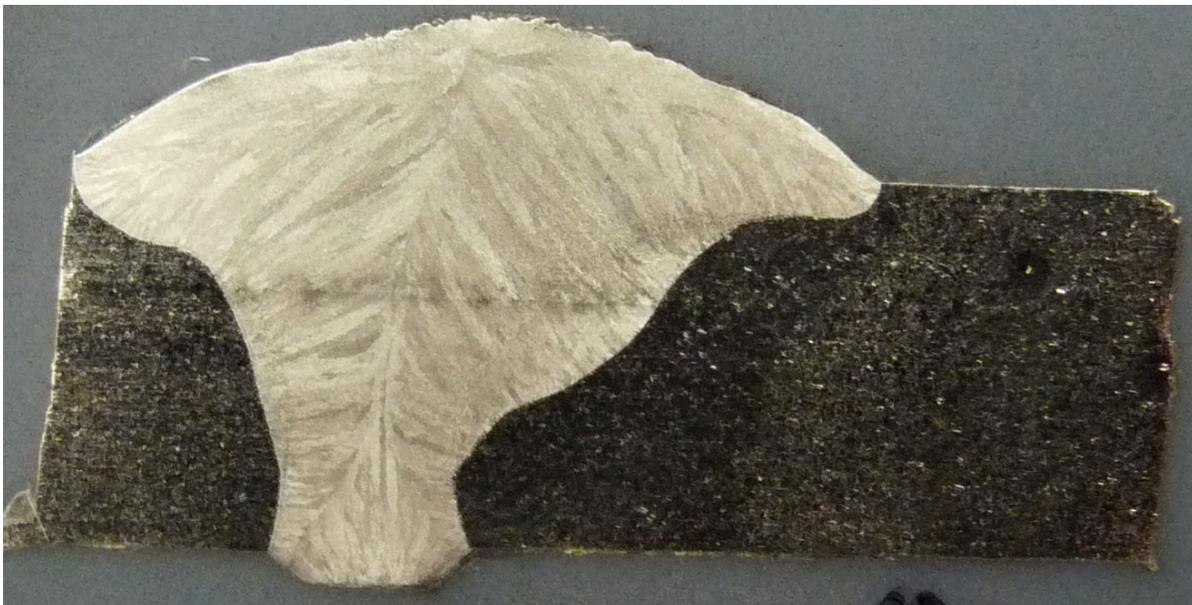
Figure A3: Macrograph cross of section W1 in the etched condition (Photo taken by authors in 2014)

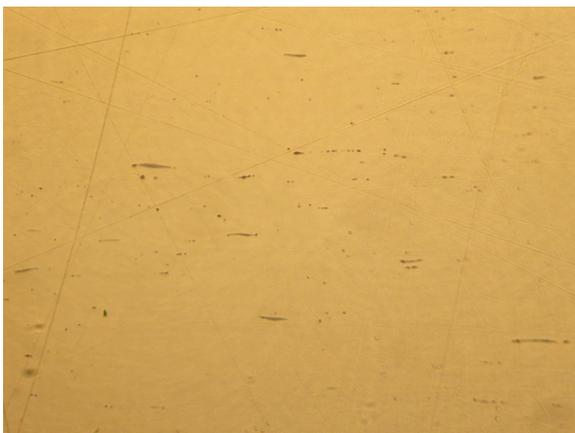
Figure A7: Micrograph of manganese sulfide stringers in the plate, W1, as-polished condition. (256x) (Photo taken by authors in 2014)

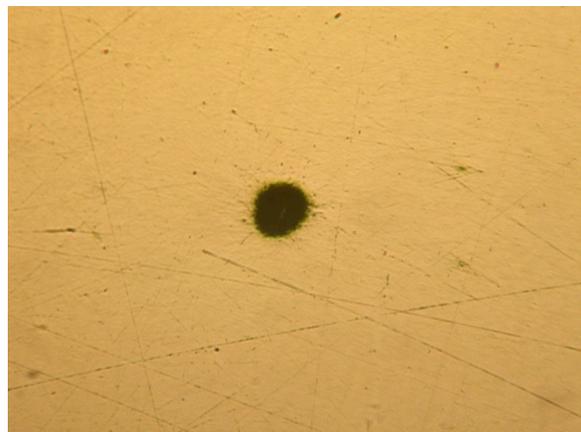
Figure A25: Micrograph, W3, weld void, approximate diameter 0.004", shown as-

polished condition. (Photo taken by authors in

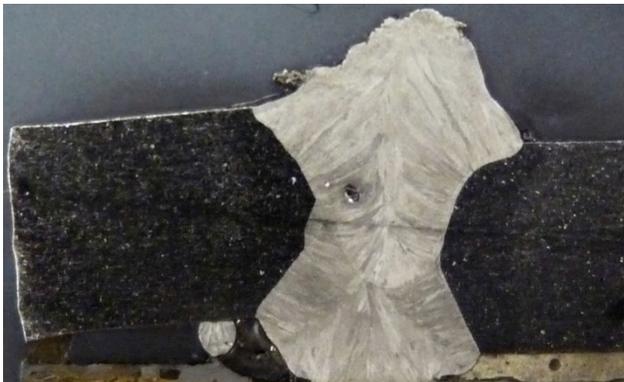
Figure A32: Macrograph W5 etched condition with a visible void. The minor plate misalignment

is not a structural concern. (Photo taken by authors in 2014)

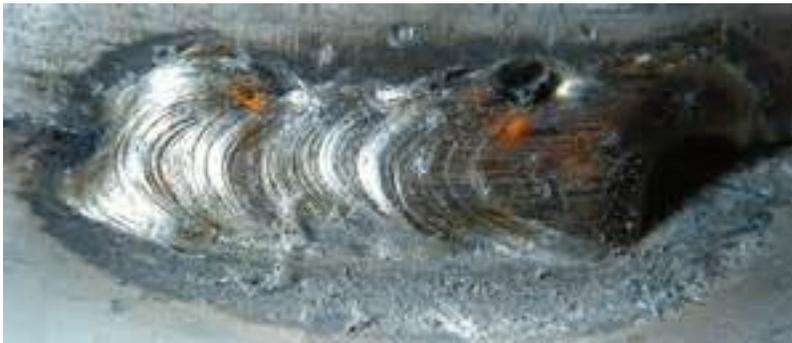
Slag "islands" occur in the surface of the weld and can be a location where corrosion can initiate. Slag "islands" generally cannot be removed by brushing but light grinding is typically sufficient. Both types of

Figure B4: Weld slag on the surface (Photo Avesta Welding Manual)

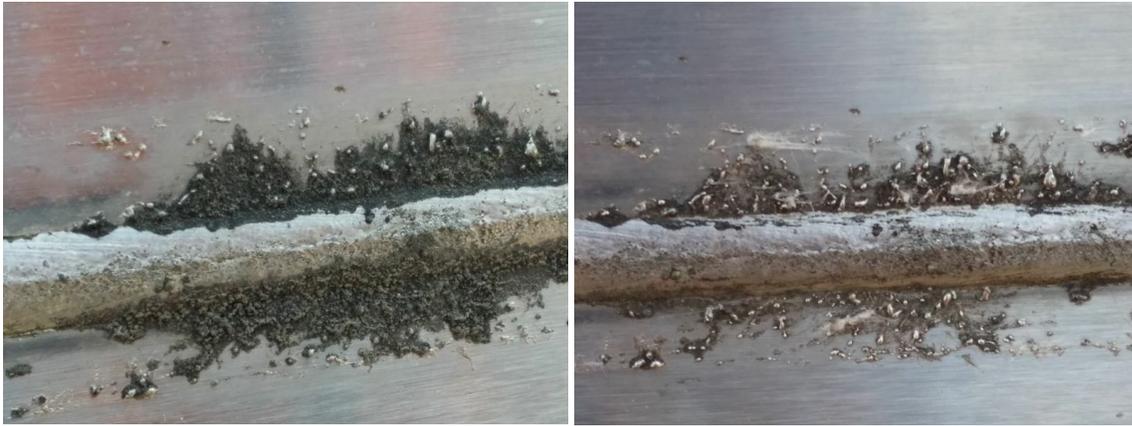
Both samples were dark in color and nearly identical in appearance and analysis. The only variation was the size of the deposit. The deposit appeared to mainly consist of particle agglomerations (Figure C1) and was largely removable with a wet cloth (Figure C2). This was representative of the appearance of the dark deposits found around welds.

Figures C1 and C2: Dark deposit accumulation around and extrados weld, before collection of sample 2B (C1, left) and after sample collection and additional cleaning with an alcohol dampened cloth (C2, right). (Photo taken by authors in 2014)
