PECOS NATIONAL HISTORICAL PARK  
KOZLOWSKI'S TRADING POST RESTORATION PROJECT

EAST WING MILLWORK RESTORATION  
COMPLETION REPORT

Prepared for  
Pecos National Historical Park  
March 2011

by  
School of Engineering, University of Vermont

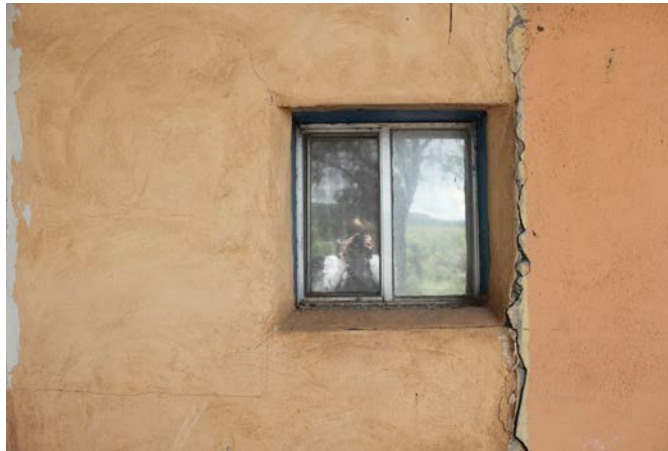
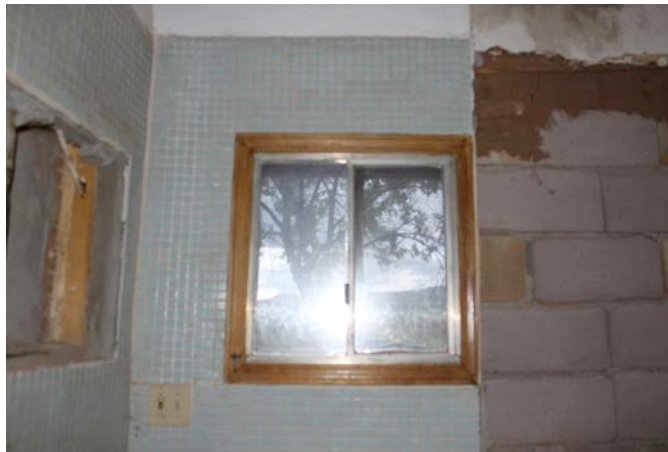
## E1W4

This rough opening, originally a window, was modified for a temporary addition to the east side of the building. The header and sides of the jamb are intact. No other historic material remains. Based on size, location and shape, the window probably was of the same style as window E1W2.

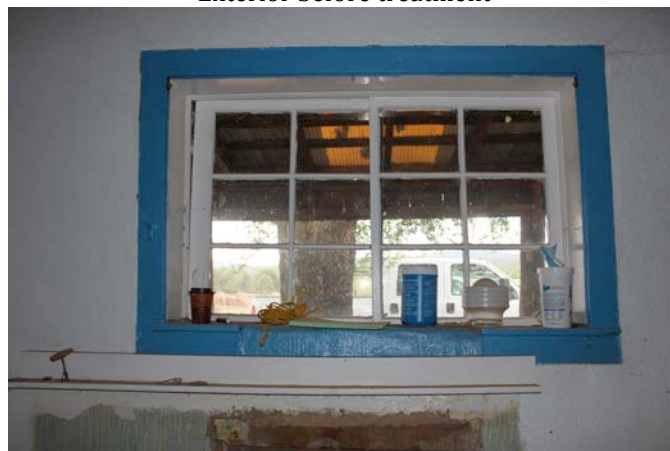
Interior before treatment

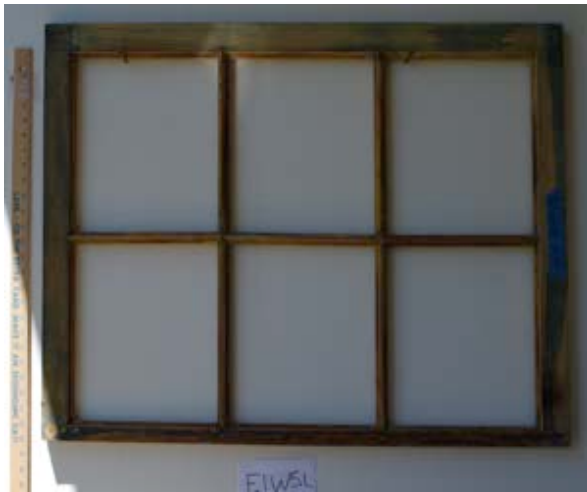
Left sash prior to treatment

- Replacement of horizontal muntin #2
- 1/8" additional material laminated to bottom stile
- Dutchman at rail/horizontal muntin joints
- Glazing bar replaced on vertical muntin #3
- Metal pins replaced with wooden dowels with exception of upper left corner.

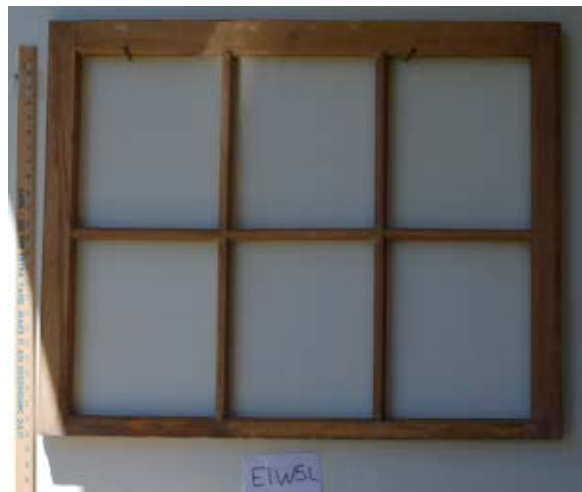
Right sash prior to treatment

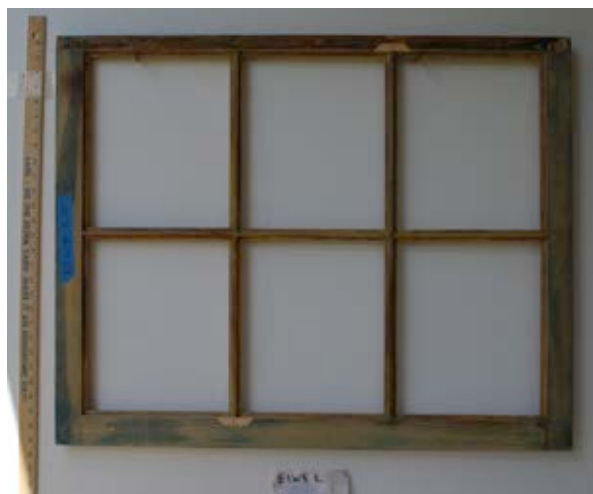
Left sash after treatment

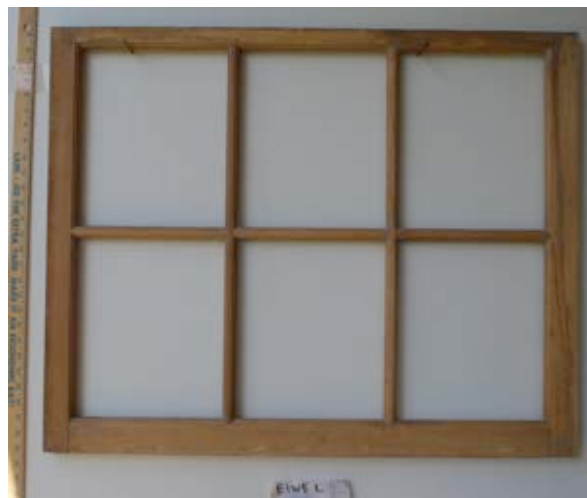
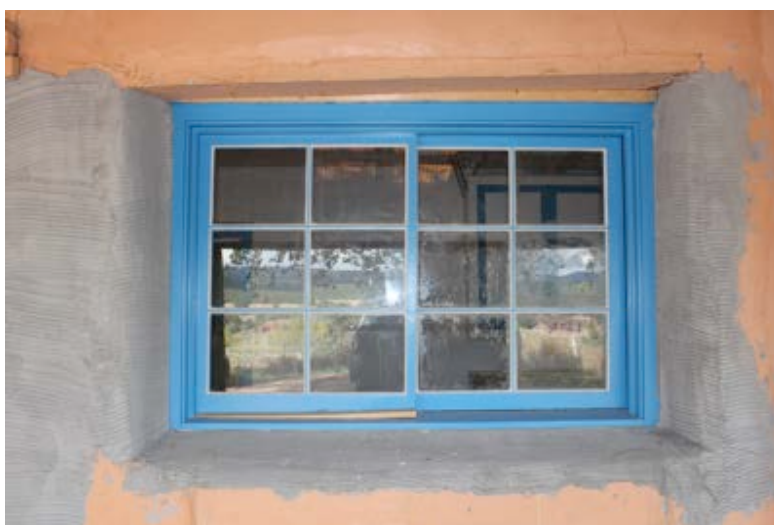
Exterior after treatment

New jamb and buck fabricated

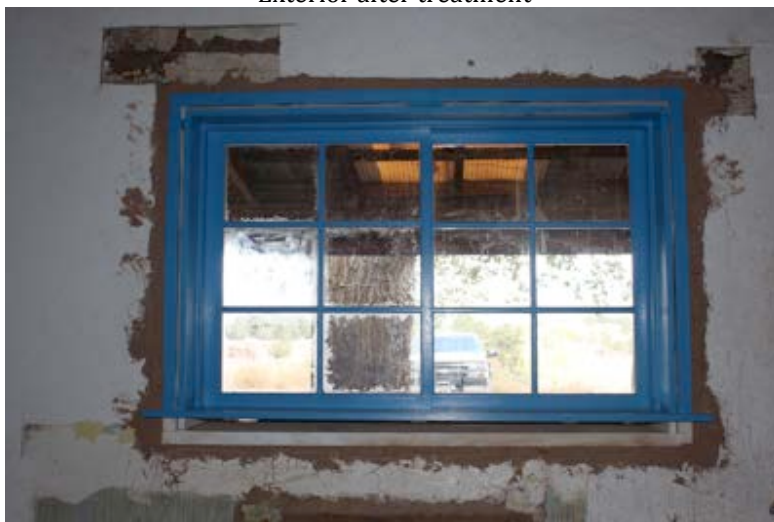
Interior after treatment

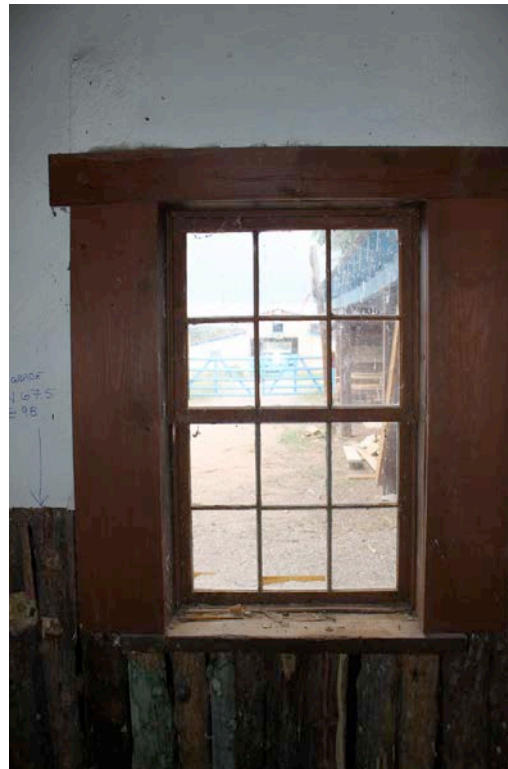
Interior before treatment

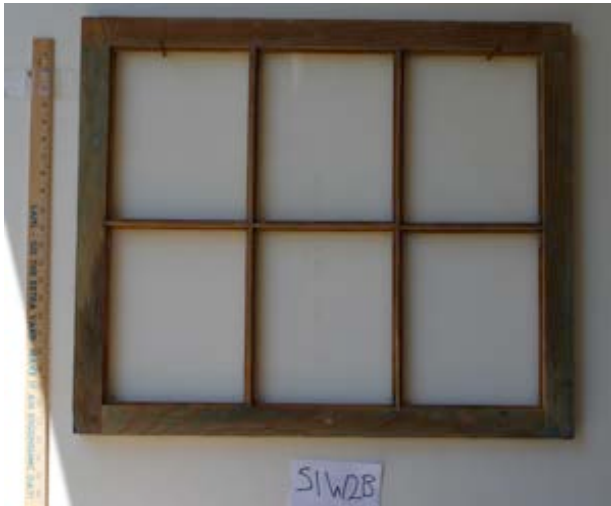
Lower sash

- Trimmed to restore squareness

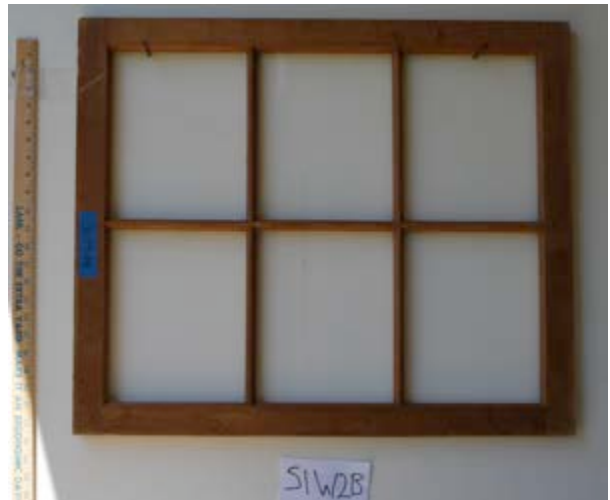
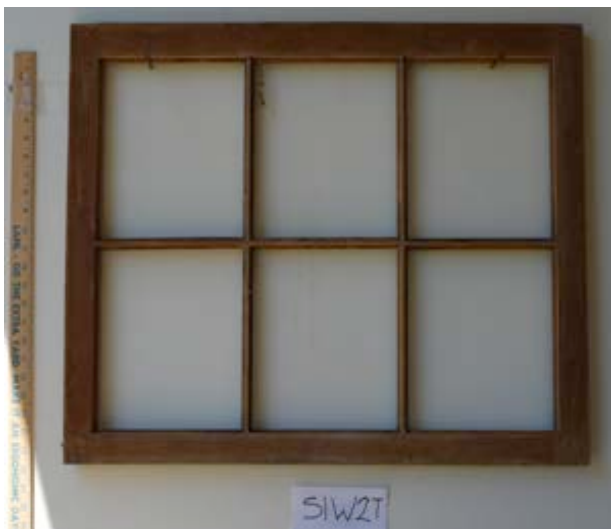
Upper sash

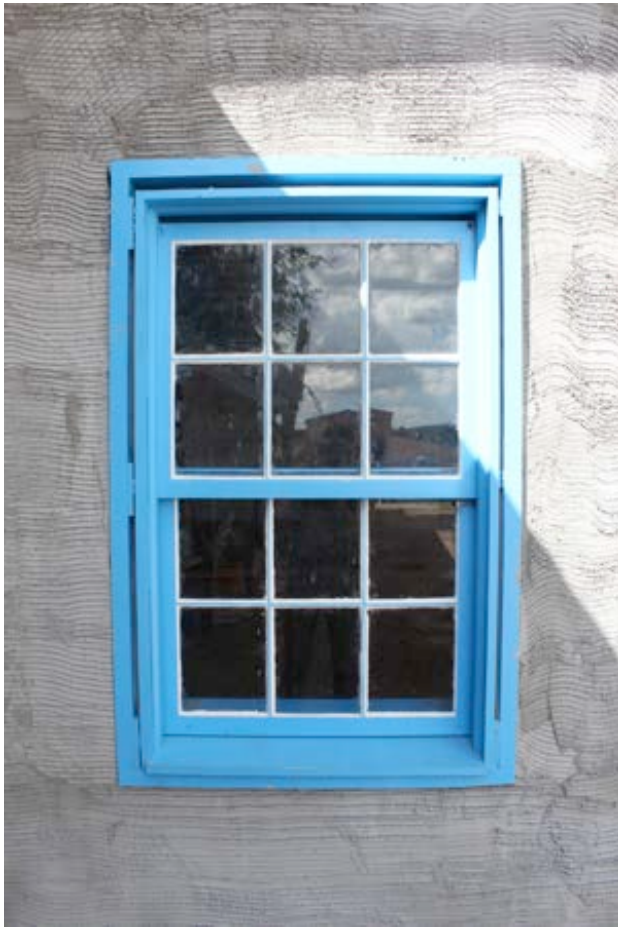
Exterior after treatment

New buck and jamb were fabricated.

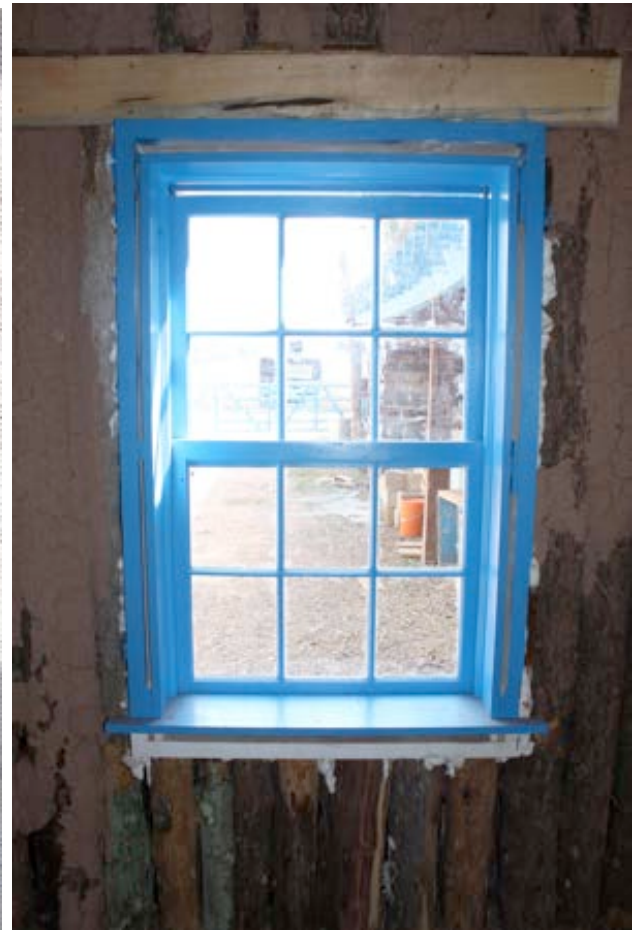
Interior after treatment

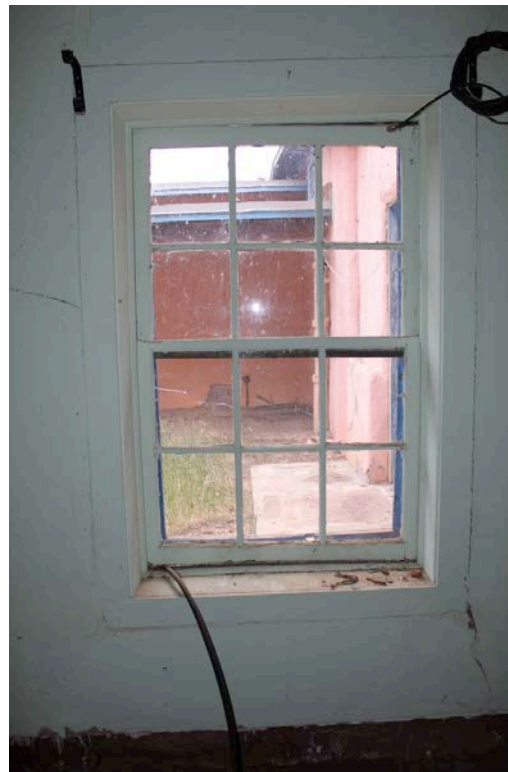
Interior before treatment

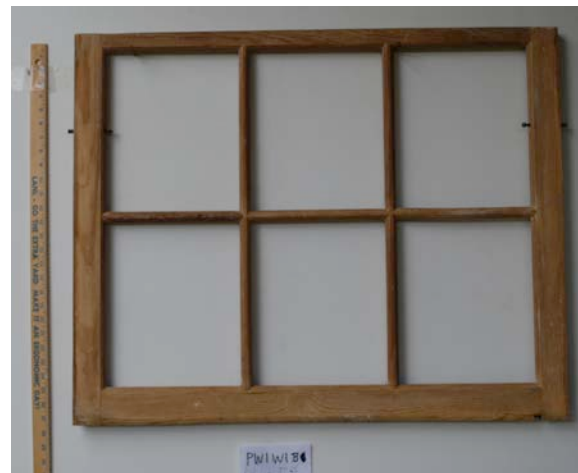
Upper sash prior to treatment

- 4" dutchman at bottom of exterior face, left stile

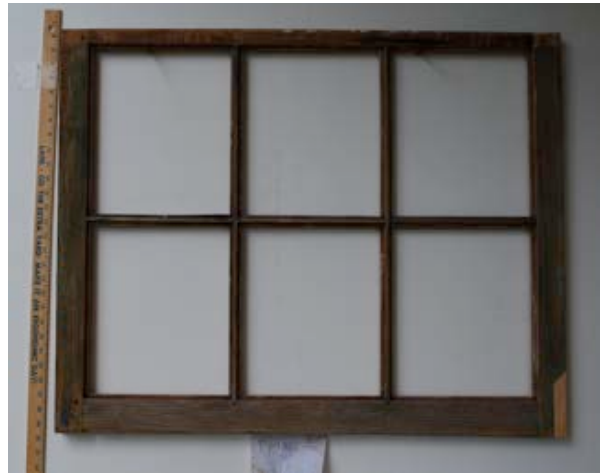
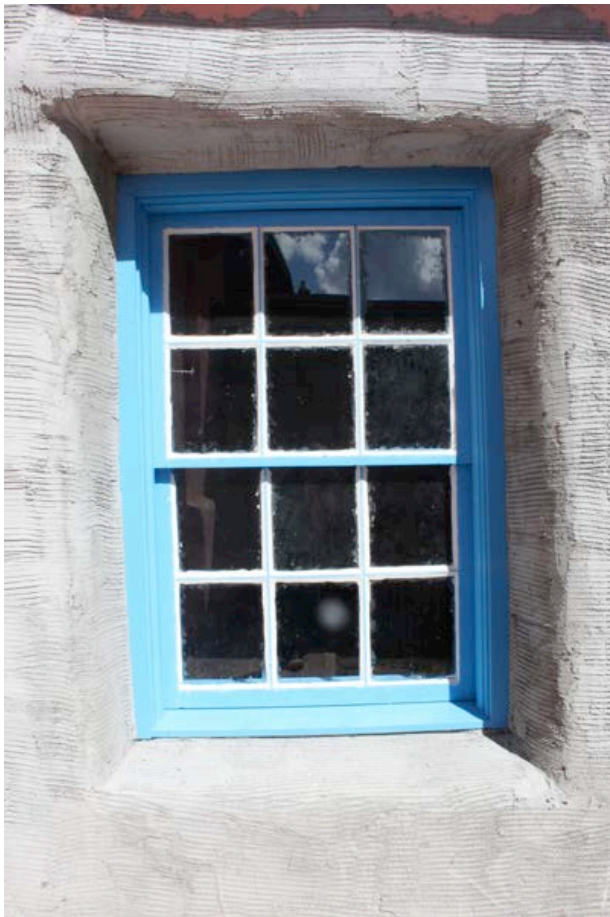
Exterior after treatment

New buck and jamb fabricated

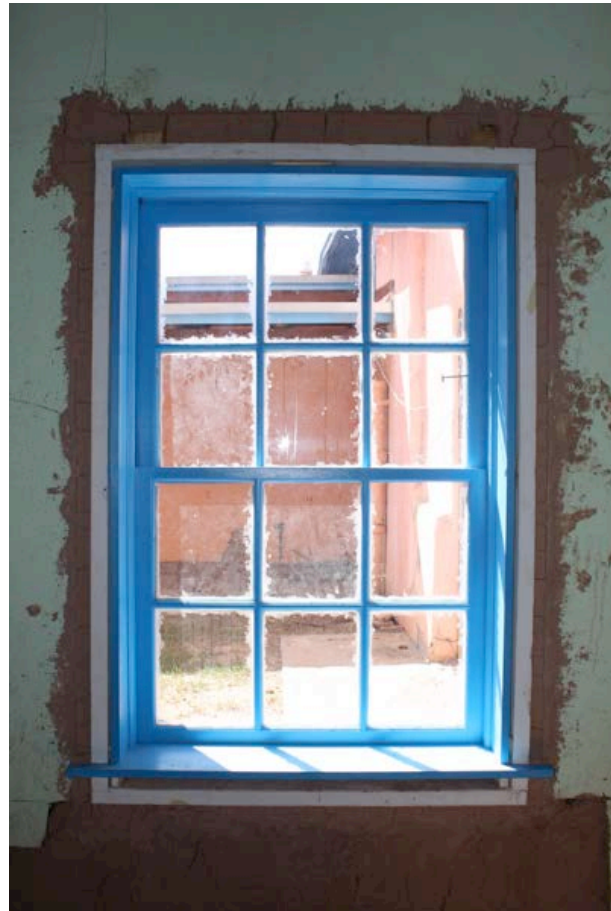
Interior after treatment

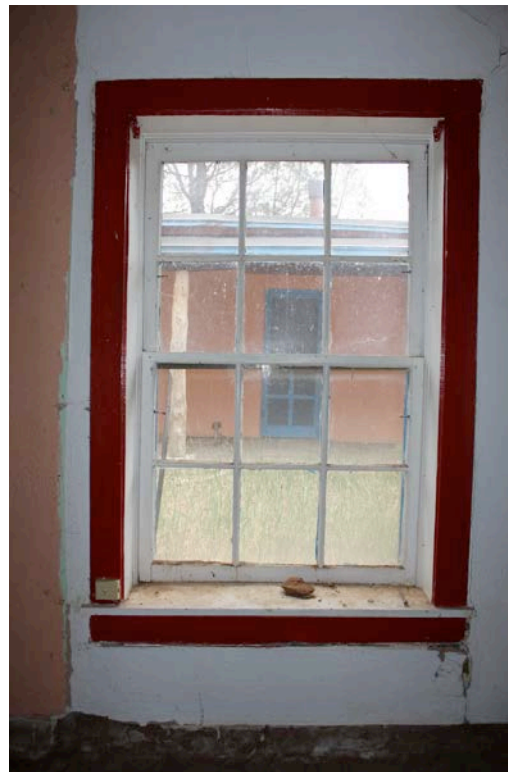
- Upper sash missing some stop molding
- Weathering on face
- Sashes misaligned
- Bottom rail of bottom sash damaged

Interior before treatment

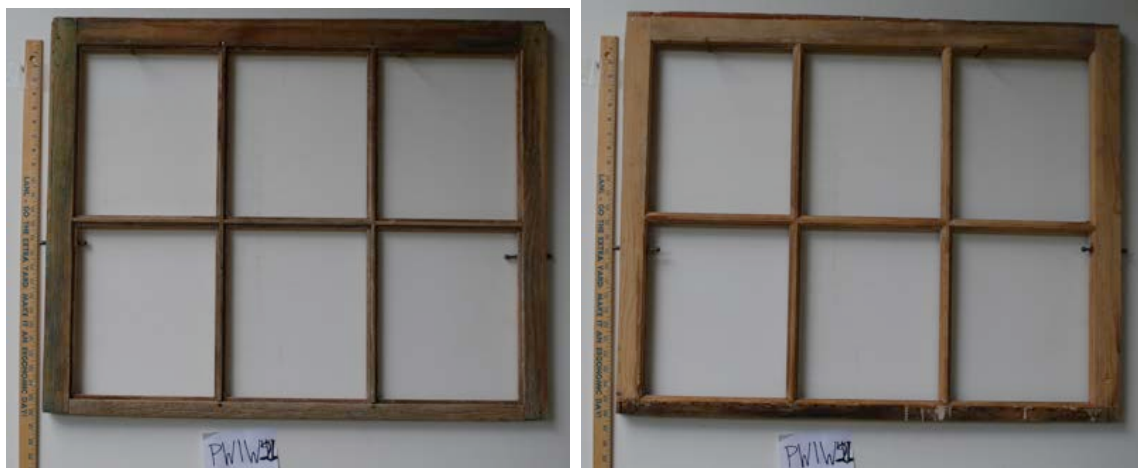
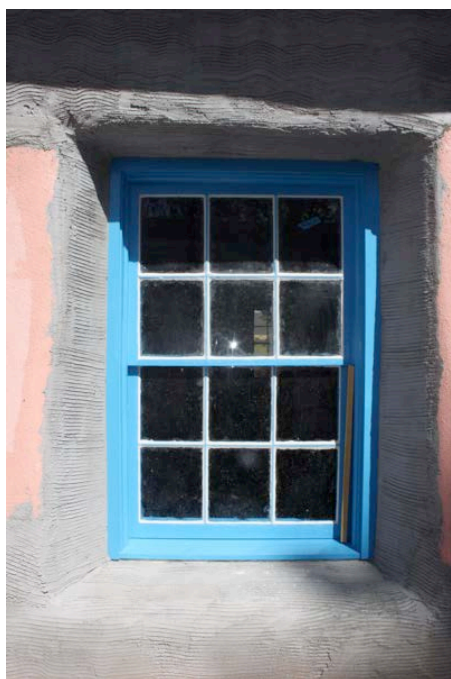
Exterior after treatment

- Laminated 1" additional material to right stile
- Replaced metal pins on right stile and at junction of vertical muntins #1 and #2 with dowels

- Replaced horizontal muntin #3
- Replaced right stile
- Dutchman to meeting rail at junction with vertical muntin #1
- Replaced metal pins with dowels on right stile

New buck and jamb fabricated

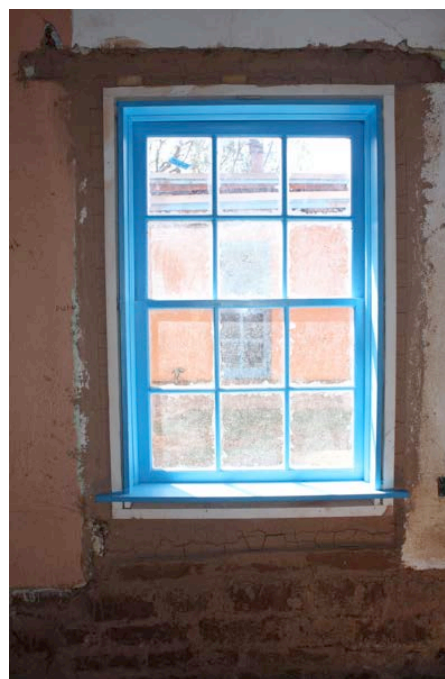
Interior after treatment

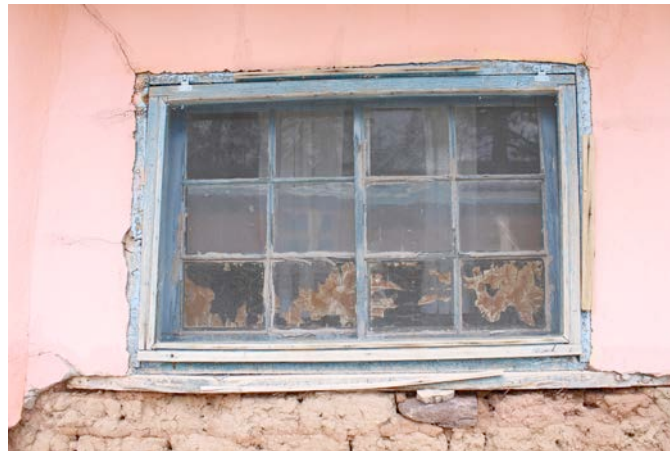
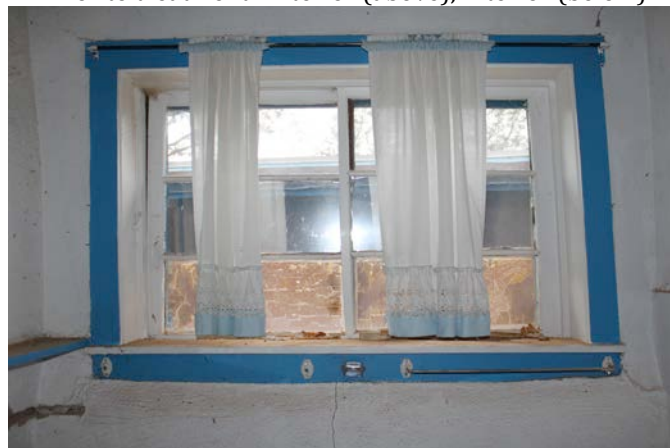
- Joints are loose
- Molding applied to sill to prevent operability
- Film on all glass
- Meeting rail on interior sash bowed
- Bottom stiles are both cut to fit opening

Prior to treatment: Exterior (above), Interior (below)

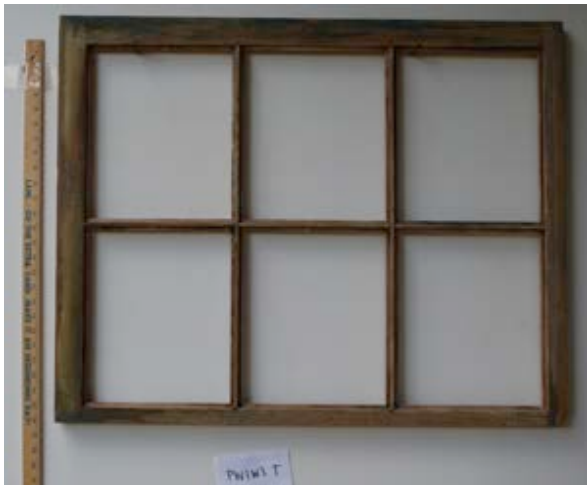
Left sash prior to treatment

- 1 3/8" additional material laminated to bottom stile
- Dutchman to meeting rail at bottom of horiz. Muntin #2
- Metal pins at lower corners replaced with wooden dowels
- Right rail/horizontal muntin #2 joint pinned with a wooden dowel

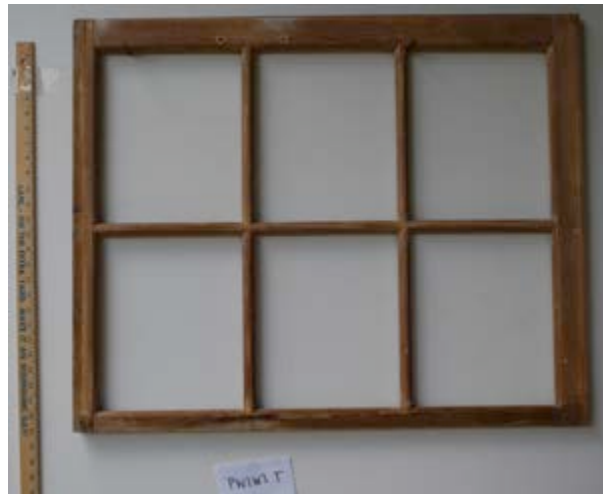
Right sash prior to treatment

- 1" additional material laminated to bottom stile
- Dutchman to left rail at junction with horiz. Muntin #1
- Dutchman to meeting rail at junction with horiz. Muntin #2

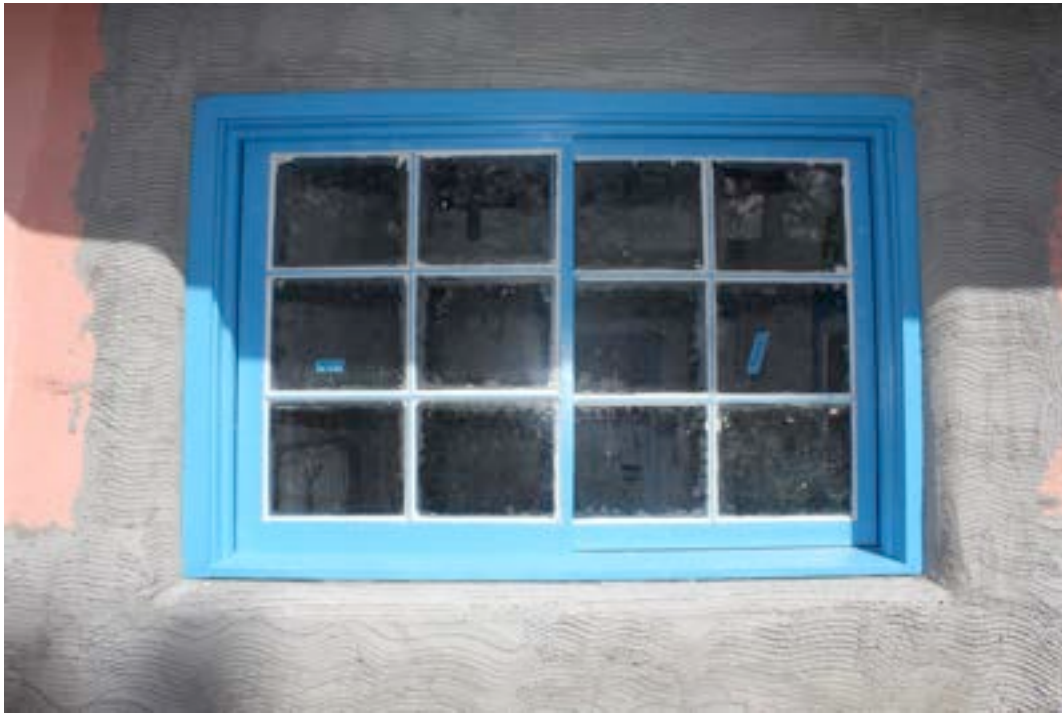
Exterior after treatment

New buck and jamb fabricated

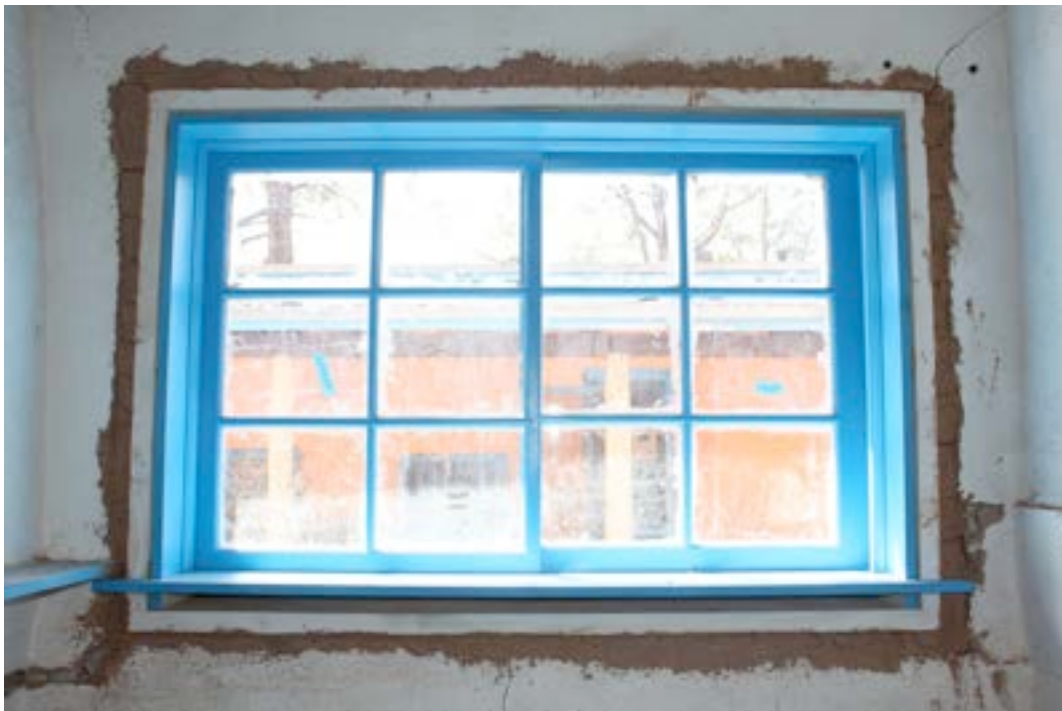
Interior after treatment

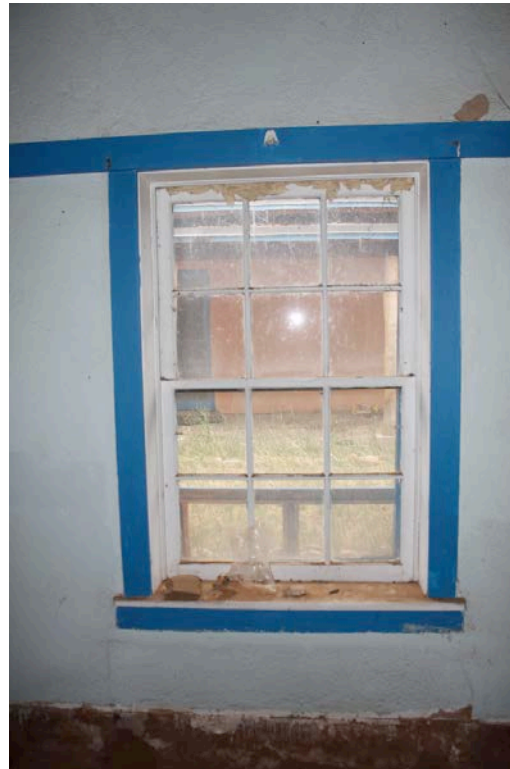
Interior before treatment

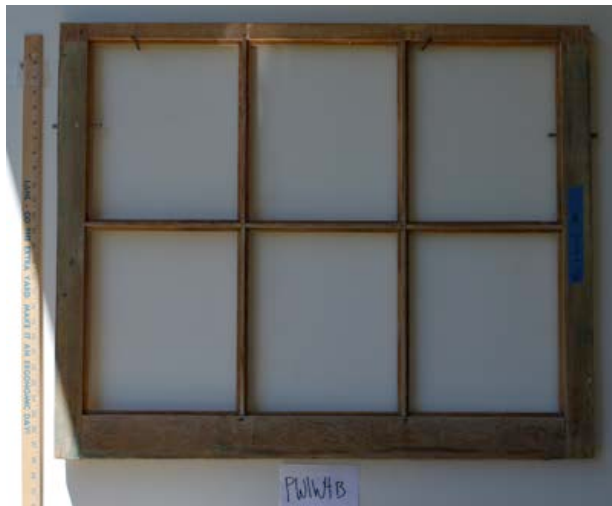
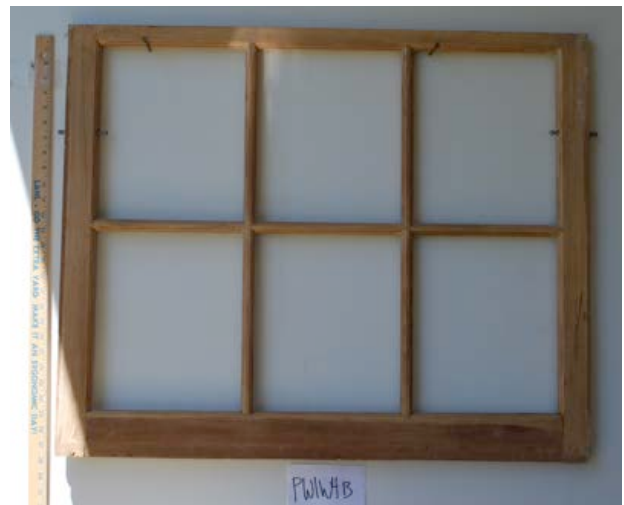
Lower sash prior to treatment

- Metal pins replaced with wooden dowels at all joints with bottom rail except the left corner

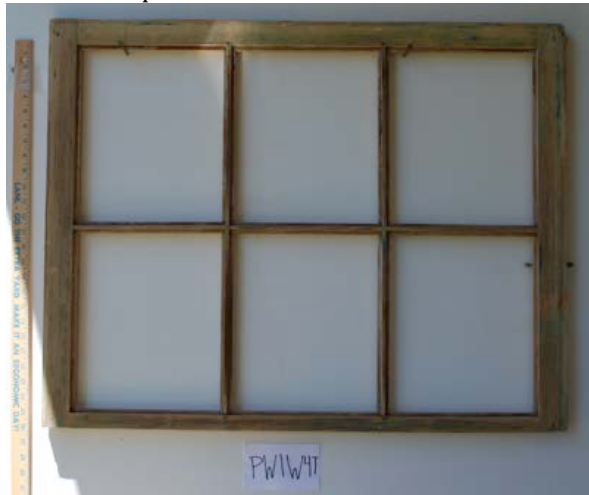
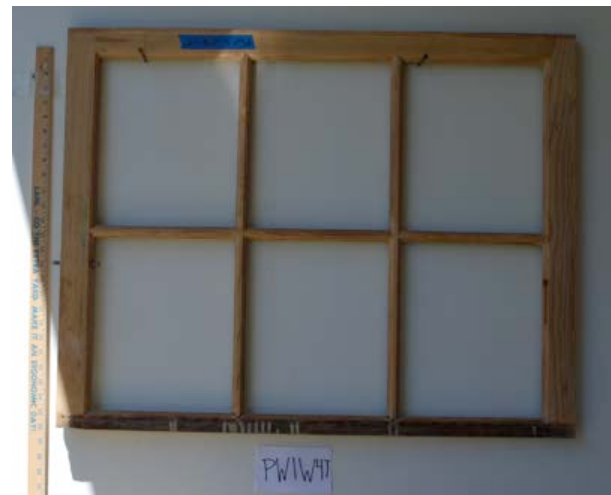
Upper sash prior to treatment

- Dutchman to upper corner of right stile, exterior face
- Dutchman to meeting rail at both vertical muntin junctions
- Metal pins replaced with wooden dowels, upper corners only

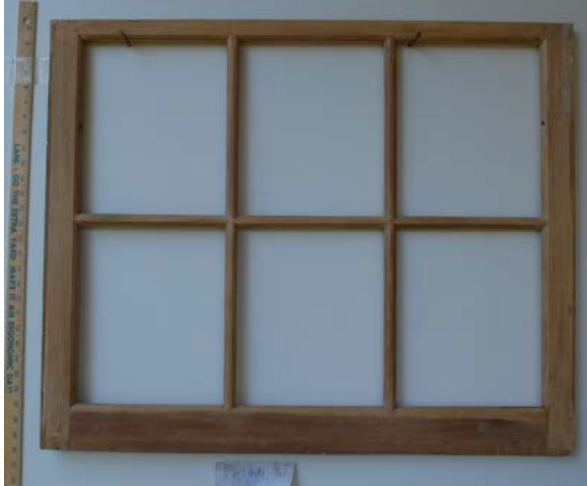
Lower sash after treatment

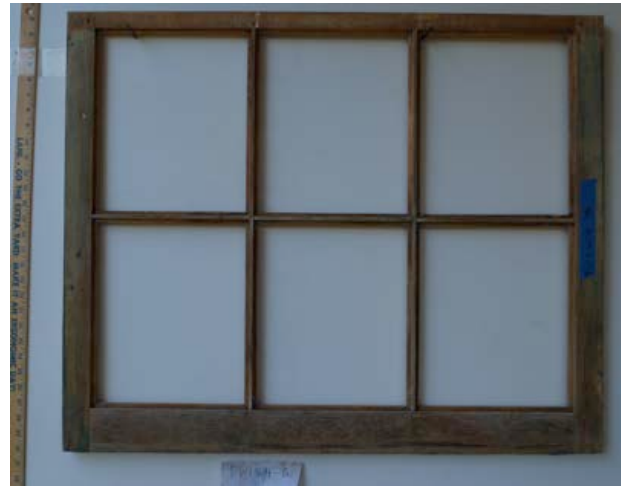
Upper sash after treatment

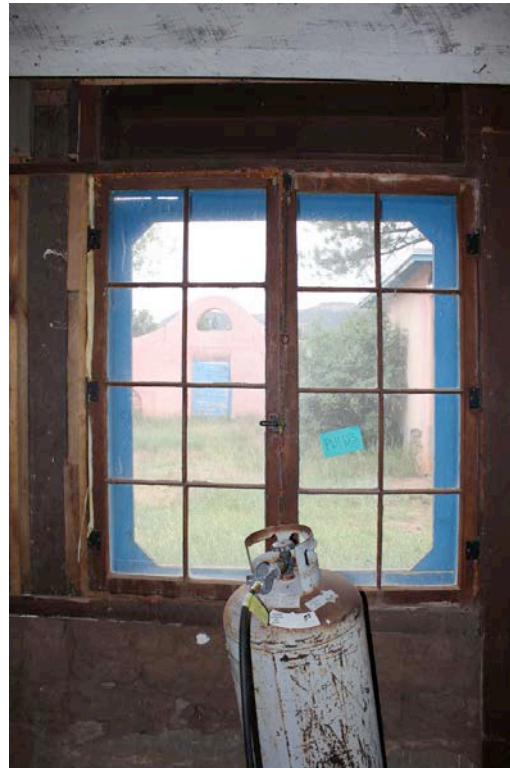
Interior prior to treatment

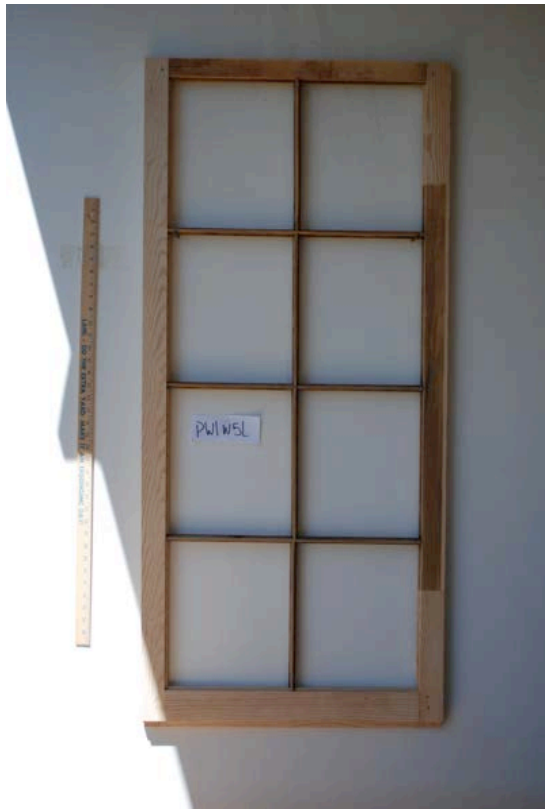
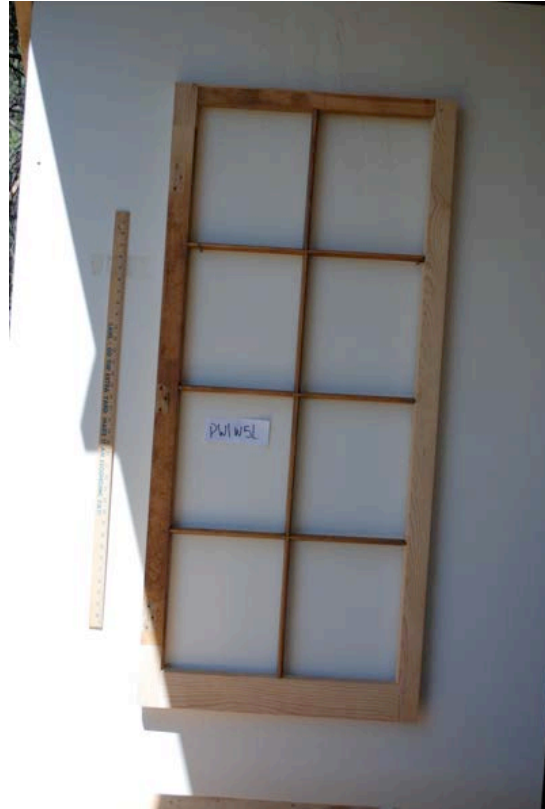
Sashes after treatment

- 1/8" new material laminated to top rail, upper edge
- 4" boot to top of hinge stile
- Bottom rail and lock stile replaced
- Corner pins replaced with wooden dowels
- Extra screw holes plugged with dowels

- 3/8" additional material laminated to hinge stile
- Astragal added
- 5" boot to bottom of both stiles
- Bottom rail replaced
- Corner pins replaced with wooden dowels
- Extra screw holes plugged with dowels

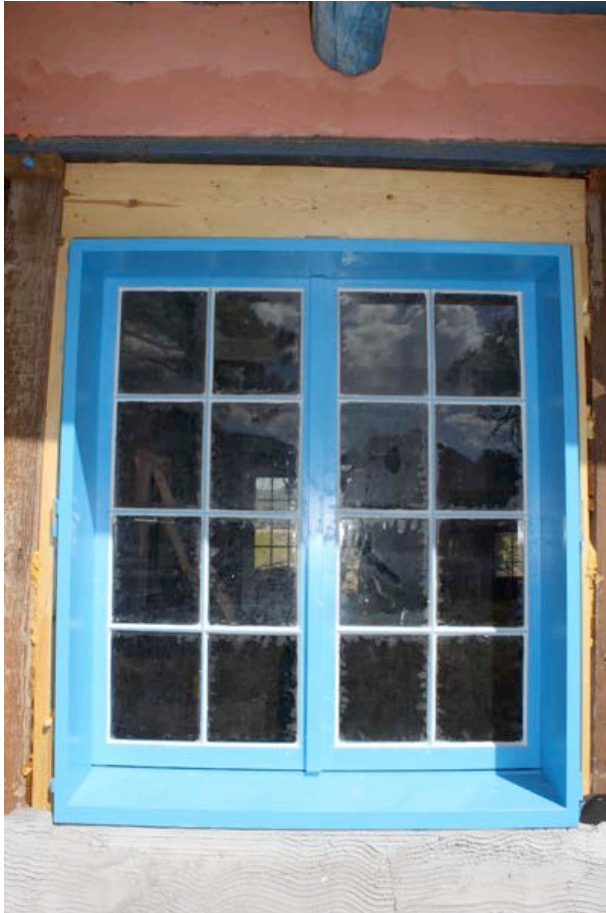
Exterior after treatment

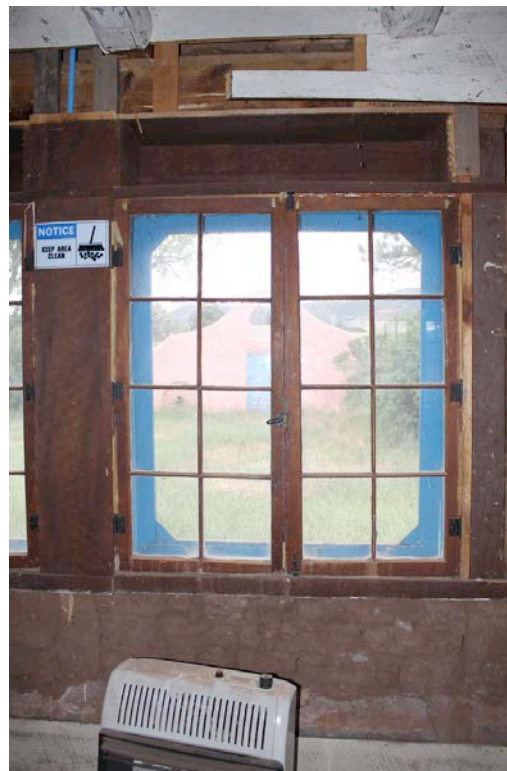
Interior prior to treatment

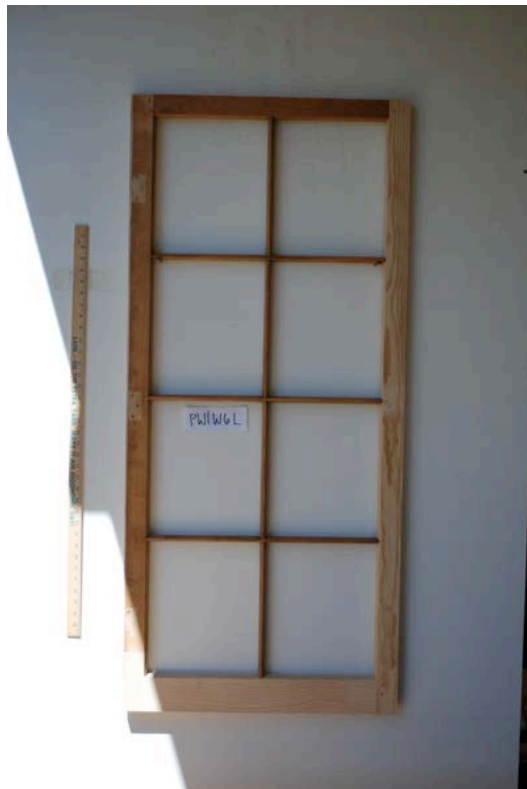
**Sashes after treatment**

- 1/4" new material laminated to hinge stile
- 5" boot to top of hinge stile
- Bottom rail and lock stile replaced
- Corner pins replaced with wooden dowels
- Extra screw holes plugged with dowels

- 1/2" additional material laminated to hinge stile
- Astragal added
- Horizontal muntins 1 and 3 replaced
- 5" boot to bottom of both stiles
- Bottom rail replaced
- Corner pins replaced with wooden dowels
- Extra screw holes plugged with dowels

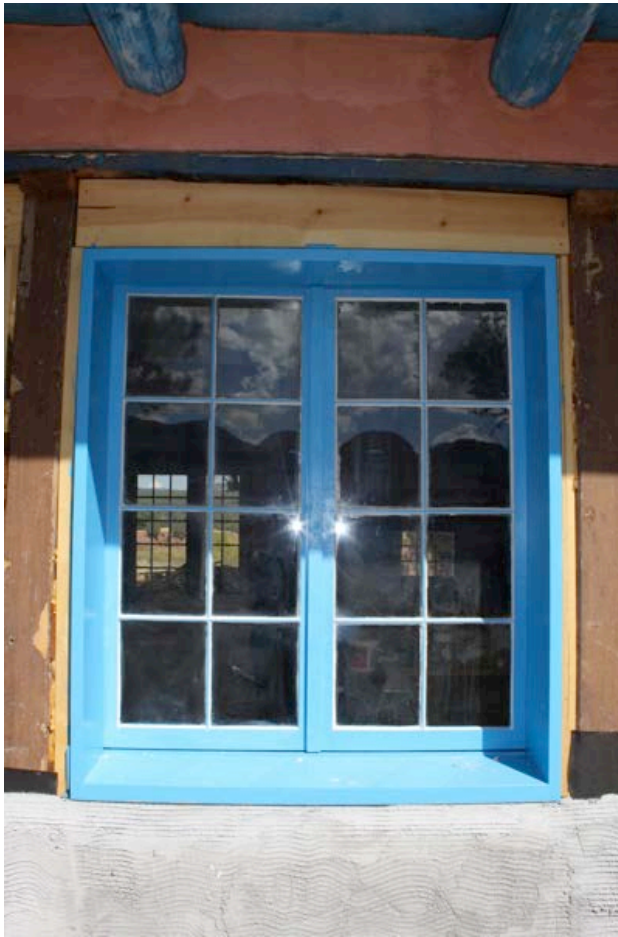
Exterior after treatment

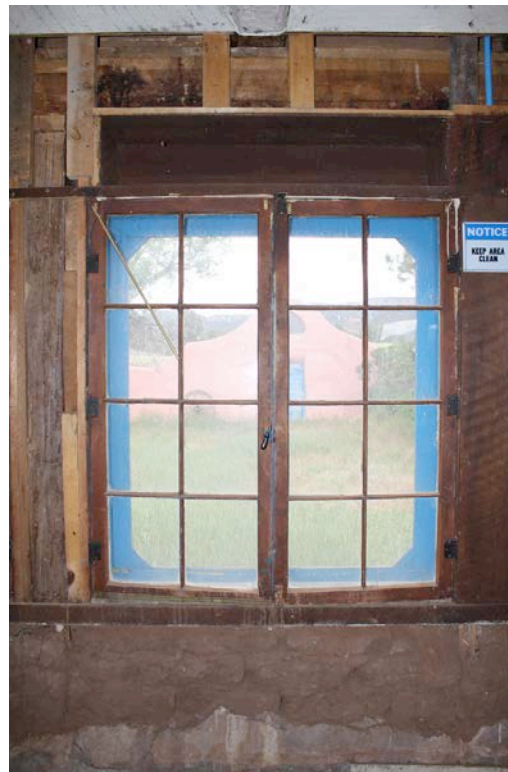
Interior before treatment

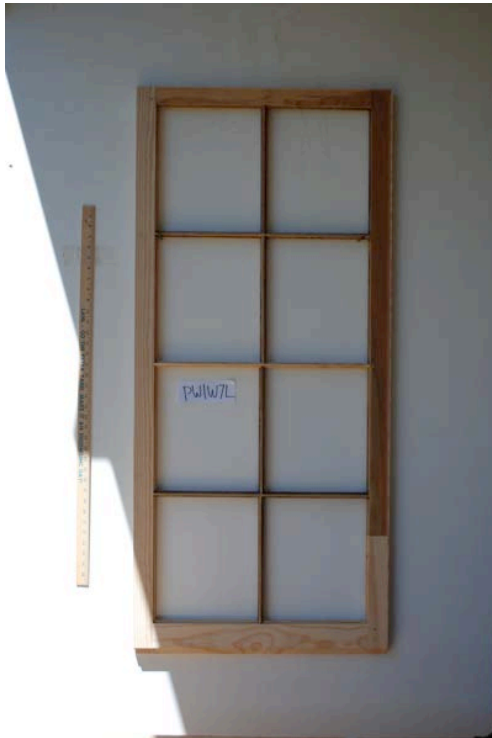
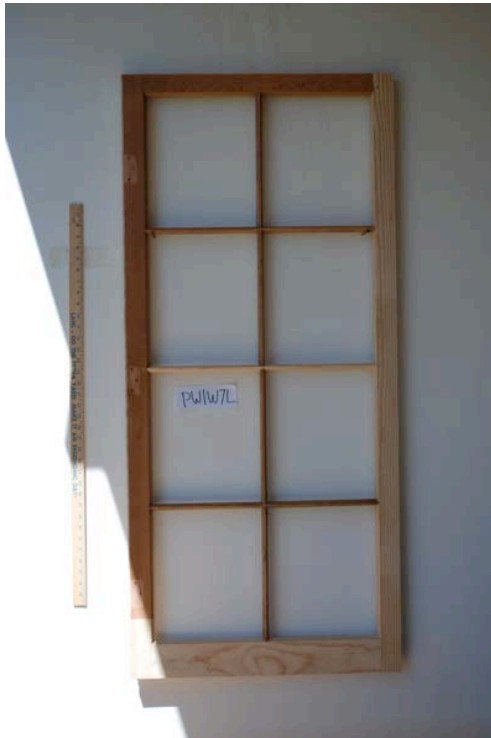
**Sash after treatment**

- 1/8" new material laminated to hinge stile
- 5" boot to top of hinge stile
- Bottom rail and lock stile replaced
- Corner pins replaced with wooden dowels
- Horizontal muntin 2 replaced, wooden dowels at joints
- Extra screw holes plugged with dowels

- 3/8" additional material laminated to hinge stile
- Astragal added
- Horizontal muntins 1 and 3 replaced
- 5" boot to bottom of both stiles
- Bottom rail and horizontal muntin 3 replaced
- Corner pins replaced with wooden dowels
- Extra screw holes plugged with dowels

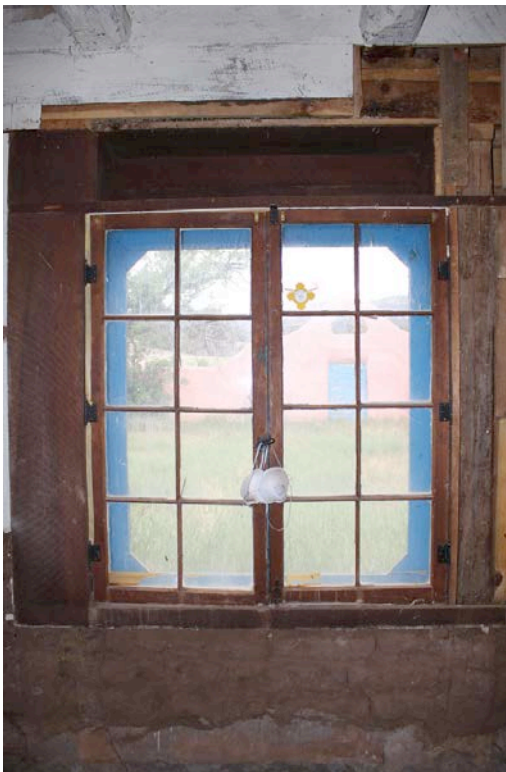
Interior before treatment

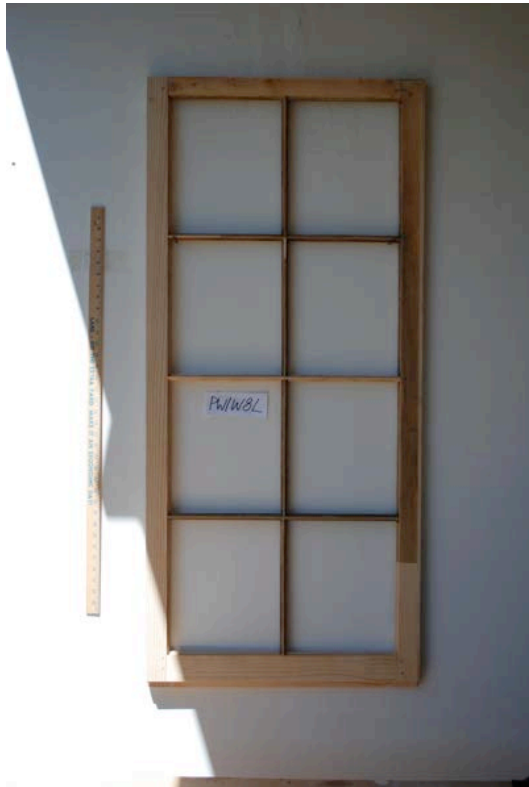
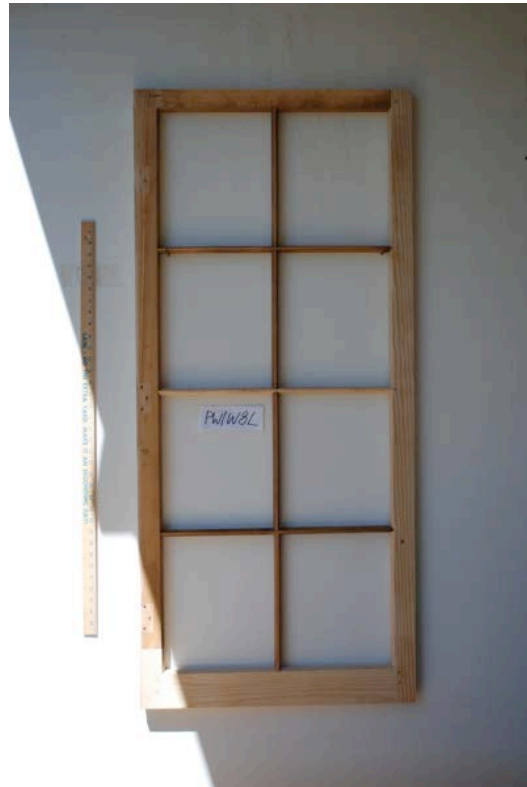
Sash after treatment

- 1/4" new material laminated to hinge stile
- 5" boot to top of hinge stile
- Bottom rail and lock stile replaced
- Corner pins replaced with wooden dowels
- Extra screw holes plugged with dowels
- Dutchman to right end of glazing bar, horizontal muntin 1
- Horizontal muntin 2 replaced

- 1/4" additional material laminated to hinge stile
- Astragal added
- Horizontal muntins 1 and 3 replaced
- 5" boot to bottom of both stiles
- 4" boot to top of lock stile
- 1/4" additional material laminated to top rail
- Bottom rail replaced
- Corner pins replaced with wooden dowels
- Extra screw holes plugged with dowels

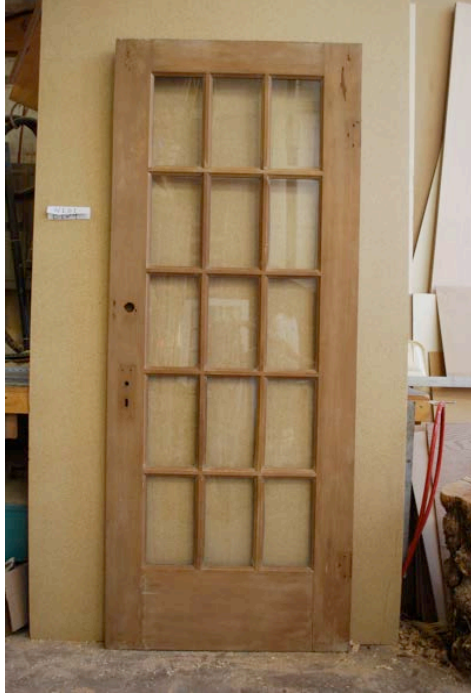
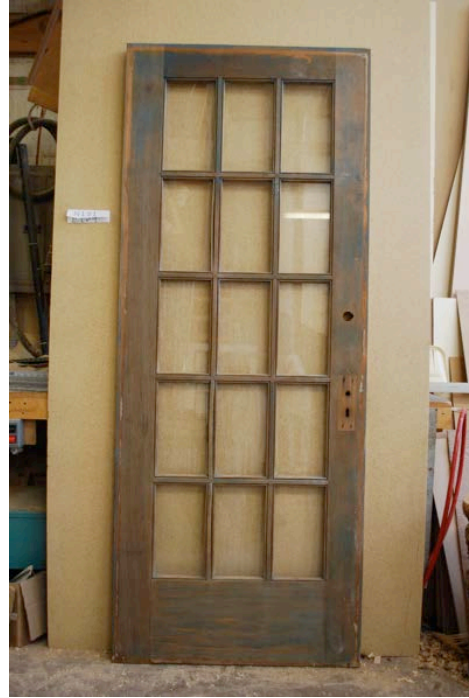
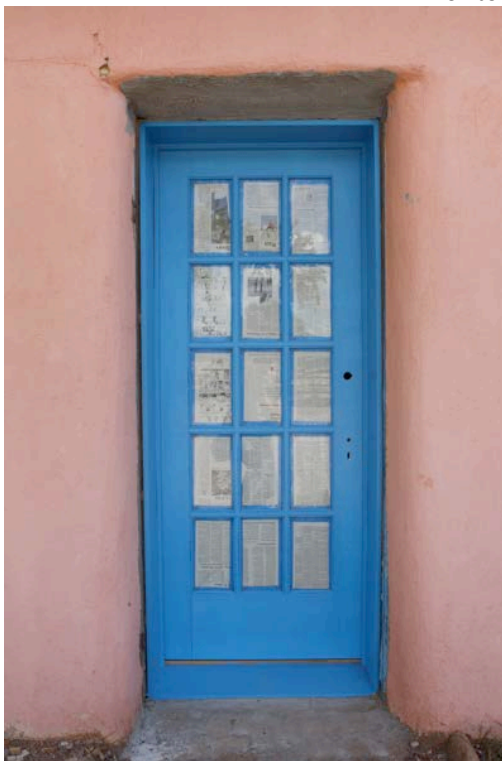
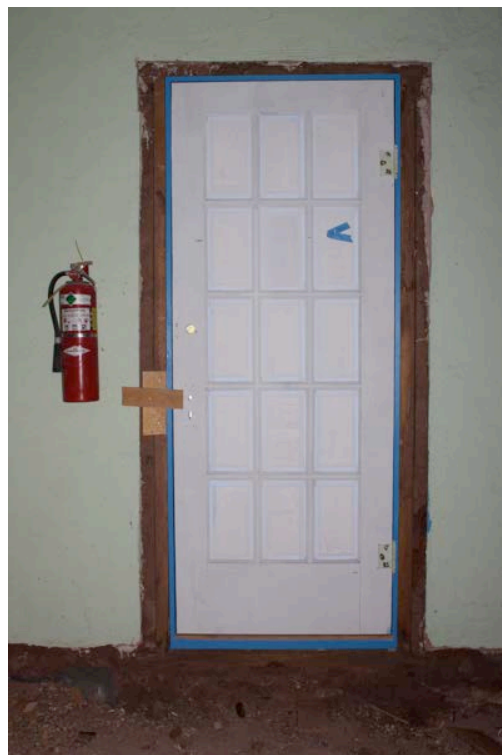
Prior to treatment

After treatment

- Strip, sand, and re-glaze
- New jamb and threshold fabricated

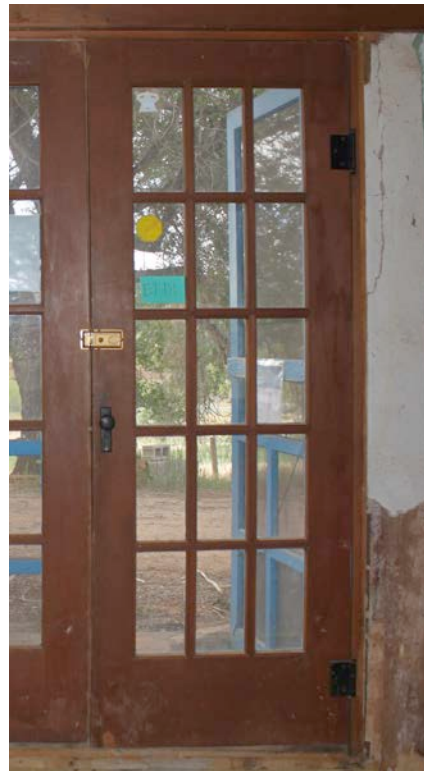
- Threshold is partially missing and rotted

- Chunk missing from top rail on the inside
  - Bottom most exterior molding missing
  - Bottom stiles show moderate signs of decay
- Partial piece of exterior threshold molding remains

- Deadbolt has been replaced

TREATMENT: Replacement units (doors and jambs) were fabricated for units E1D1-3

E1D1 is now a fixed sidelight. Dimensions: 78 ½" x 26 ½"
