PECOS NATIONAL HISTORICAL PARK  
KOZLOWSKI'S TRADING POST RESTORATION PROJECT

EAST WING MILLWORK RESTORATION  
COMPLETION REPORT

Prepared for  
Pecos National Historical Park  
March 2011

by  
School of Engineering, University of Vermont

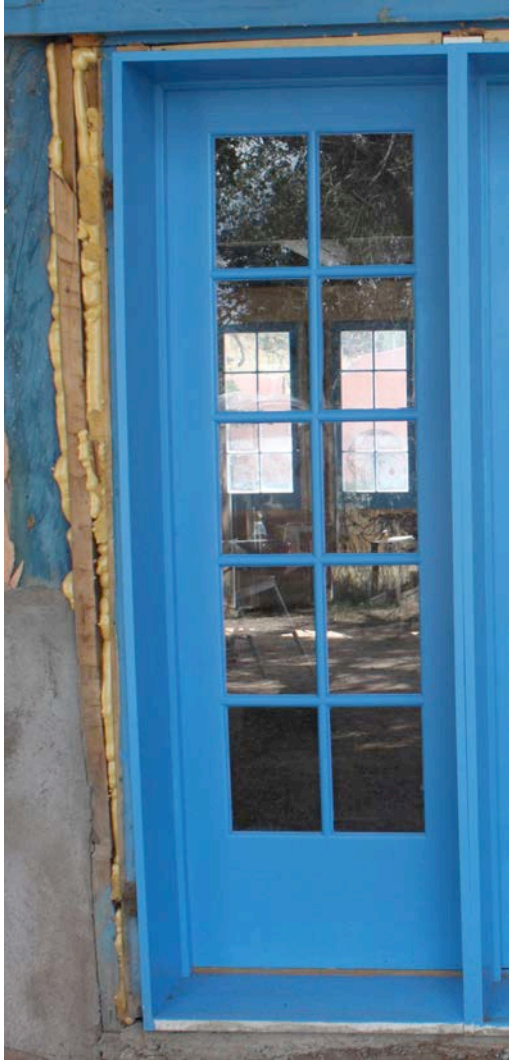
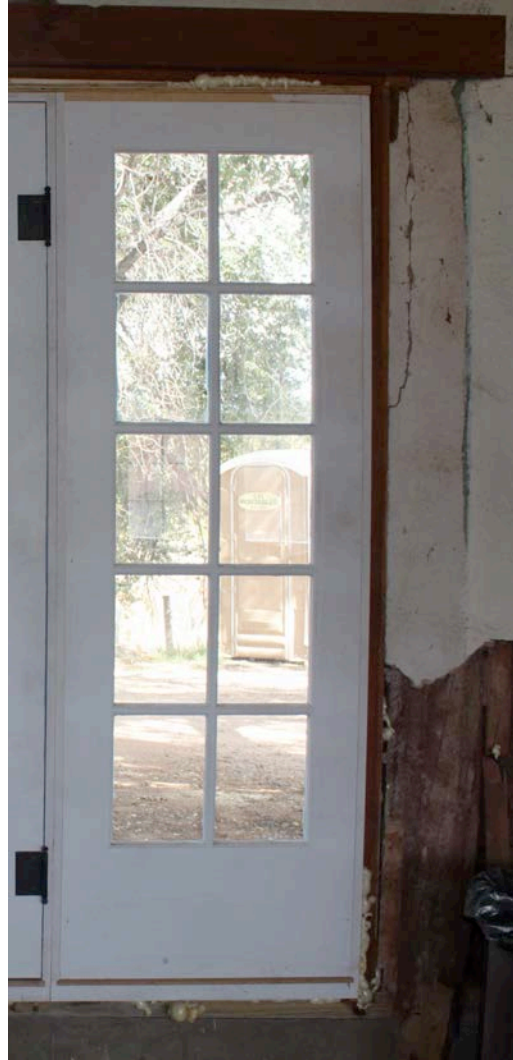
**Exterior after treatment**

**Interior after treatment**

TREATMENT: Replacement units (doors and jambs) were fabricated for units E1D1-3

E1D1 is now a fixed sidelight. Dimensions: 78 ½" x 26 ½"

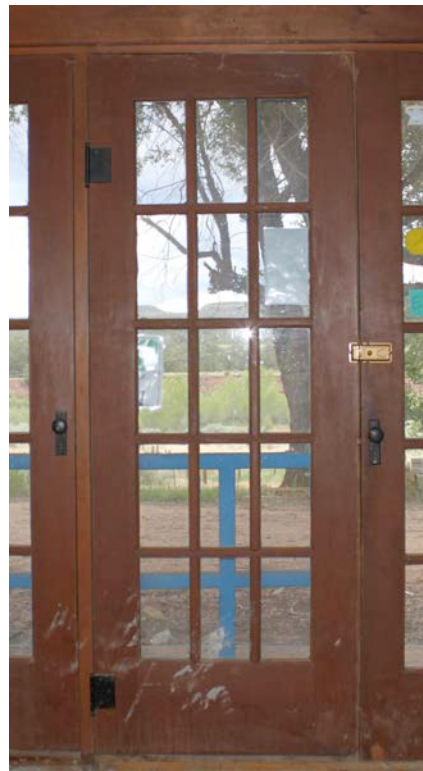
- Some damage near strike plate
- Newer lock applied
- Astragal cracked 24" up from bottom
- Portion missing from top of lock stile

- Threshold is partially missing and rotted

- Bottom exterior molding missing
- Bottom of both stiles show signs of decay

- Deadbolt has been replaced

TREATMENT: Replacement units (doors and jambs) were fabricated for units E1D1-3  
New door dimensions: 78 ½" x 36"

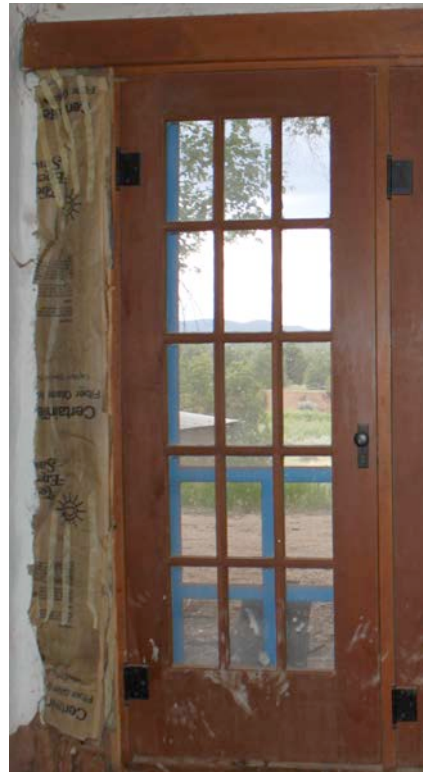
- Chunk missing from lock stile

- Threshold is partially missing and rotted

- Plywood panel added to bottom section of door
- Inner stile has big gouge at bottom
- Casing along out edge of jamb missing

TREATMENT: Replacement units (doors and jambs) were fabricated for units E1D1-3  
E1D1 is now a fixed sidelight. Dimensions: 78 ½" x 26 ½"

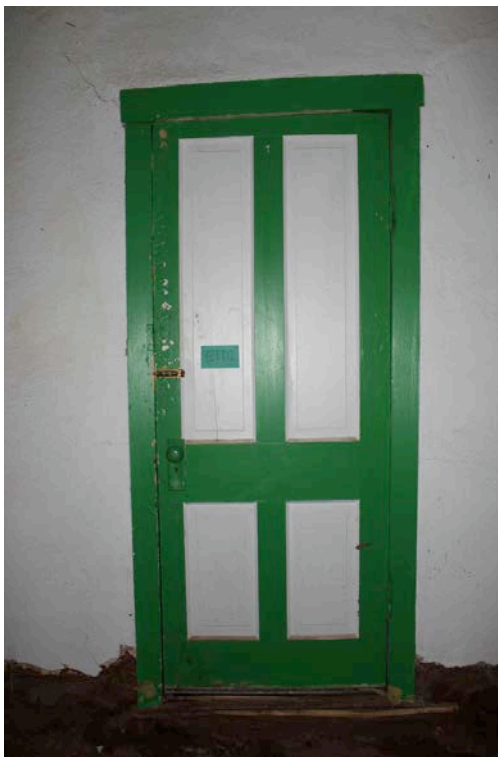
- Top rail cut at an angle to accommodate jamb
- Upper panel on handle side cracked
- Lock stile damaged by hammer
- Gaps at top and bottom handle side joints
- Stop molding cracked
- Gouged above lock on interior handle side stile

- Casing cut to accommodate crooked jamb
- Hinge side of jamb cracked
- Threshold decayed
- Hinge side stile has a big gouge at chest level

- Top rail cut at angle to accommodate jamb
- Bottom rail shows signs of decay
- Bottom of both stiles show signs of decay
- Stop molding damaged near bottom of jamb

- Replaced lock stile
- Extended hinge stile
- Replaced top rail
- Repaired upper south panel
- New jamb and threshold fabricated

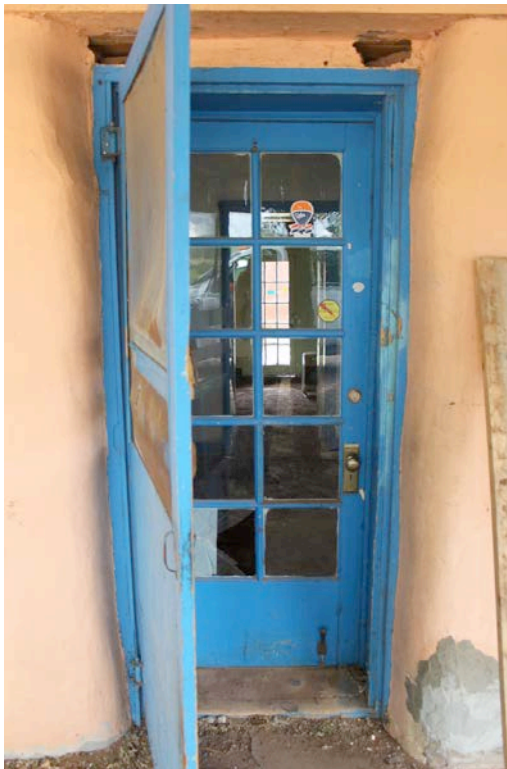
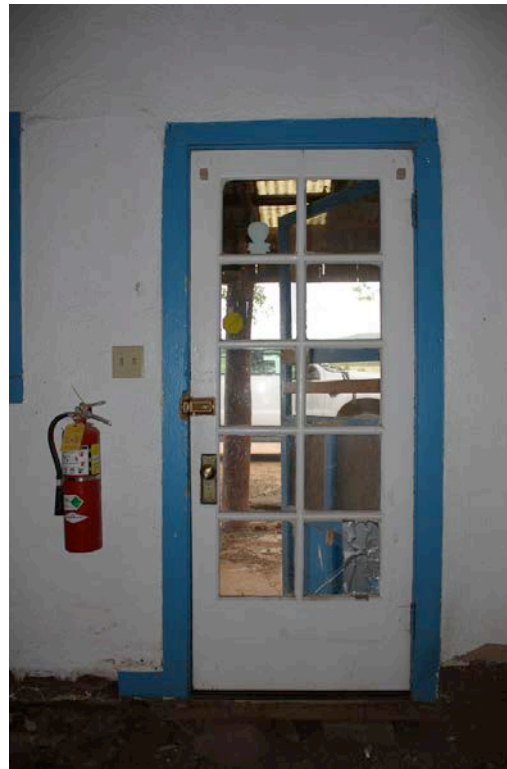
- Visible gaps at upper rail / stile joint on handle side
- Caulk used to keep glazing in place
- Broken glazing in lowest opening on hinge side
- Bottom rail is cracked

- Threshold is partially missing and rotted

- Muntins on bottom half of door broken
- Doesn't open completely because of new concrete doorstep
- Possibly a replacement screen

- Deadbolt has been replaced

TREATMENT: A replacement unit (door, buck threshold and jamb) was fabricated

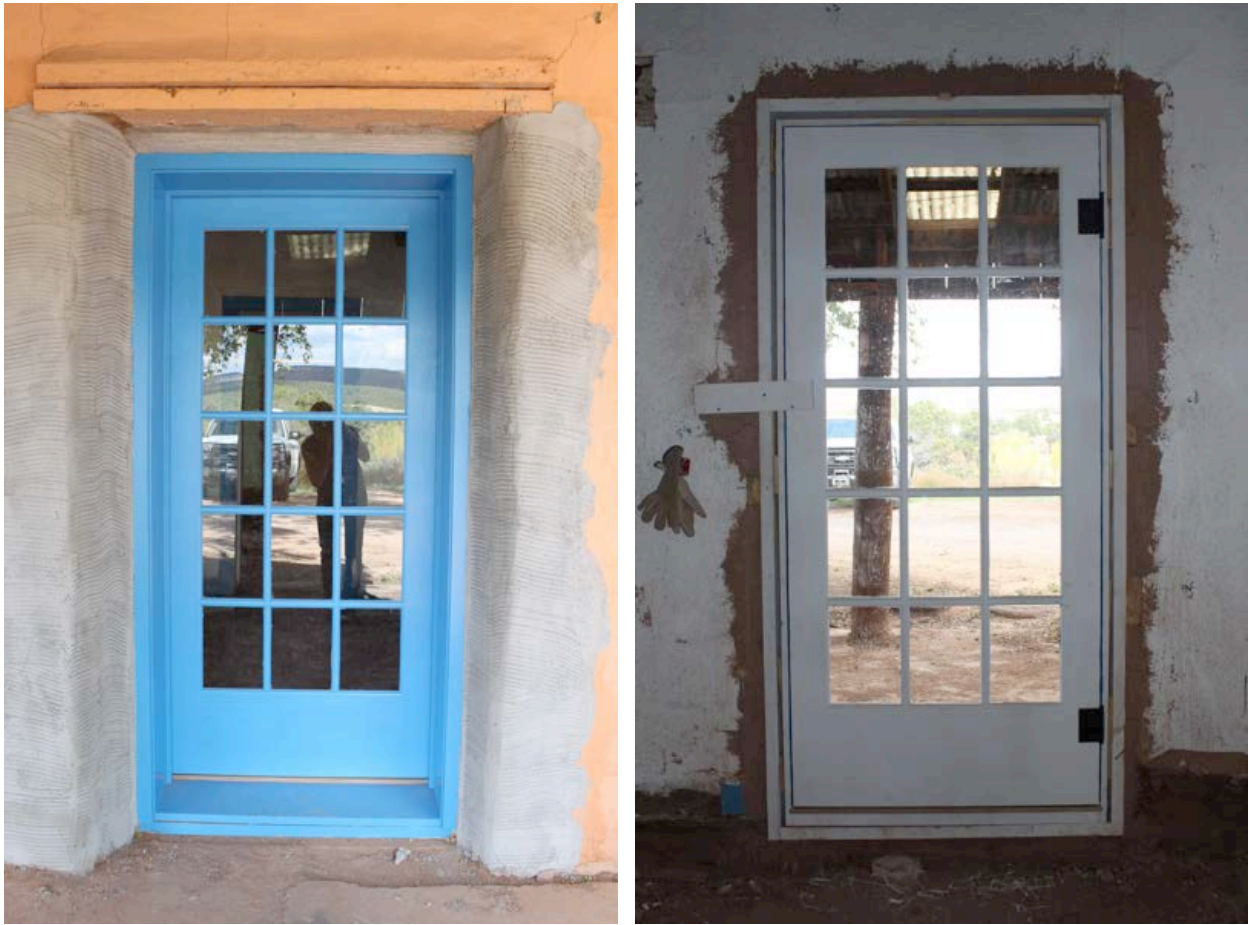
Replacement unit: Exterior (left) and Interior (right)

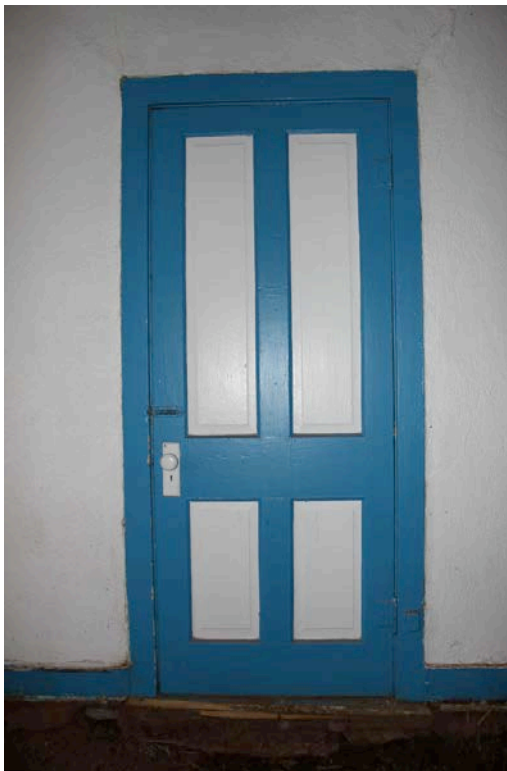
- Threshold is partially missing and rotted

- Weathered exterior
- Missing an ornamental brace in the upper corner of the door
- Screen stop has been replaced and is mismatched

- Deadbolt has been replaced

- Strip, sand
- New buck,jamb and threshold fabricated

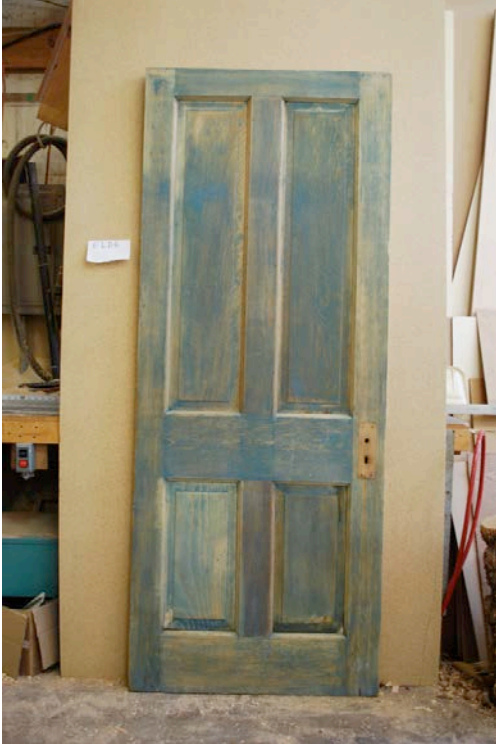
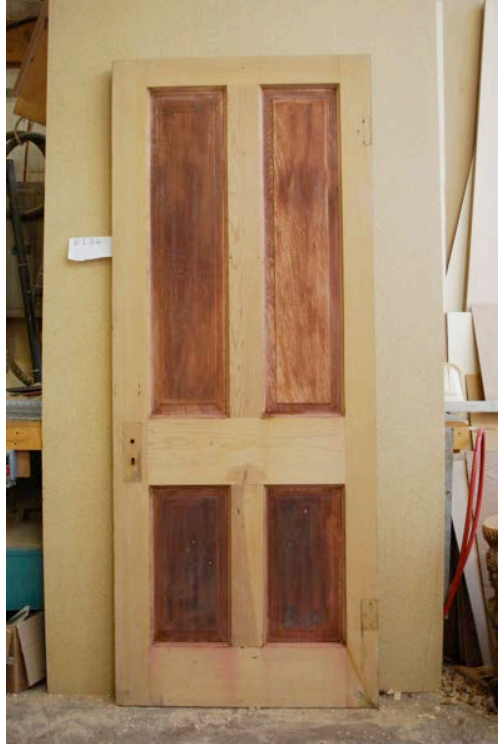
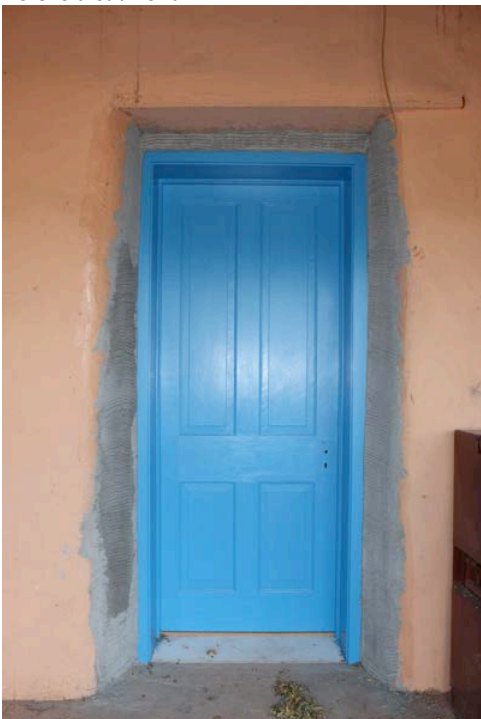
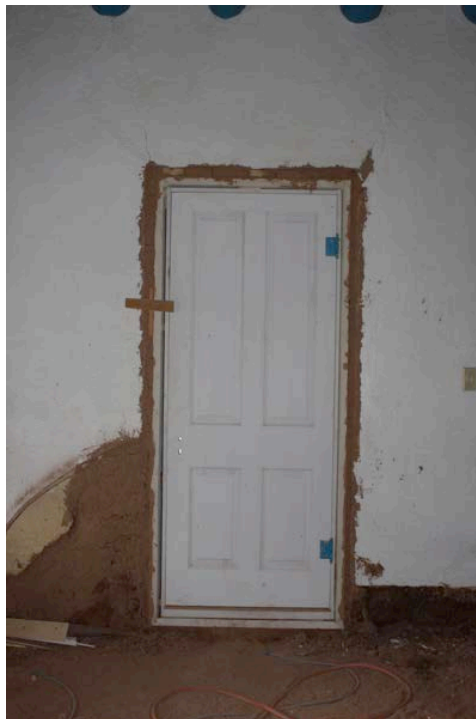
Before treatment

After treatment

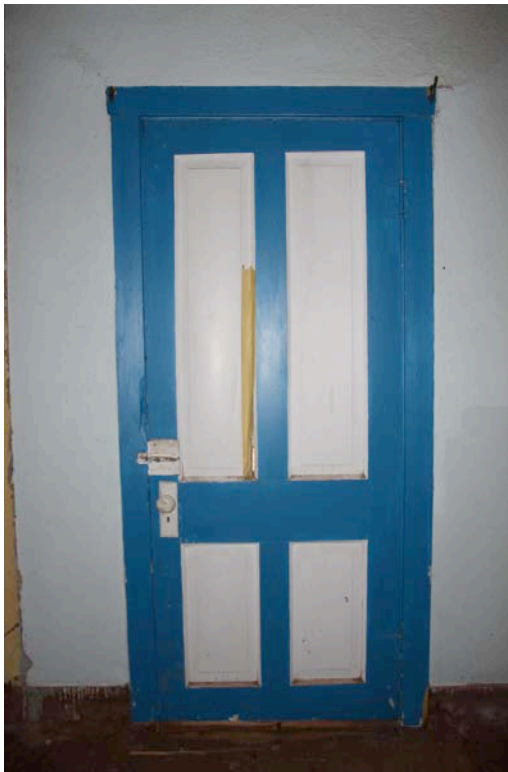
- Door is inoperable
- Material added to upper rail to fit jamb
- Material cut from bottom rail to fit jamb
- Interior casing missing a big chunk on hinge side at bottom
- Upper, handle side panel warped
- Caulked closed

- Decayed at bottom on exterior

- Has been removed

- Replicated/replaced upper south panel
- Extended both stiles
- Replaced bottom rail
- New three-sided buck was fabricated using existing lintel as a header
- New jamb and threshold fabricated
