Old Firehouse Beaufort, South Carolina Historic Structure Report

Old Firehouse

Reconstruction Era National Historical Park

Historic Structure Report

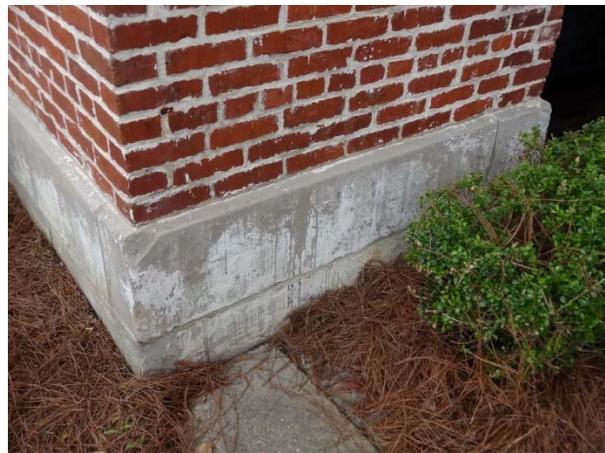
Foundation. The Old Firehouse sits on a stone foundation. A portion of the foundation wall is visible at the base of the building. Typically, two courses of ashlar cut stone are visible throughout the perimeter of the building (Figure 23). The cut stone ranges in height from 7-1/2 inches to 13 inches tall. The stone foundation wall extends outward from the brick masonry wall above by approximately 1 inch.

FIGURE 23. A view of the stone foundation wall.

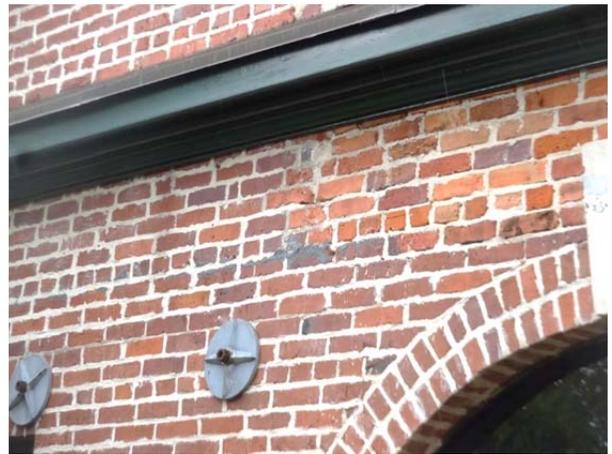
of the brick differs slightly (Figure 25). Large portions of the west elevation appear to have been rebuilt, with much of the brick differing in size and color. The mortar joints between brick units are typically 3/8 inch to 3/4 inch in size.

FIGURE 25. A detail view of the brick masonry wall. Note the different color brick at the upper right.

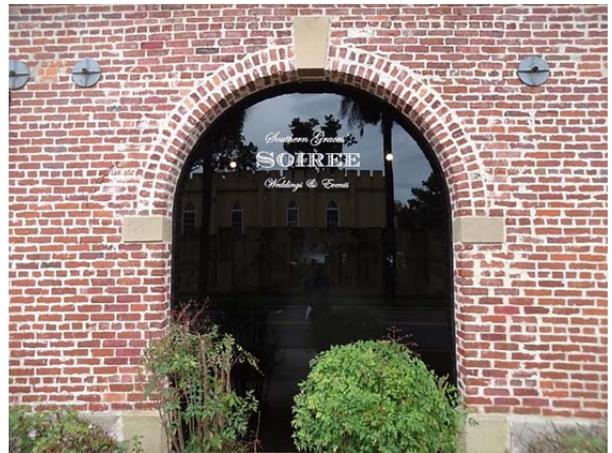
At the arched openings, two rows of rowlock brick form the top of the arch (Figure 26). A stone keystone and stone imposts are also located at each arched opening. The stone matches the style and finish of the stone at the top of the foundation walls. There are brick sills situated slightly above the finished floor level at each of the arched openings (Figure 27).

FIGURE 26. A typical arched window opening. Note stone keystone and imposts.

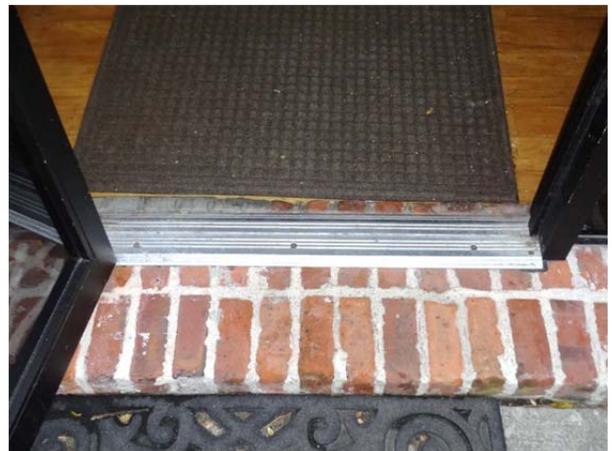
FIGURE 27. A typical brick sill at the arched storefront windows.

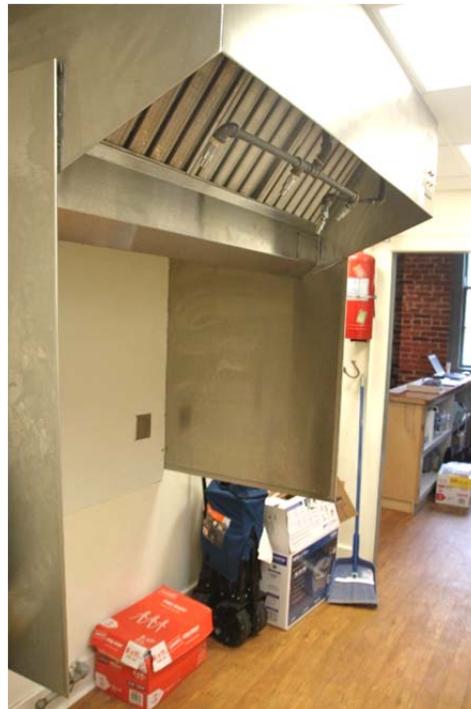
Most of the kitchen equipment is gone, and the exhaust hood, associated plumbing, and chemical fire-suppression system were recently removed, according to National Park Service staff (Figure 63). A low, suspended, acoustical ceiling intersects one of the windows on the east wall, and broken glass in the lower sash is covered by unpainted plywood. Shallow, wood shelves span across the window opening, with wire shelving on each side of the opening (Figure 64). National Park Service staff explained that gypsum board was removed from the wall below the window and above the suspended ceiling to find and repair a water line leak and to allow the wall to dry (Figure 65). In the southeast corner of the kitchen is a janitor's closet with a floor sink and faucet. Here, too, missing gypsum board on the back wall reveals hot and cold water lines that would otherwise be concealed (Figure 66).

FIGURE 63. Exhaust hood at kitchen.

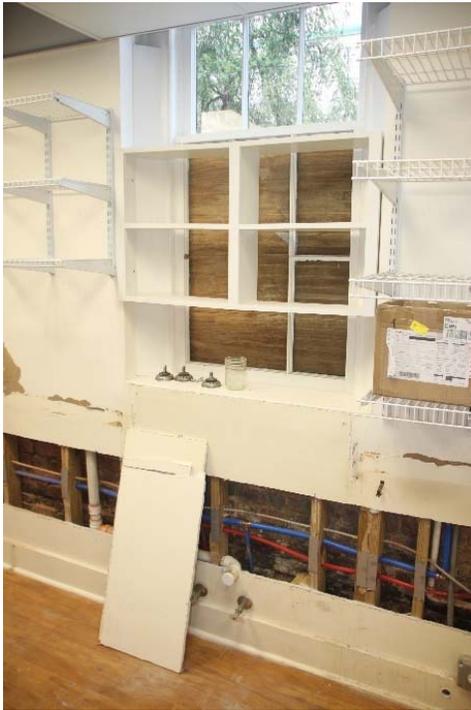
FIGURE 64. Wire shelving around east kitchen window.

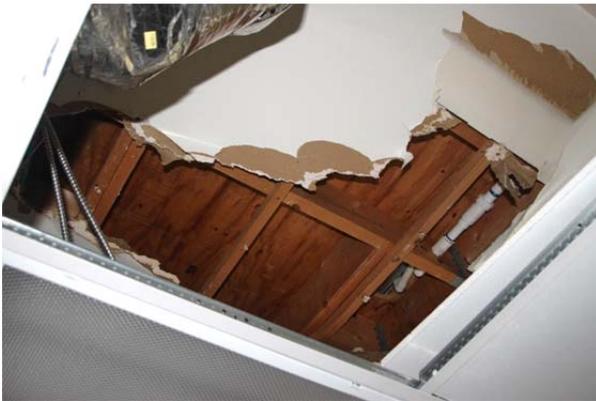
FIGURE 65. Opening at kitchen ceiling.

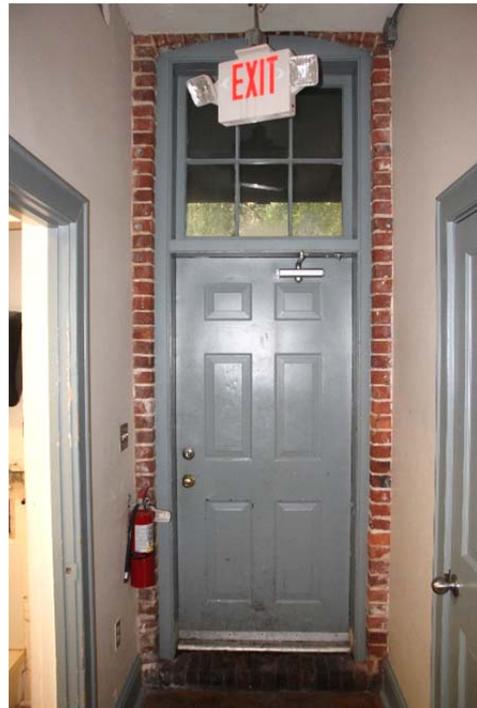
FIGURE 67. Overall view of hall.

and water to enter the building. The raised brick sill is a barrier to accessibility and should be evaluated (refer to Figure 67).

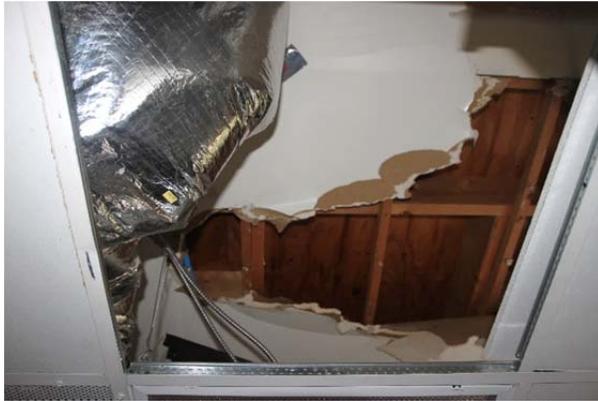
FIGURE 80. Opening above suspended ceiling. Note remnants of gypsum board on the wood framing.

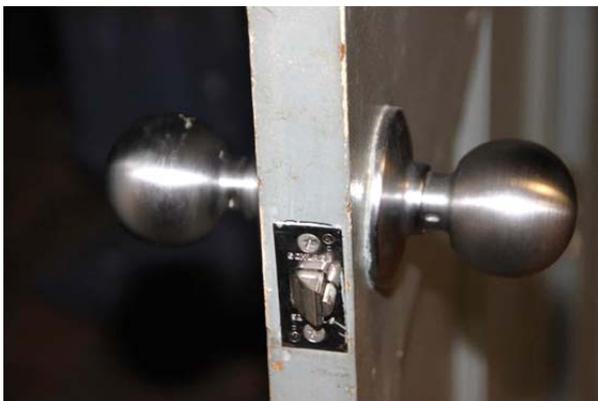
FIGURE 86. Detail at knobbed latch set.

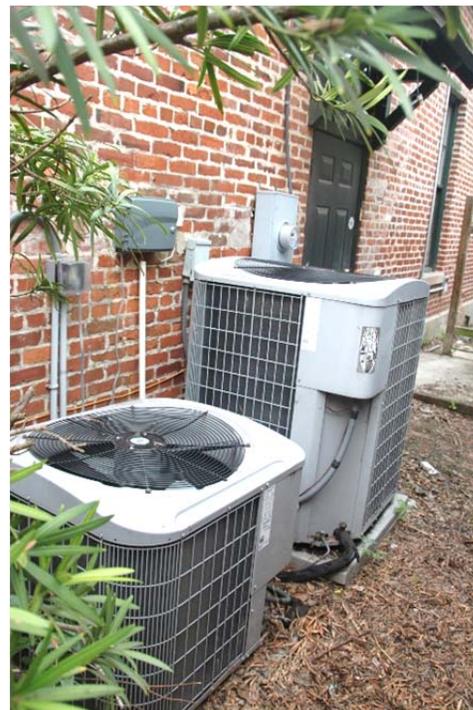
FIGURE 87. HVAC condensing units.

- Door hardware is not Architectural Barriers Act (ABA) compliant.
- Existing HVAC systems are operating, but age and repair histories are not available, so reliability is unknown, and they are likely to be out of warranty.

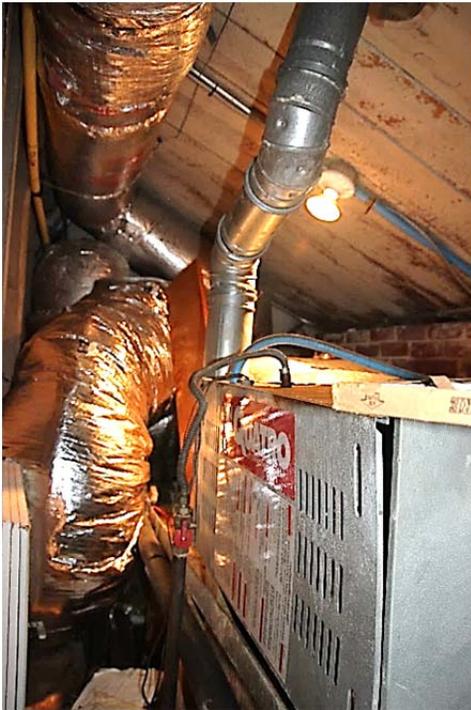
FIGURE 88. Furnace and blower unit.

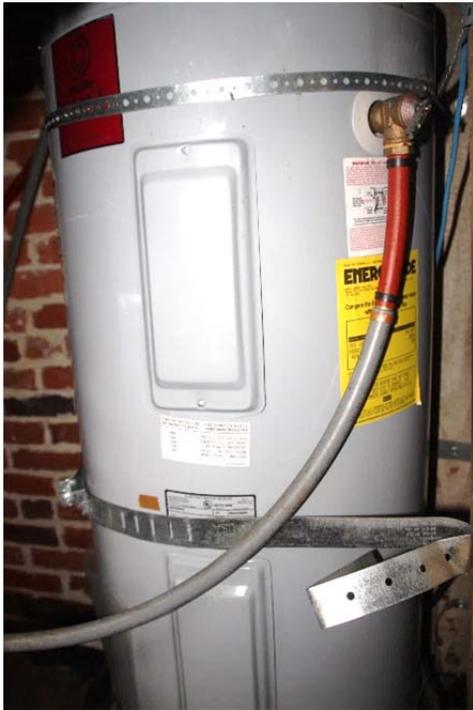
FIGURE 92. Tank-type water heater.

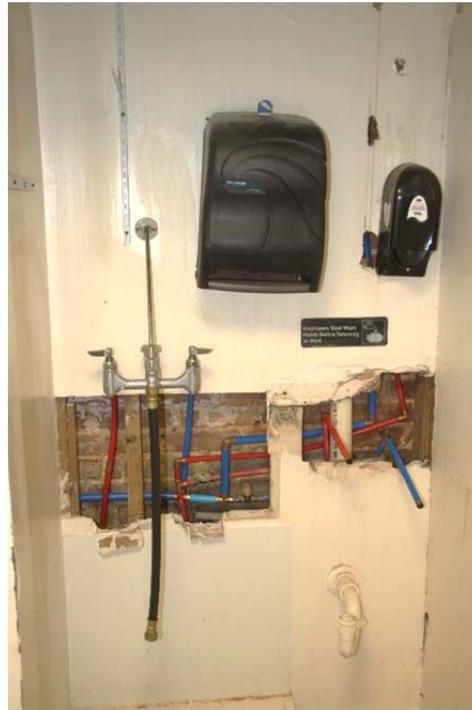
FIGURE 94. Exposed piping at janitor's closet.

- Recent plumbing problems were resolved, and old piping was replaced with new pex tubing and copper fittings.
- The current electrical system appears to be adequate, but the main panel is full. This could limit future upgrades and changes to the firehouse.

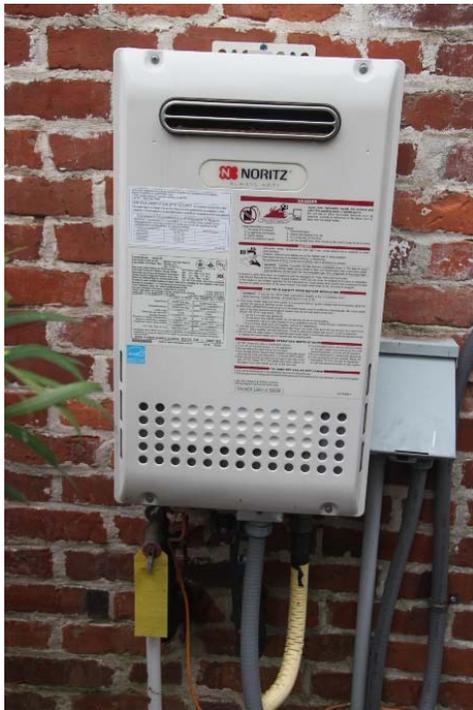
FIGURE 93. Tankless water heater.

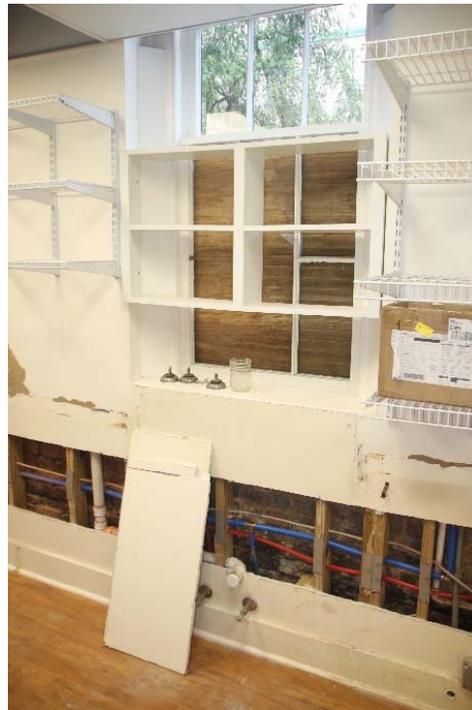
FIGURE 95. Exposed piping at kitchen.

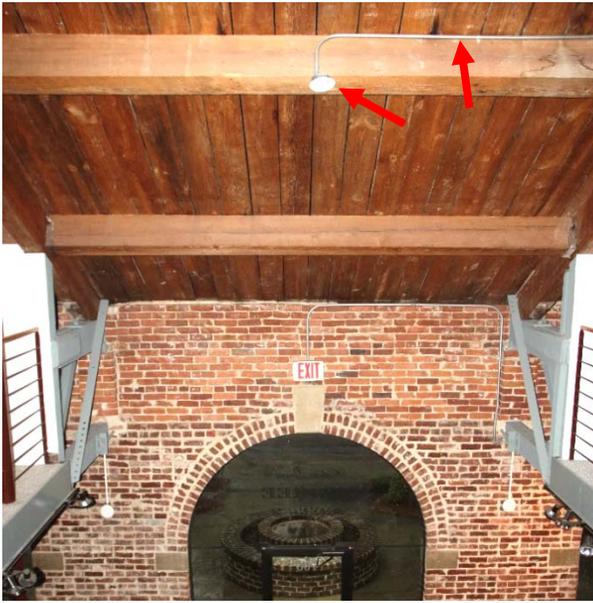
FIGURE 99. Surface-mounted conduit and devices.

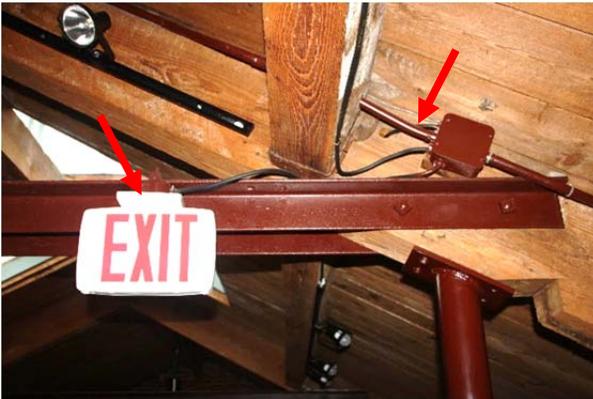
FIGURE 100. Surface-mounted conduit and devices.

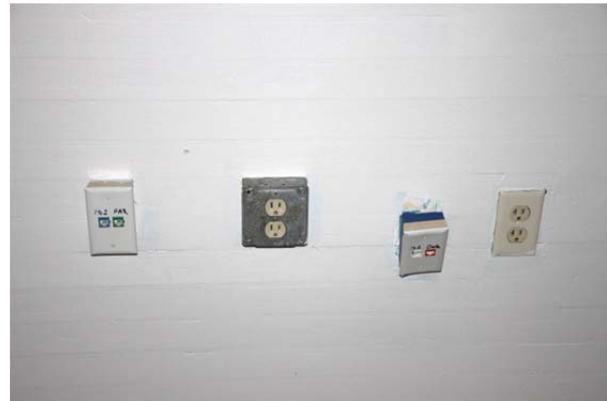
FIGURE 103. Surface-mounted communications receptacles.

Communication and Data. The Old Firehouse is wired for phone, data, and cable television (Figure 103). The age of these systems is unknown, so their reliability is questionable. After the site visit for this report, new wiring for data / internet service was installed to NPS standards, and some of the old wiring was removed.

- Communication and data systems are outdated, and some jacks could be non-functional. Wireless technology would be an improvement. Some exposed conduit and surface-mounted devices were removed and replaced with wireless systems in 2018.

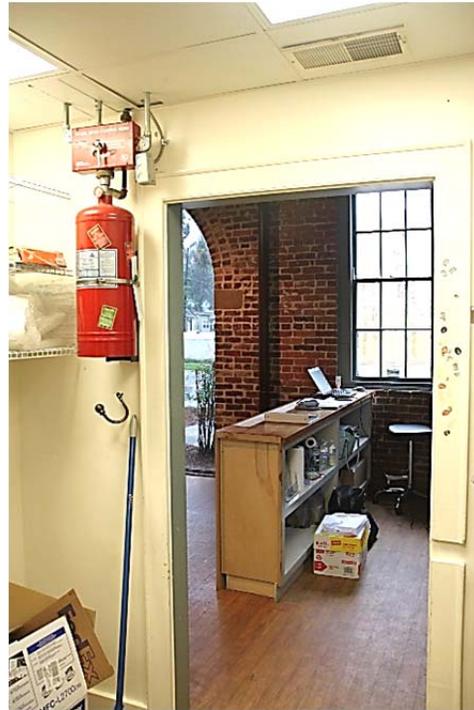
The commercial grade exhaust hood in the kitchen has an integral, dry chemical fire-suppression system. A red chemical tank is mounted on the north wall adjacent to the hood, and the pull station that activates the system is outside the kitchen on the opposite side of that wall next to a light switch and a thermostat. This fire-suppression system may be active. Testing it was outside the scope of this report (Figure 106 and refer to Figure 91). This dry chemical fire-suppression system has since been removed.

FIGURE 106. Fire-suppression system components for kitchen hood.

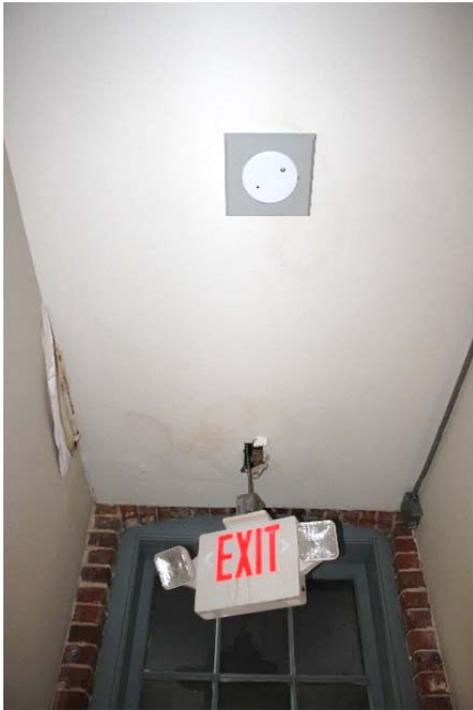
Illuminated exit signs are mounted above exits and at the stair on the mezzanine. A combination illuminated exit sign and emergency light hangs from conduit detached from the ceiling in the east hall (Figure 107, Figure 108, and Figure 109).

FIGURE 109. Illuminated exit sign with emergency lighting at rear exit hall.

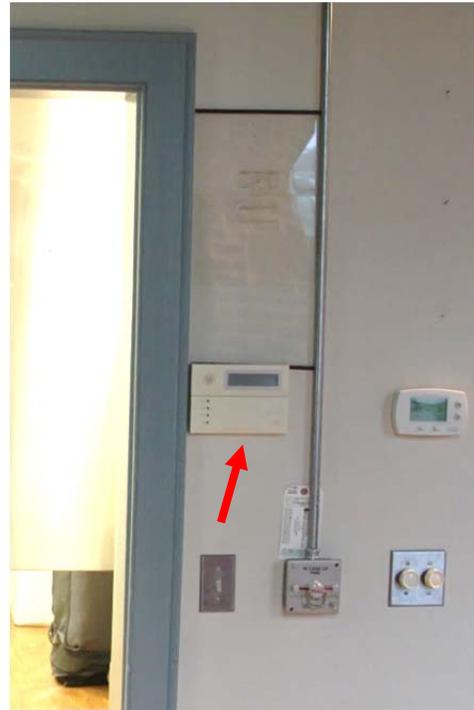
Intrusion and glass-break sensors communicate with a security system panel in the utility closet and with a remote monitoring service. The system is armed and disarmed at a digital keypad on the south wall in the bar area (Figure 110). According to NPS staff, this security system was changed in 2018 to a totally wireless system.

FIGURE 110. Security alarm control panel at bar area. The pull station in the center was subsequently removed, along with the dry chemical fire suppression system, which is on the opposite side of this wall.

- Wireless technology for the security system would eliminate more exposed conduit and sensors in unsightly surface-mounted electrical boxes. Some exposed conduit and surface-mounted devices were removed and replaced with wireless systems in 2018.
