National Park Service
Cultural Landscapes Inventory
1998

Revised 2004

Ellis Island
Statue of Liberty NM - Ellis Island National Monument

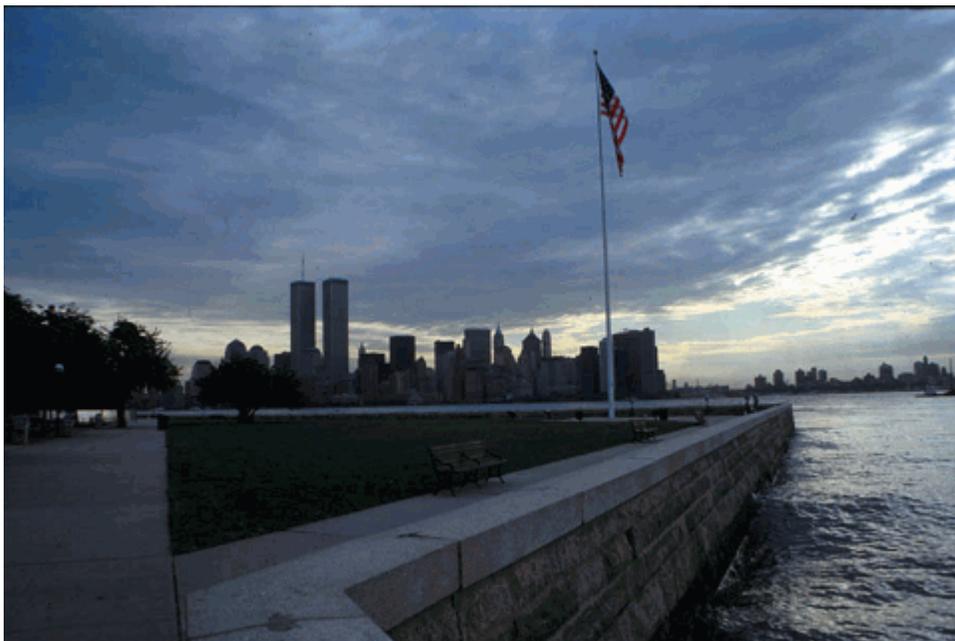
Granite seawall surrounding Islands One, Two and Three (OCLP, 1999).

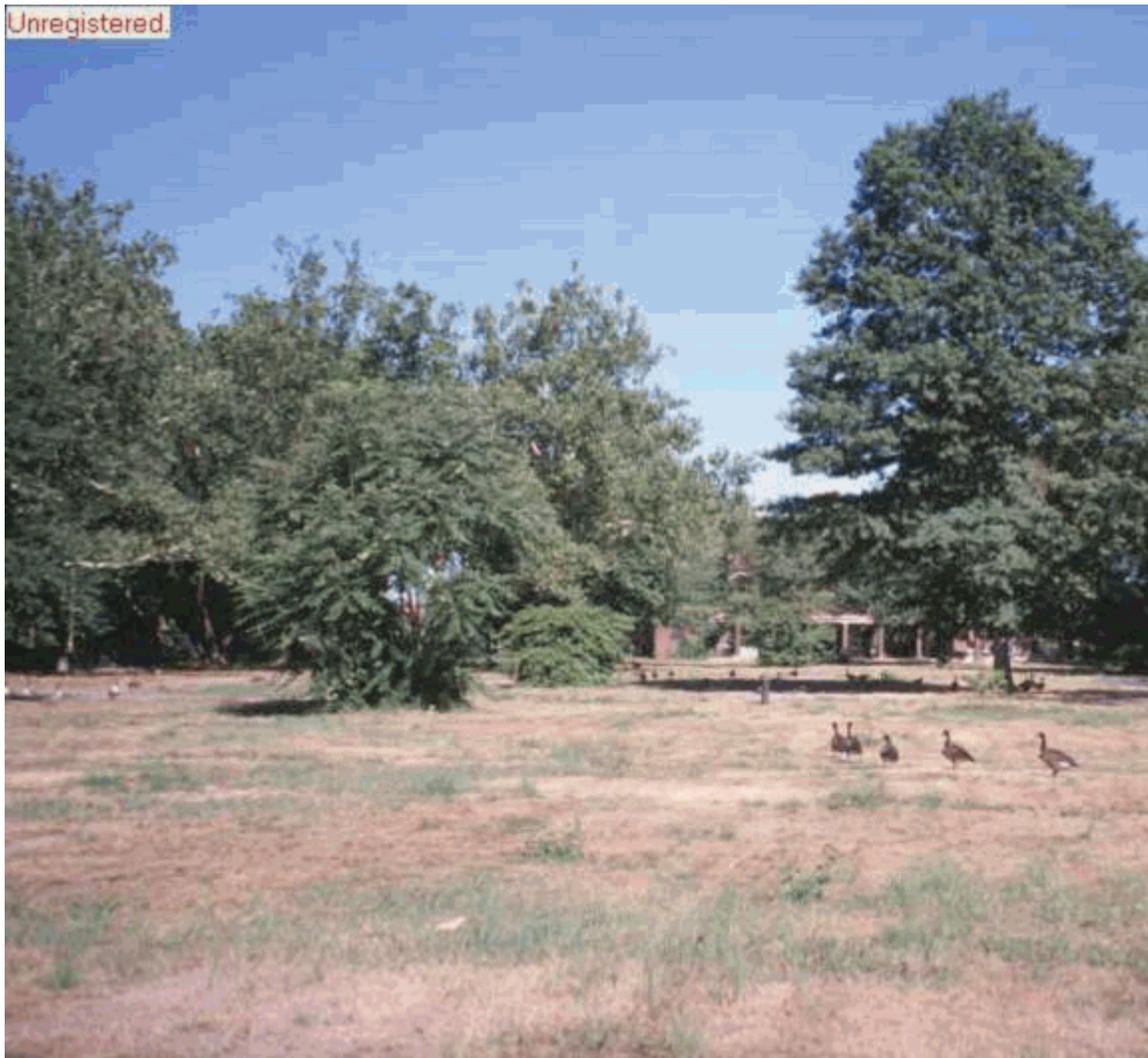
Today, geese, gulls and pigeons currently inhabit many areas of the island. These birds are considered pests; goose guano stains many public surfaces, creating an annoyance for visitors. Gull and pigeon guano stains many of the buildings and contributes to their deterioration. Additionally, layers of pigeon guano in the neglected buildings of Islands Two and Three pose a health hazard. Goose habitation is discouraged via the use of a dog patrol throughout the island. Other methods of mitigation are used to discourage nesting on Island One buildings. Buildings on Islands Two and Three are left unprotected. Ducks, in smaller numbers, are also found on Ellis Island. In addition, barn owls have been found nesting in the attic of one of the buildings, as a result, owl boxes on the southside have been installed to encourage nesting in the boxes rather than the buildings.

Geese on the lawn between Islands Two and Three (OCLP, 1999).

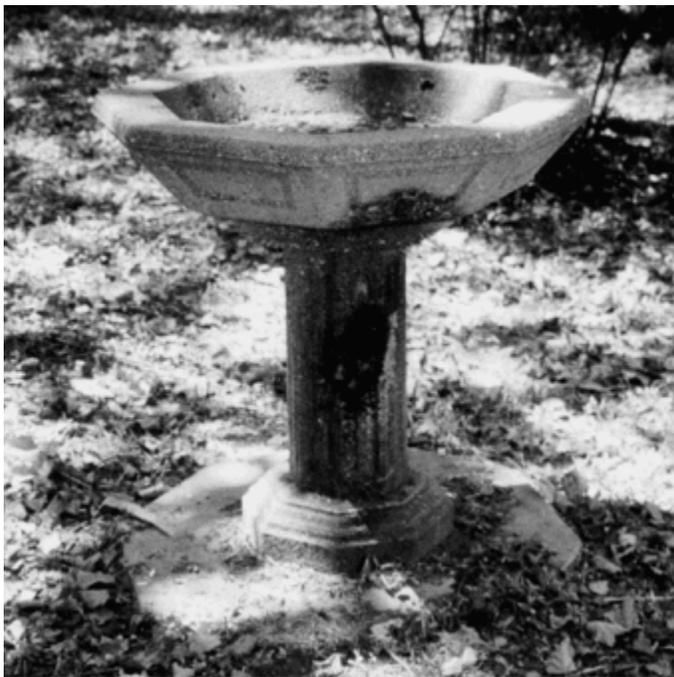
Historic birdbath, west side of Main Hospital, Island Two (OCLP, 1999).

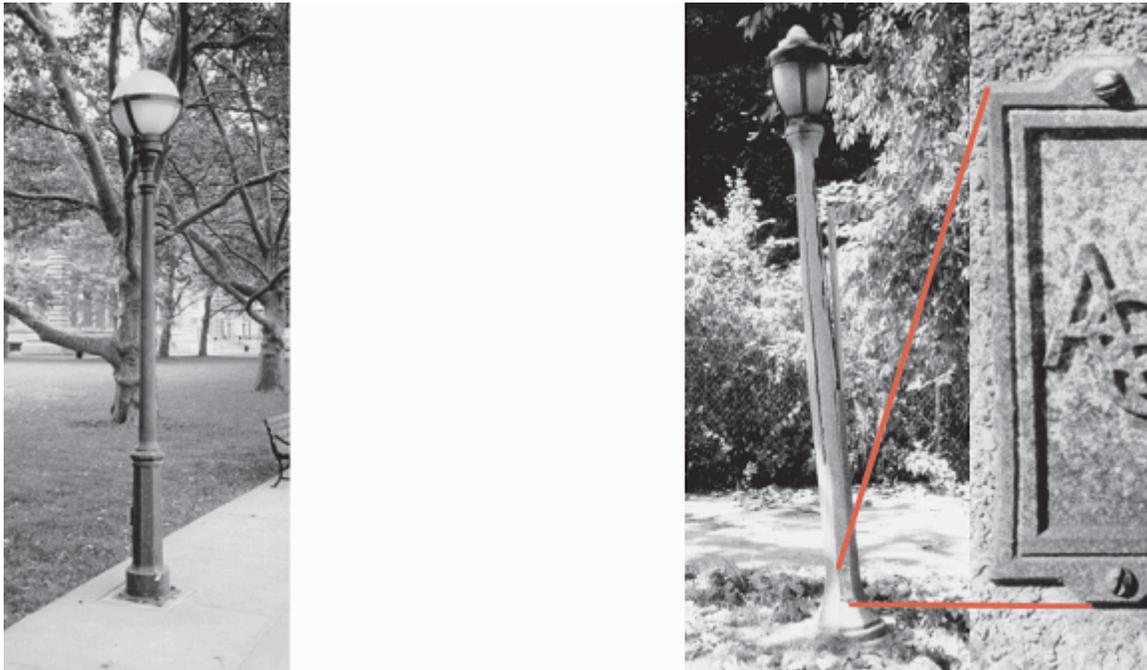
Contemporary (L) and historic (R) lighting, Islands One (L) and Three (R). Detail of medallion found at base of historic lamppost (far R) (OCLP, 1999). Only base of historic fixture remains in landscape. Post has been transferred to collection.

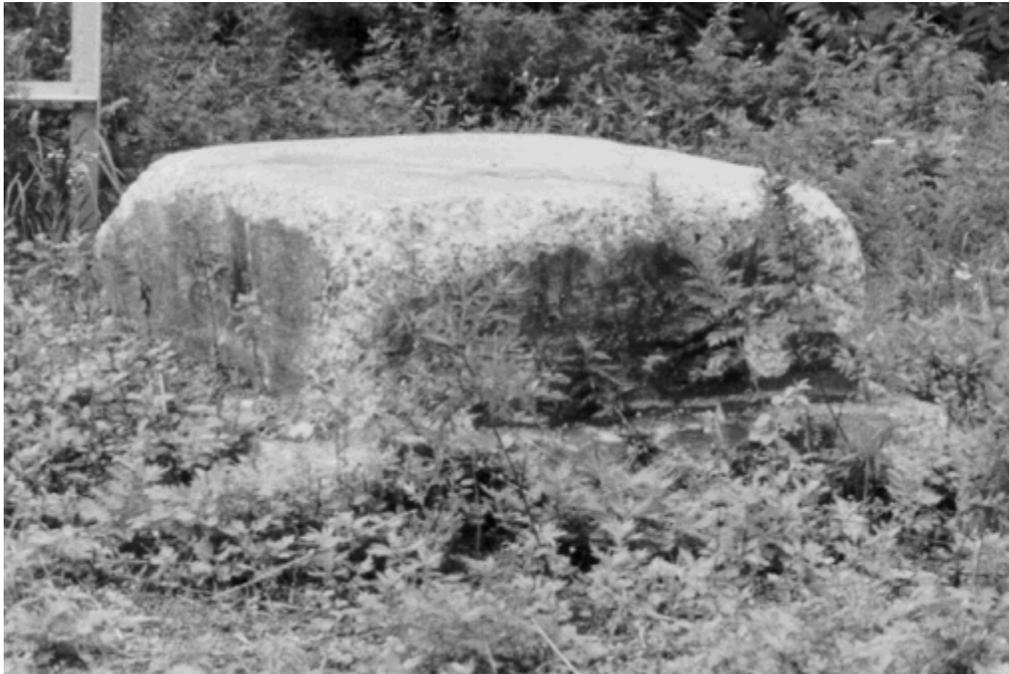
Remnant footing from old water tower, Island One (OCLP, 1999).

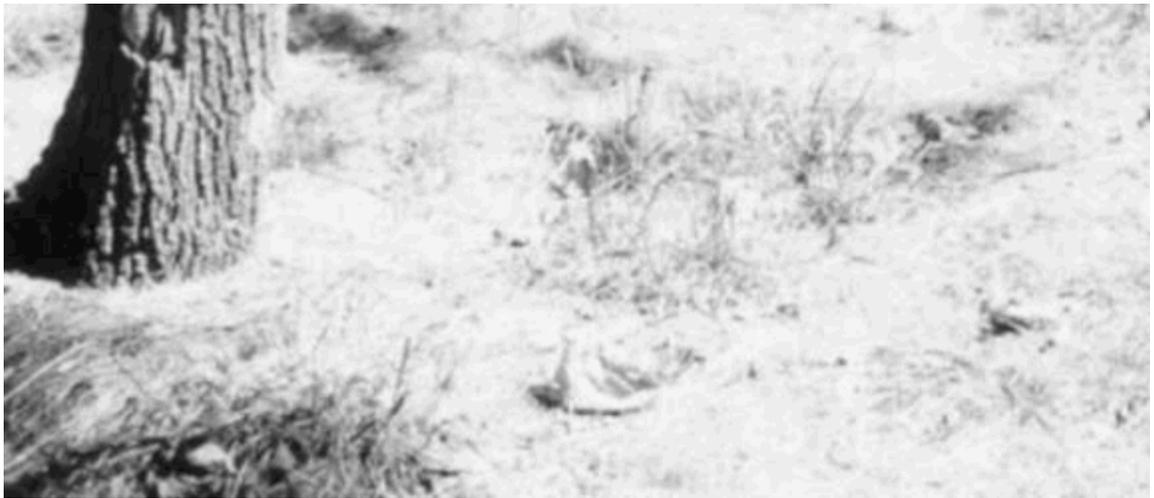
Remnant allee on Island Two, south side (OCLP, 1999).

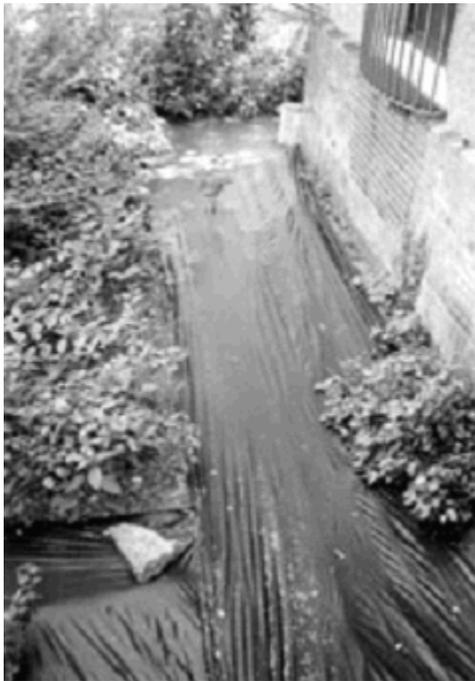
Landscape fabric used to control invasive plant material, Island Three (OCLP, 1999).

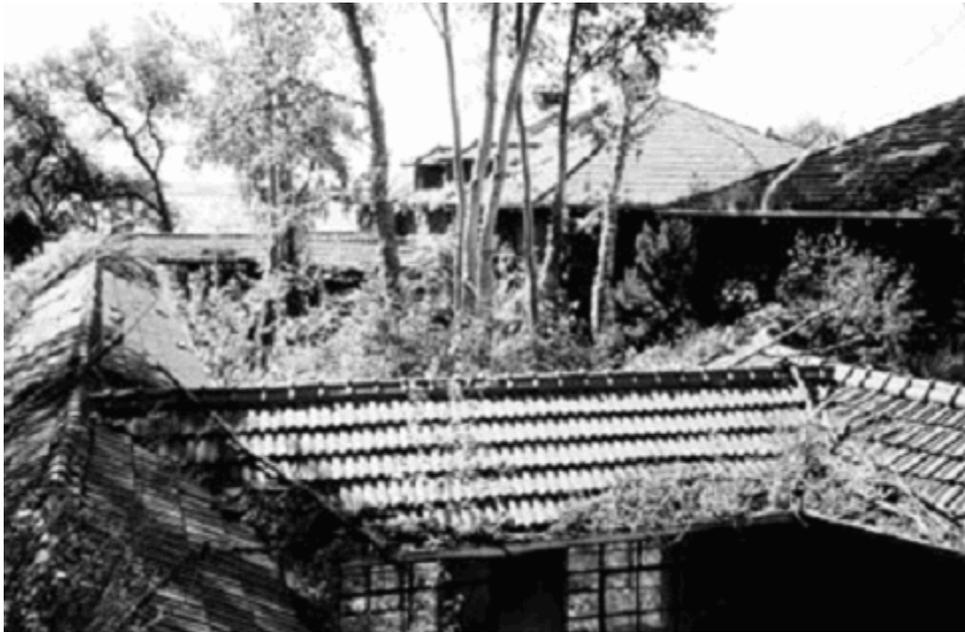
Overgrown, mostly volunteer, plant material in enclosed courtyard, Island Three, some of which has been removed since this photograph was taken (OCLP, 1999).

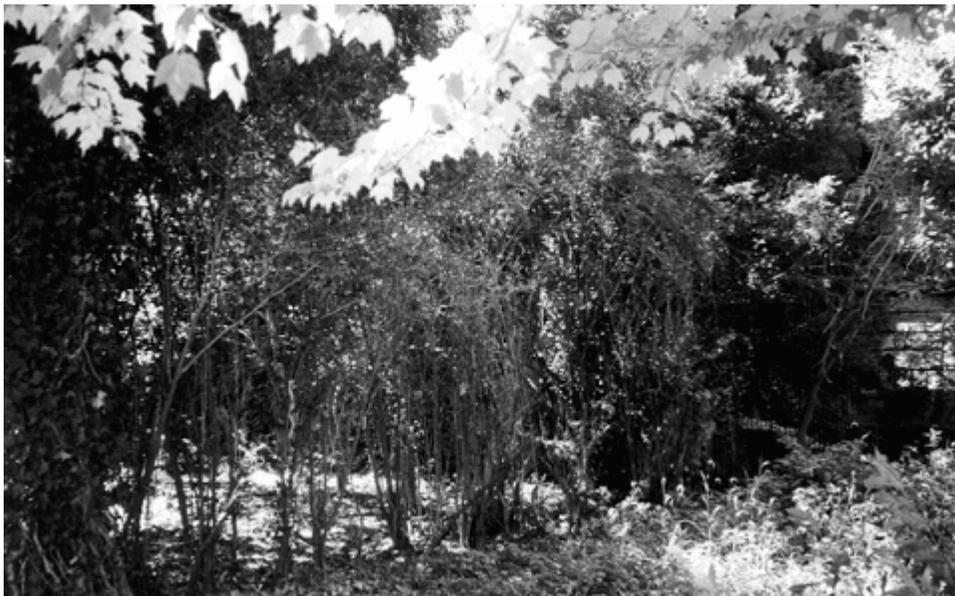
Overgrown historic privet hedge, Island Three (OCLP, 1999).

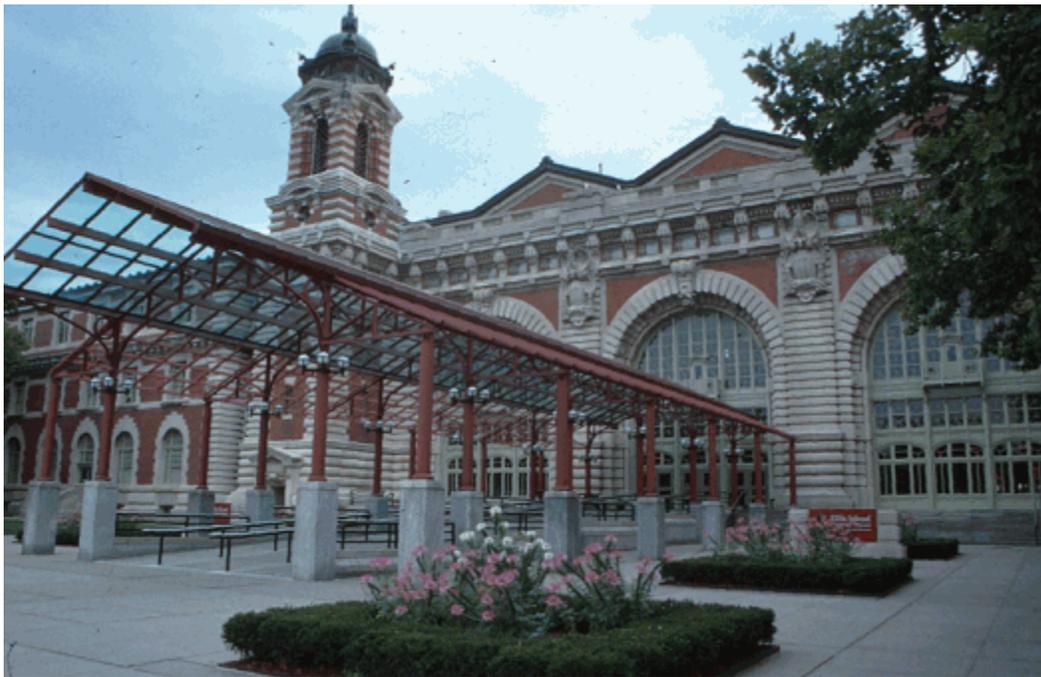
Planting beds at main entrance to Museum, Island One, (OCLP, 1999).

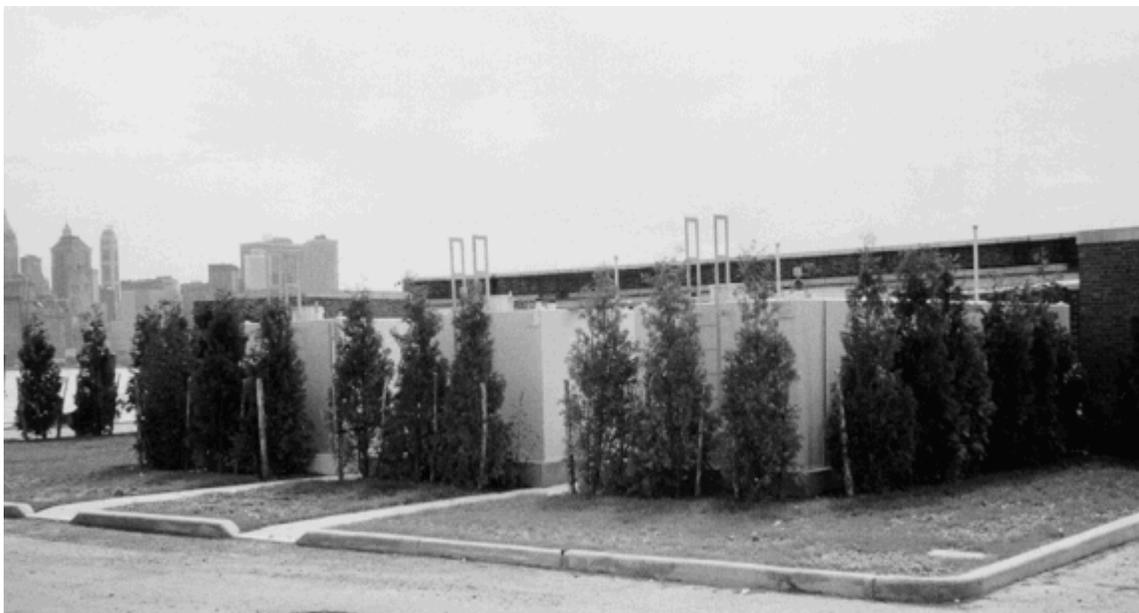
Vegetation used to screen utilities, north side Island One (OCLP, 1999).

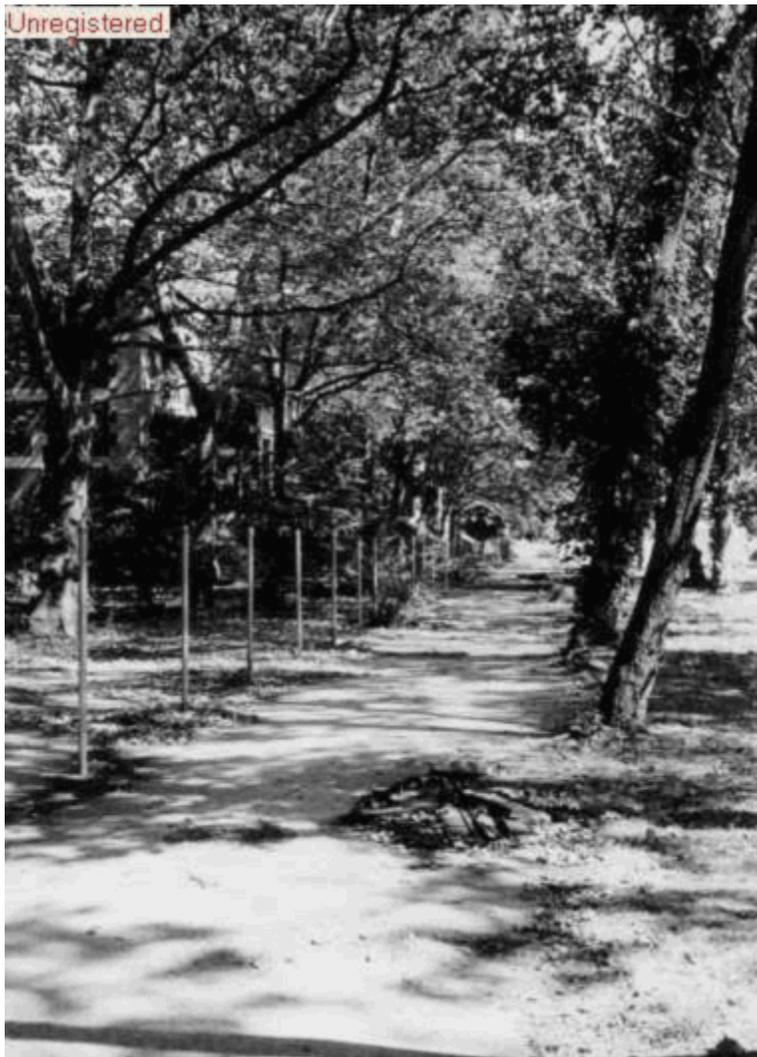
View along remnant alley from 1939 planting plan found on Island Two (OCLP, 1999).
