HISTORIC STRUCTURE ASSESSMENT REPORT

CARL SANDBURG HOME

CARL SANDBURG HOME
NATIONAL HISTORIC SITE,
FLAT ROCK, NC

NATIONAL PARK SERVICE
HISTORIC PRESERVATION TRAINING CENTER
FREDERICK, MD
JANUARY, 2011

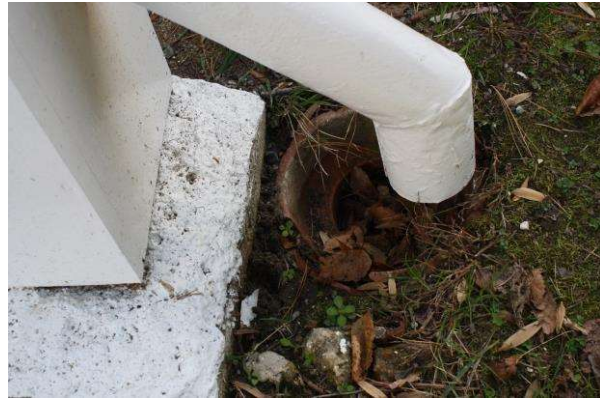
Gutter draining boot at porte cohere. Full of leaves.

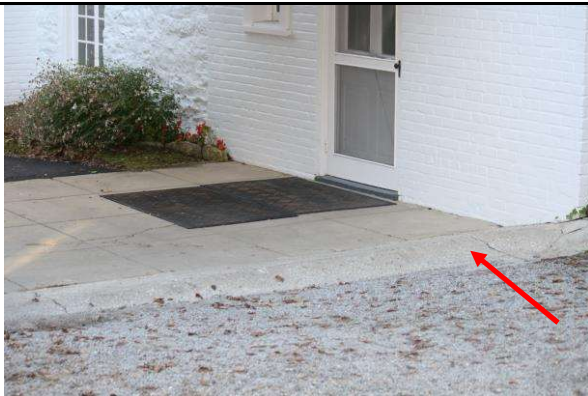
Concrete paved area under porte cochere. Concrete ledge prevents water from draining away from the door.

Material & Amount	Unit Cost	Cost
Jet and scope underground drain lines	Per job	\$3,000
Repair underground drainage lines (general estimate – actual costs will be based on the result of the scope)	Per job	\$10,000
Install drain in pavement under porte cochere (<i>in conjunction with paving repairs</i>)	Per job	\$750
TOTAL		13,750.00

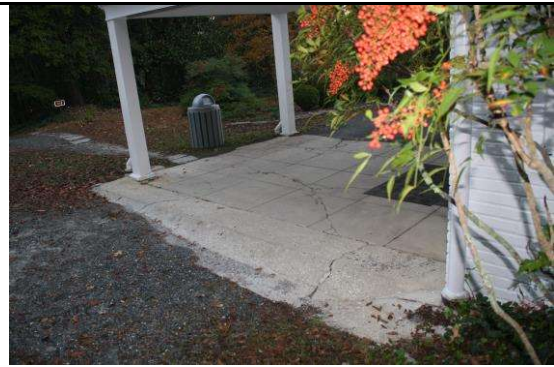
View of concrete slab; Concrete cracked likely due to repeated freeze/ thaw cycles.

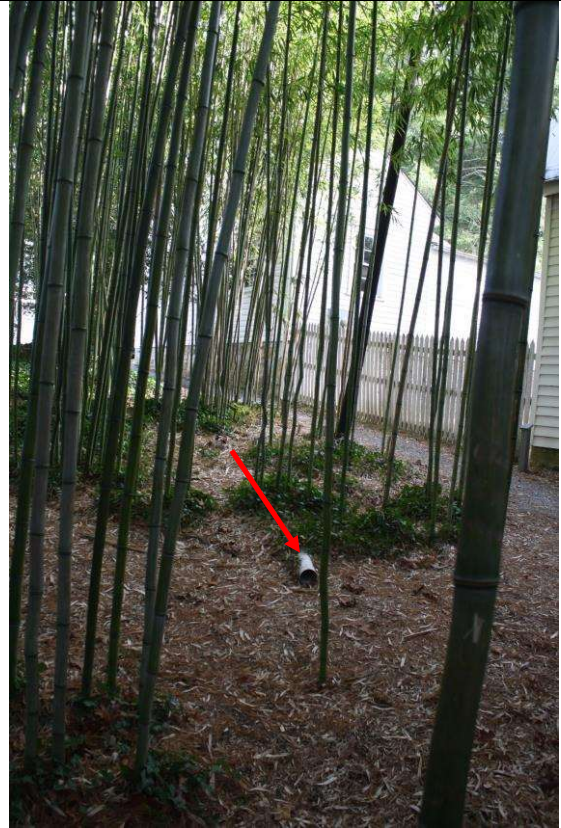
Another drainage outlet to the S of the Swedish House.

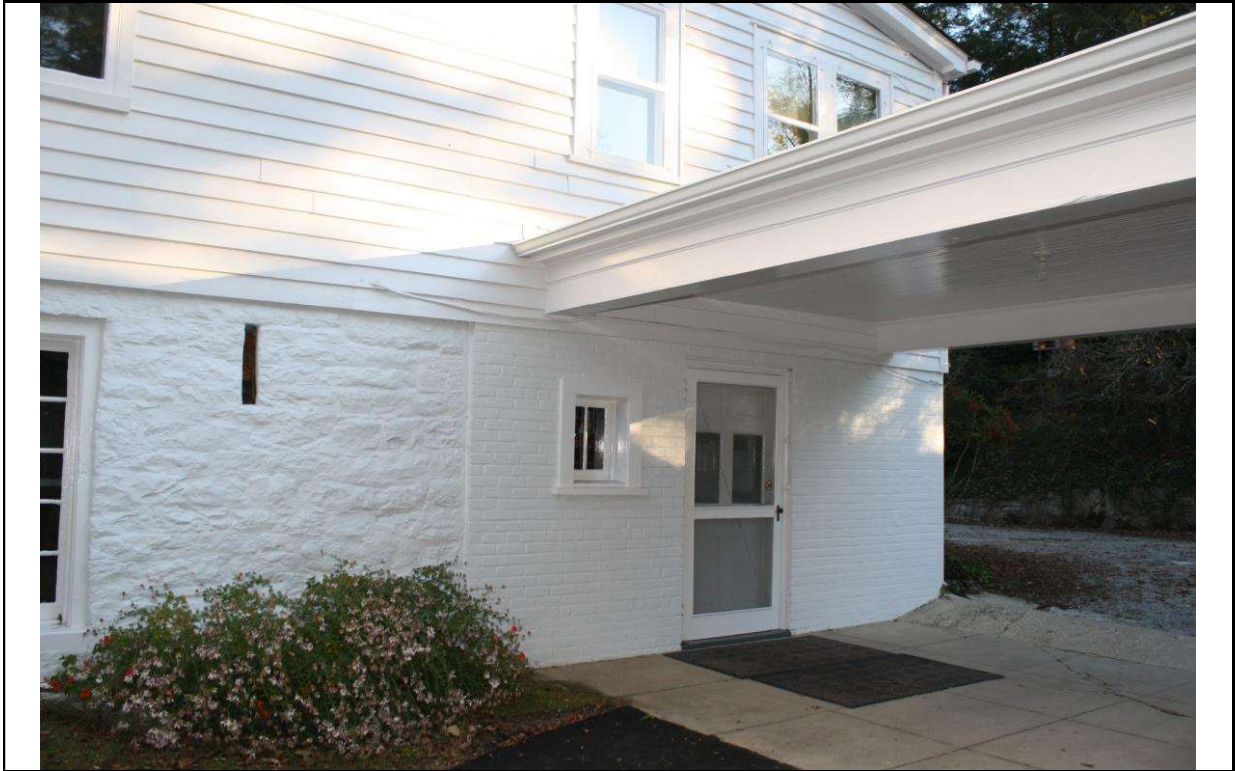
West elevation – Main block stone foundation and brick foundation of addition visible.

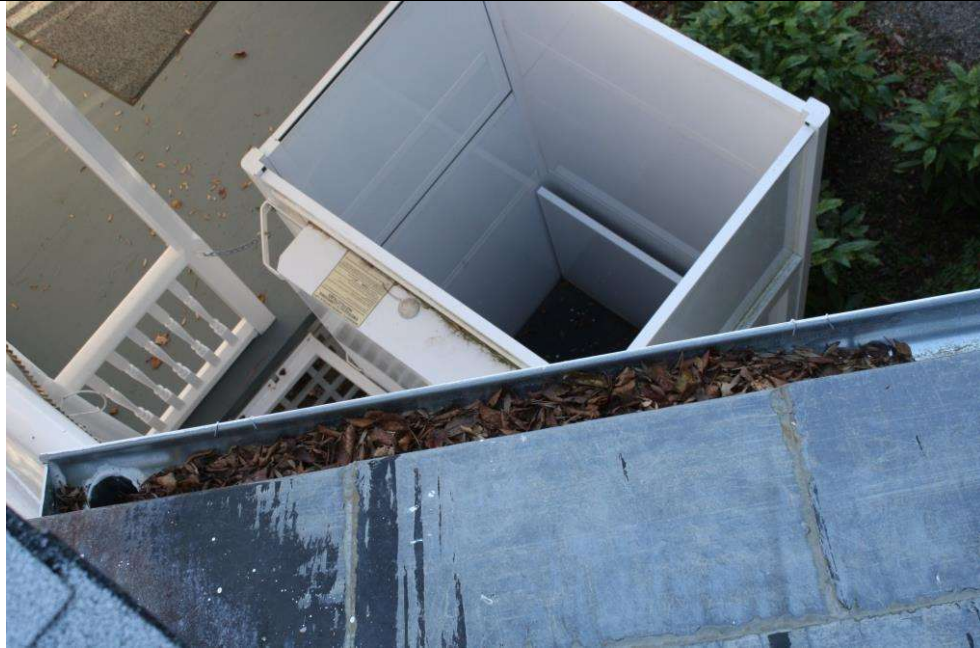
Leaves in East Bay Window gutter.

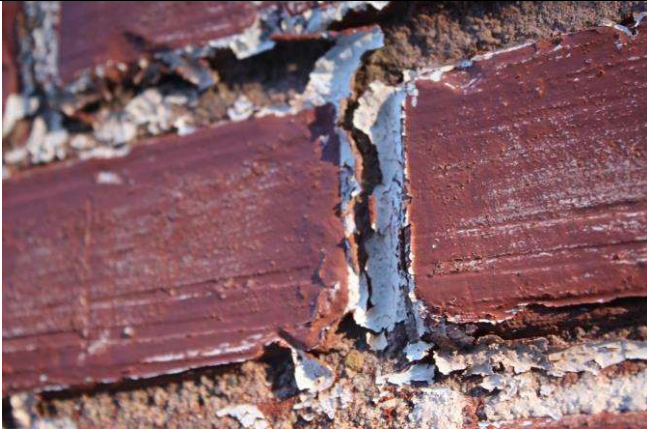
Detail of mortar joints on East main block chimney.

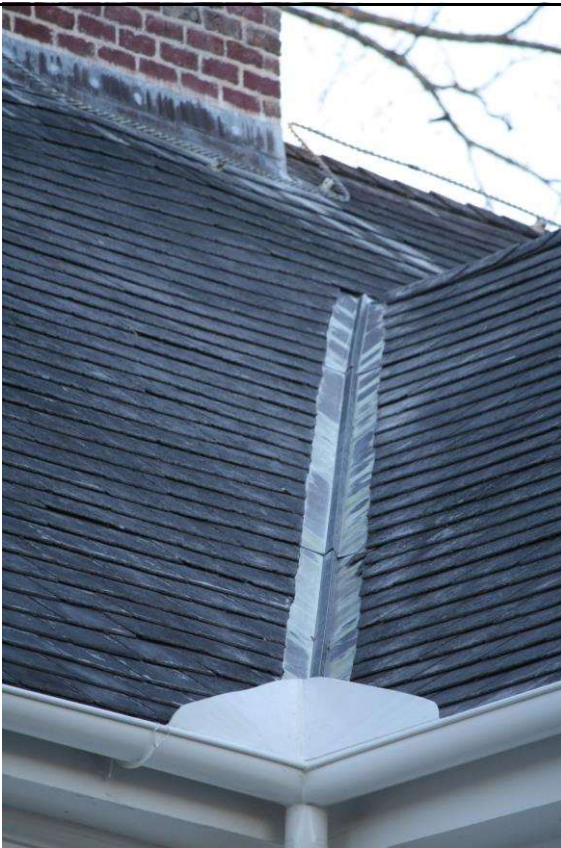
Valley flashing between main roof and portico

Material & Amount	Unit Cost	Cost
Install new galvanized metal flashing on all chimneys, dormers and skylight.	\$750/unit*	\$8,250.00
Install new galvanized metal flashing at transitions between main roof and portico and addition roof	\$10/lf*	\$1,160.00
TOTAL		\$9,410.00

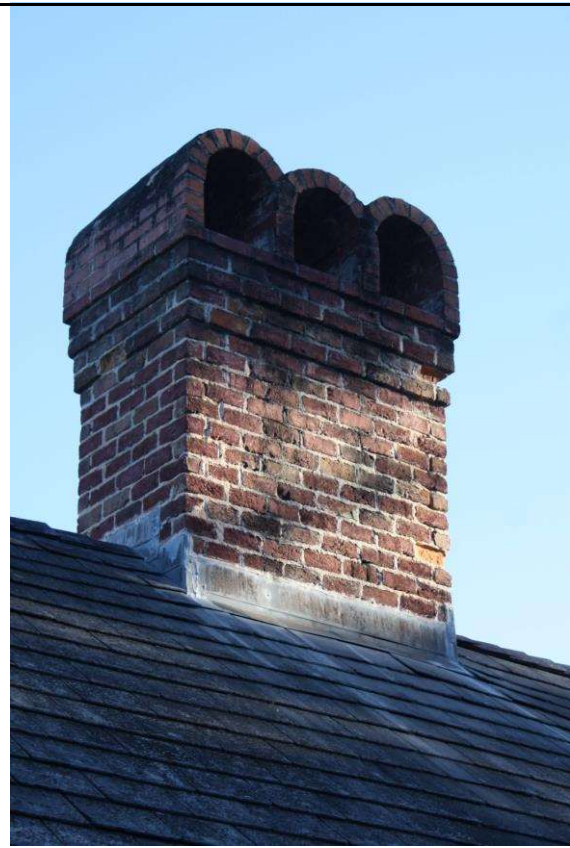
Step, base and cap flashing on chimneys

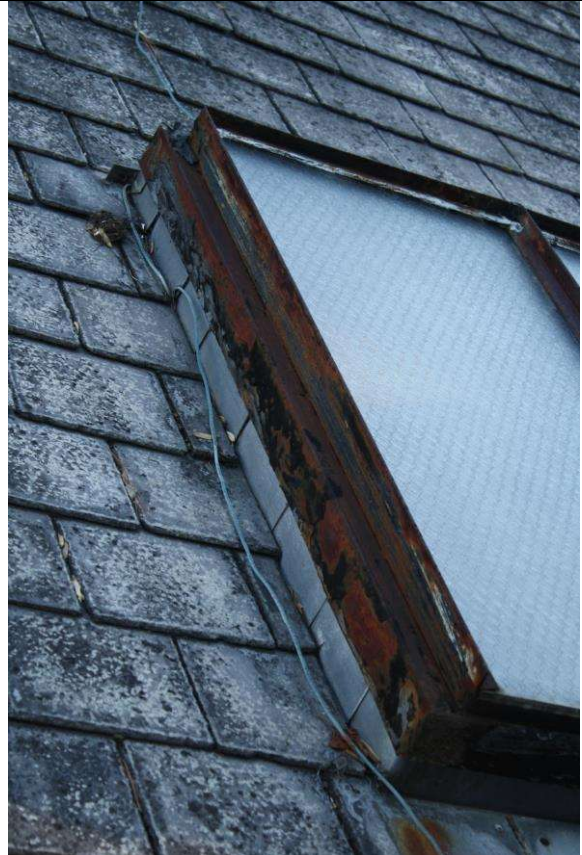
Step flashing on skylight

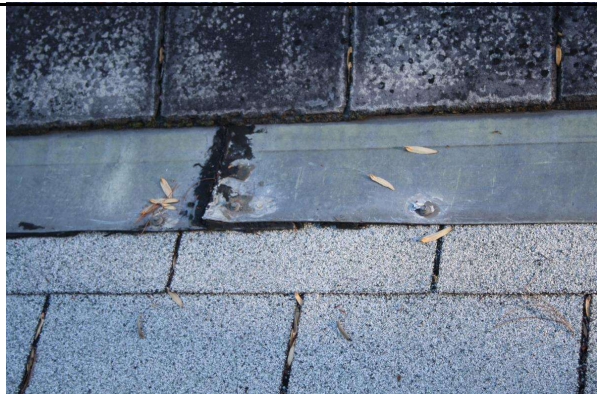
Flashing at junction of main roof and addition roof

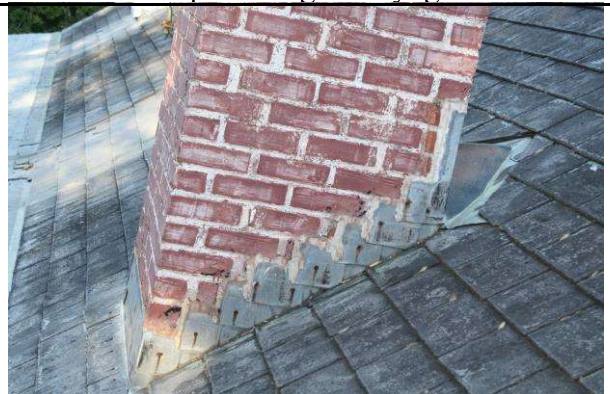
View of step flashing and cricket on east chimney

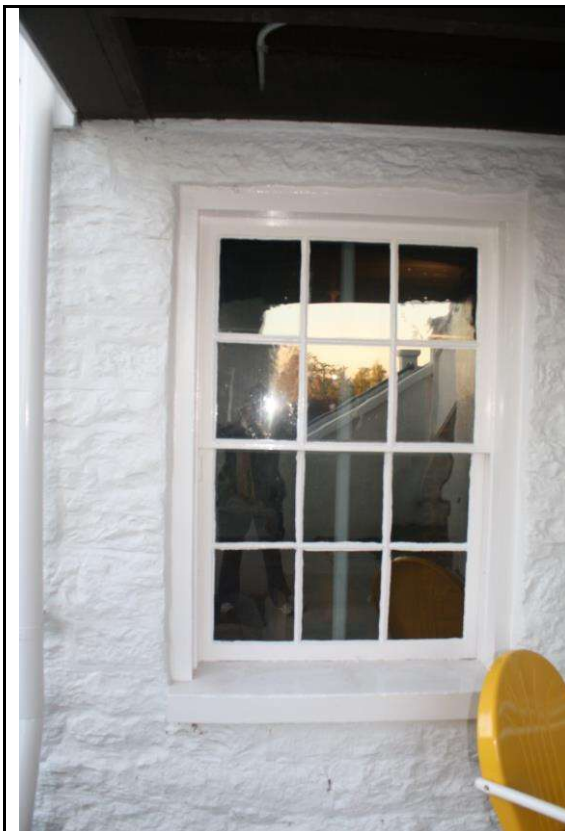
Similar conditions were found on the main block 6/6 double hung units:

- Failed glazing in areas
- Upper sash painted shut
- Missing parting bead
- Cracked lights

Exterior view of 6/6 double-hung main block window

- a. Remove window sash and strip windows of existing paint and glazing putty. Maintain a "paint window". Remediate lead paint hazard during this process.
- b. Perform any necessary repairs.
- c. Reinstall historic lights, and replace any broken lights or modern flat glass with Bendheim Restoration Glass where applicable. Re-bed and re-glaze the lights with pure linseed oil putty.
- d. Prime and repaint the sash with two finish coats.

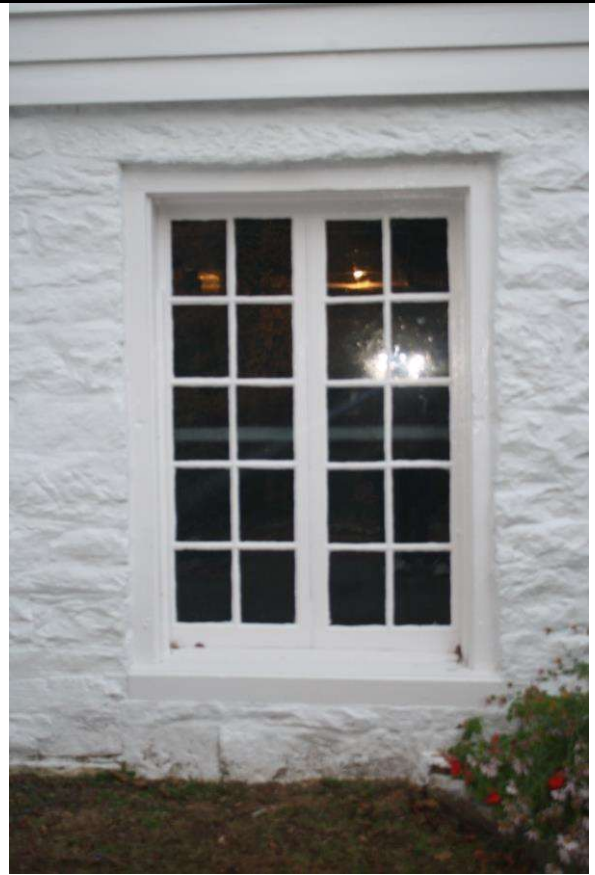
Conditions found on the 6-by-6 casement windows:

- Sash painted shut
- Failed glazing
- Paint peeling on sills
- Rot found in several areas on W011 (sill, jambs, stiles)

Exterior view of 6-by-6 casement.

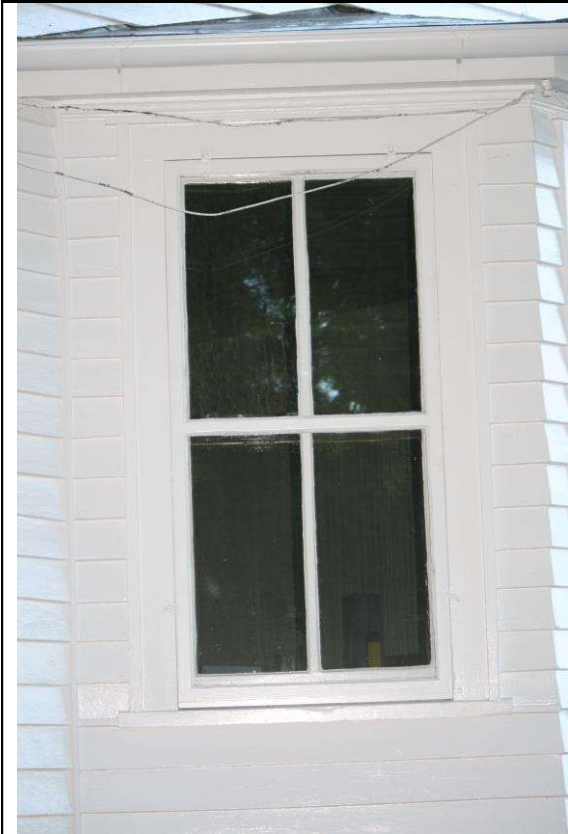
Typical 2/2 window on first floor

a. Remove window sash and strip windows of existing paint and glazing putty. Maintain a “paint window”. Remediate lead paint hazard during this process.
b. Perform any necessary repairs.
c. Reinstall historic lites, and replace any broken lites or modern flat glass with Bendheim Restoration Glass where applicable. Re-bed and re-glaze the lites with pure linseed oil putty.
d. Prime and repaint the sash with two finish coats.
e. Prep and repaint interior and exterior frame and casing.
f. Reinstall windows with bronze weather-stripping.

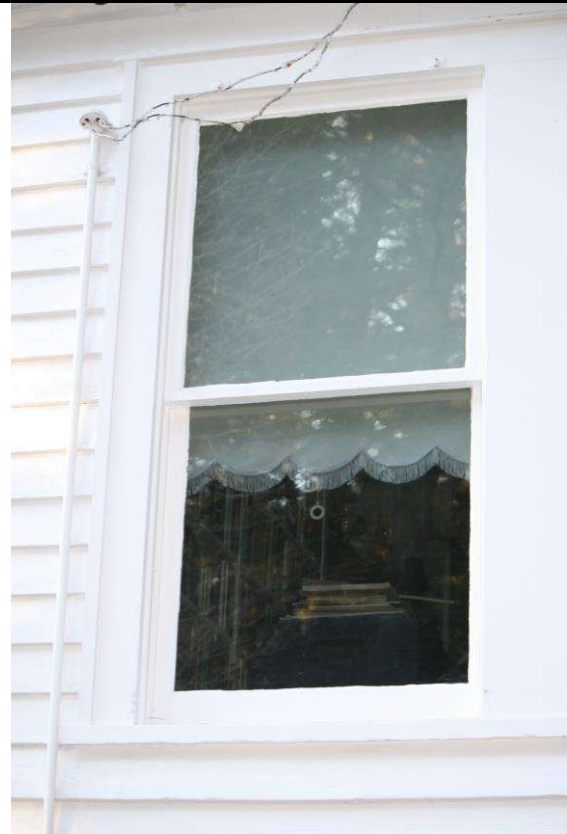
Typical 1/1 on first floor

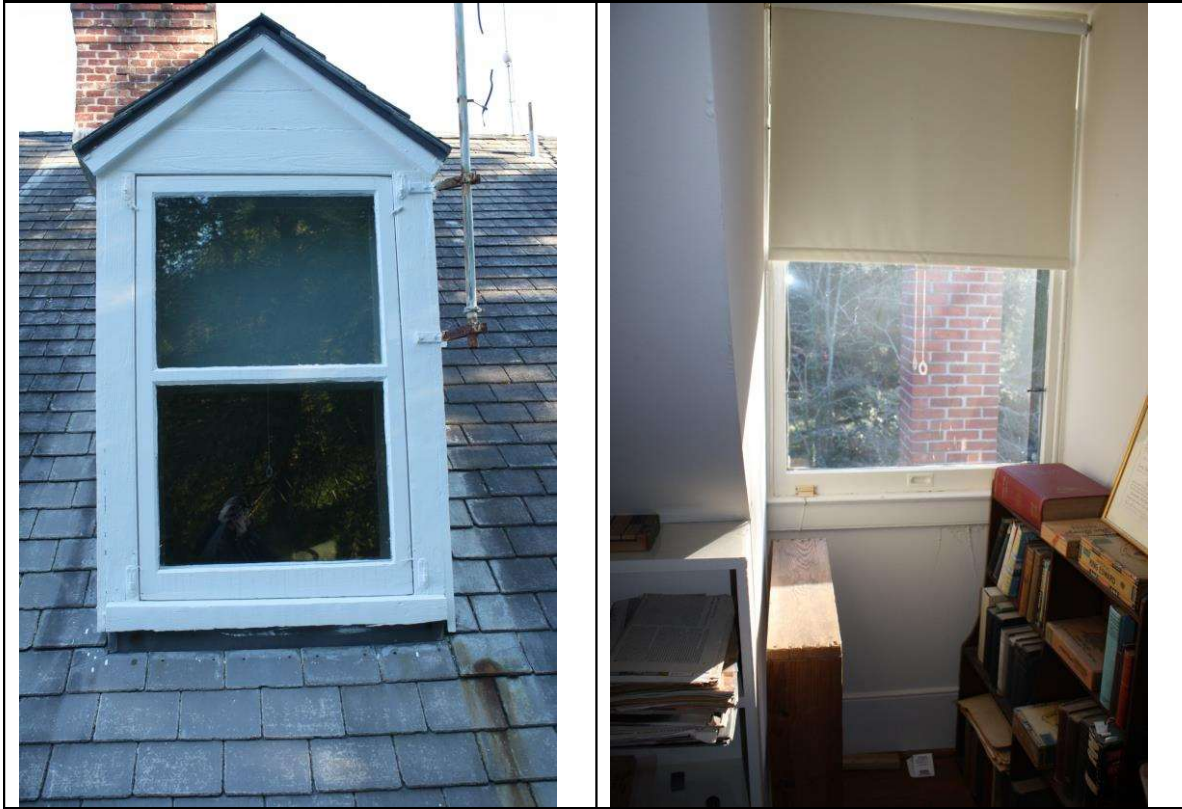
CONDITION ASSESSMENT REPORT CARL SANDBURG HOME FEATURE INVENTORY ASSESSMENT REPORT					
FEATURE	FEATURE NAME	MATERIAL TYPE	JOINERY	CONDITION RATING	PRIORITY RATING
Wall Opening & Penetrations	Second floor windows	Wood, Glass	Mortise & Tenon	Fair	Serious
<u>Feature Description</u> The second floor windows are all one-over-one, wooden double- hung sash. Many of the units have interior storm windows installed making the windows inaccessible.					
<u>Feature Condition</u> <ul style="list-style-type: none"> ▪ Deteriorated glazing ▪ Paint chipping in interior ▪ A few cracked lights ▪ Sash painted shut

Exterior and interior view of second floor dormer windows.

a. Remove window sash and strip windows of existing paint and glazing putty. Maintain a "paint window". Remediate lead paint hazard during this process. b. Perform any necessary repairs. c. Reinstall historic lights, and replace any broken lights or modern flat glass with Bendheim Restoration Glass. Re-bed and re-glaze the lights with pure linseed oil putty. d. Prime and repaint the sash with two finish coats. e. Repair, prep and repaint interior and exterior frame. f. Reinstall windows with bronze weather-stripping.

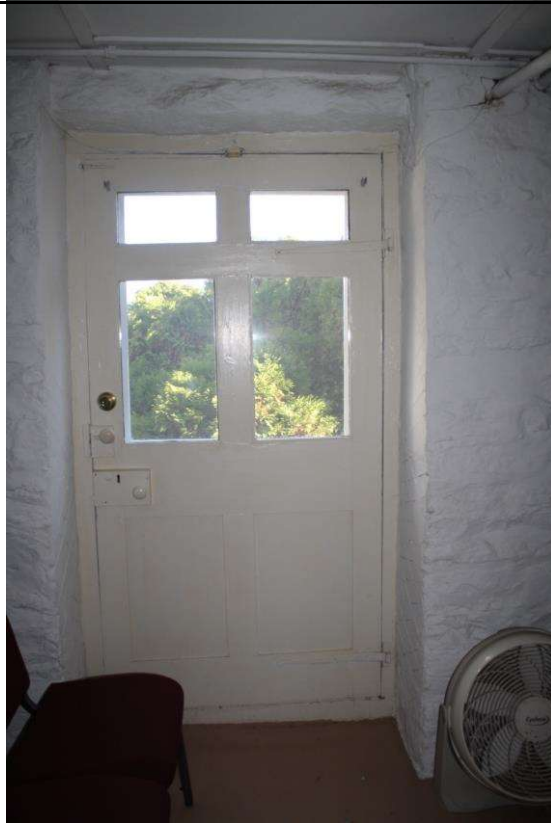
The basement doors are in fair condition. The paint is abraded on the interior and end rot is evident on the kitchen door due to moisture wicking up from the ground. Some of the locking hardware is missing or no longer functioning. The base of D003 screen door has some rot.

N elevation basement door

- a. Replace/Refurbish hardware on the first and ground floor doors
- b. Repair deteriorated wood
- c. Repair any splits or checks
- d. Plane doors as necessary to allow them to open and close properly
- e. Repair screen doors as necessary
- f. Scrape, prep, prime and paint all doors

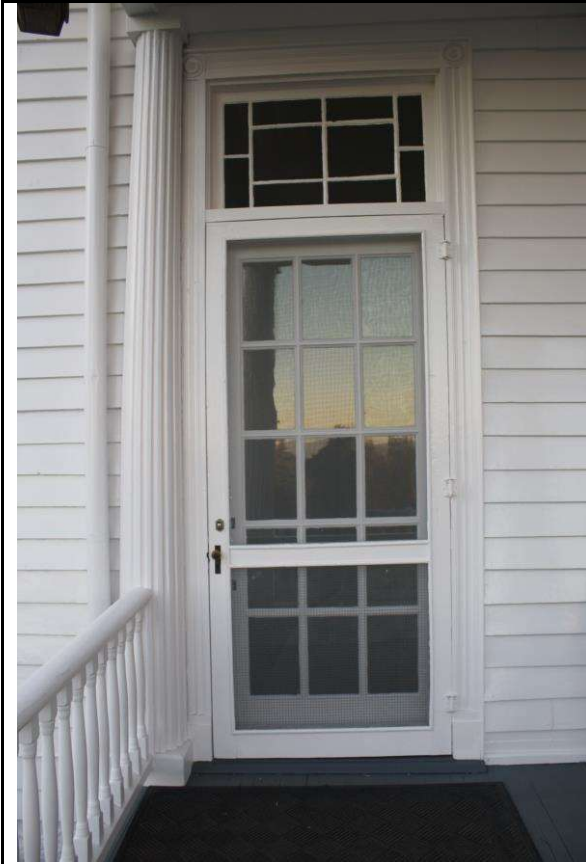
The first floor doors exhibit abraded surfaces, cracked lights and inoperable or missing hardware to some degree. All of the doors were operable but D103 is difficult to close.

N entry door with screen door

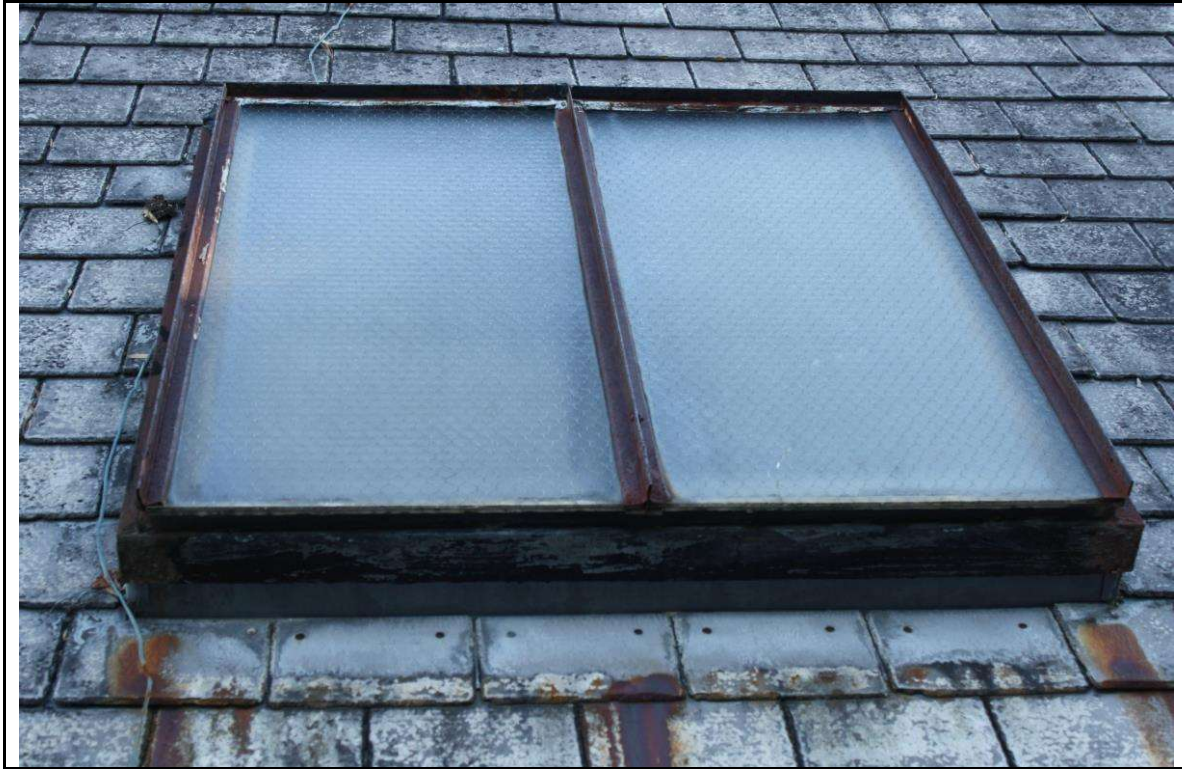
The metal frame is severely rusted and the east light is cracked.

- Scrape existing rust from frame and treat with a rust convertor.
- Replace broken light and reglaze unit.
- Paint frame with an exterior grade metal paint.
- Replace flashing (*See Roof & Chimney flashing*).

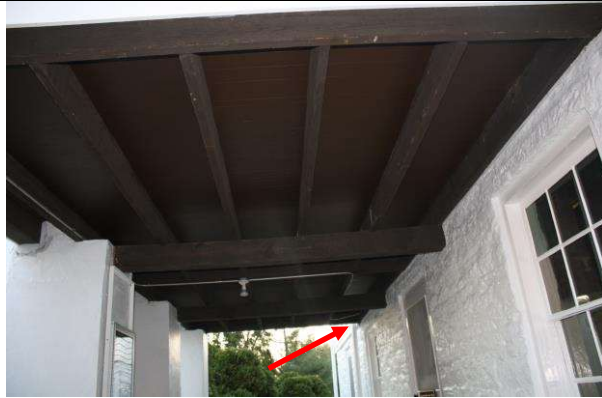
Areas of rot were noted on the two end beams where they connect with the north wall.

End beam rotted where it meets the N wall

- Monitor east column to determine if there is any further movement
- Cut out deteriorated sections of beams and replace with new material. New material will match the existing in species, joinery, and dimensions.
- Repair deteriorated concrete on steps
- Patch missing stucco on steps
- Prime and paint metal handrail

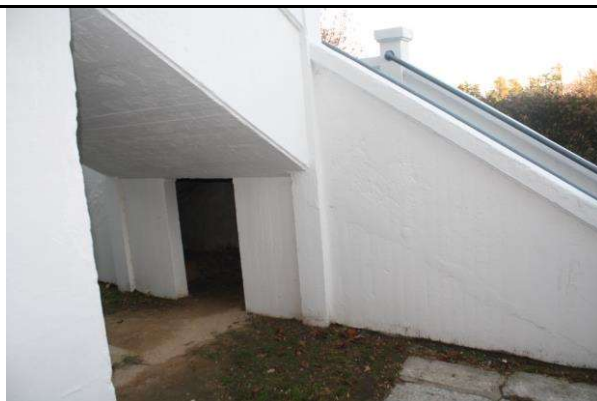
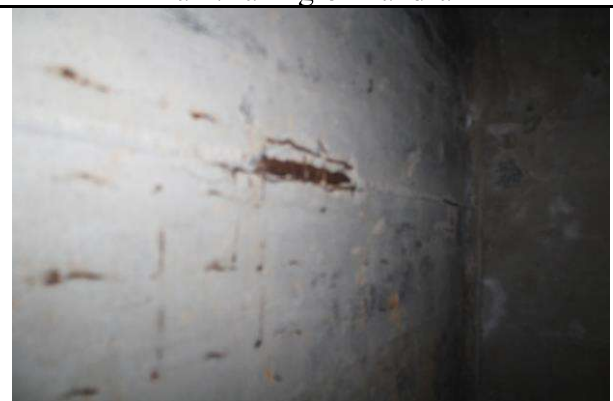
Areas of the concrete under the steps are deteriorated and the rebar is visible. The paint on the metal handrail is worn and abraded.

Rebar visible in concrete under steps

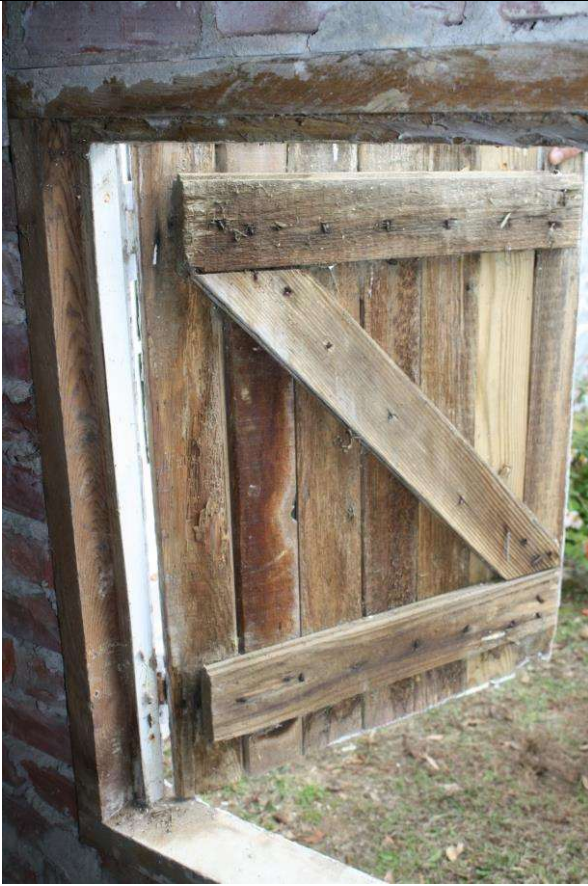
Areas of the brick have been repointed with Portland cement. The board and batten door is weathered and has evidence of termite damage. A portion of the west sill plate is visible from the crawlspace and termite damage is evident.

Board & batten door in S wall

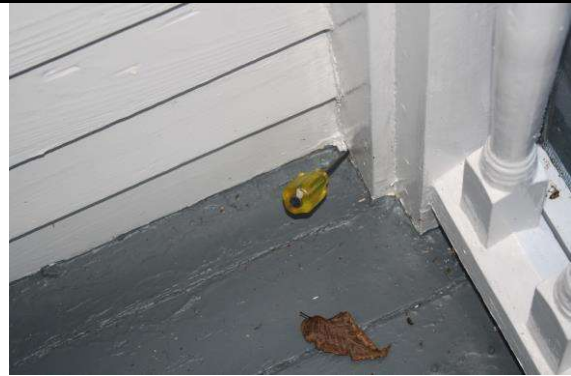
Floor rotted in NE corner

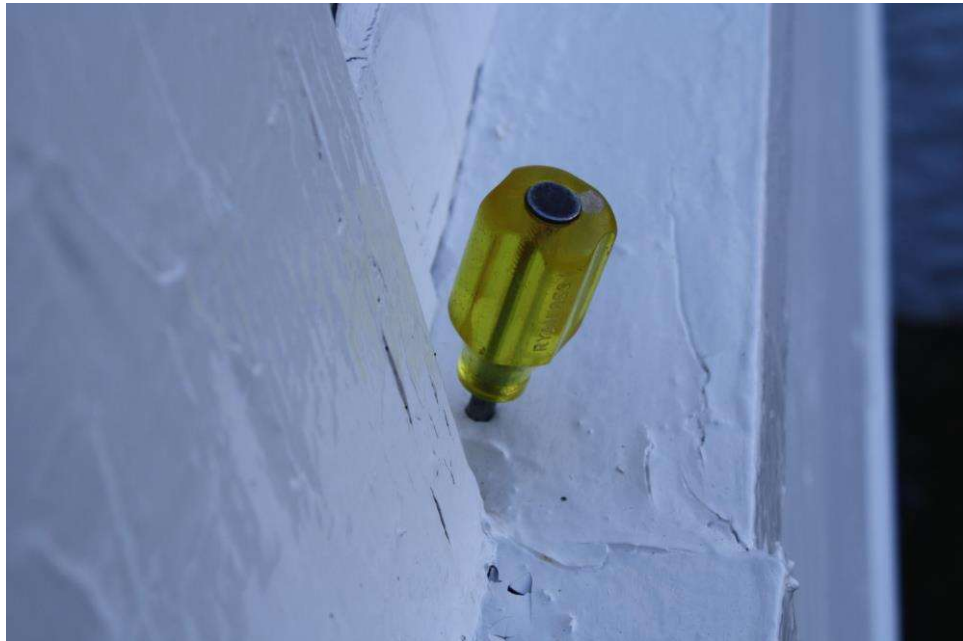
Sill rotted

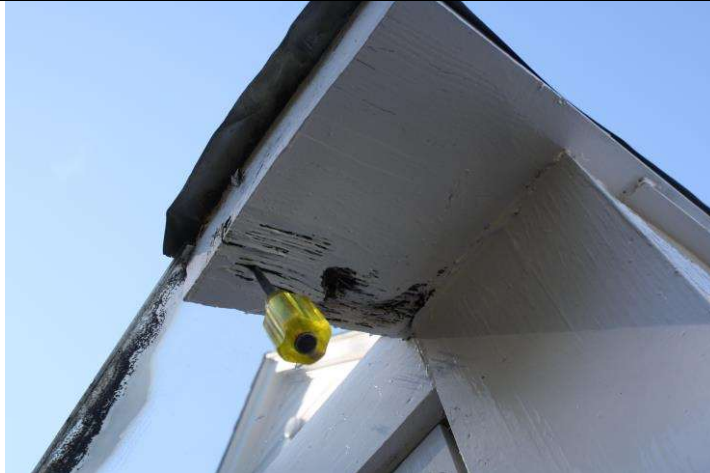
Rafter tail rotted

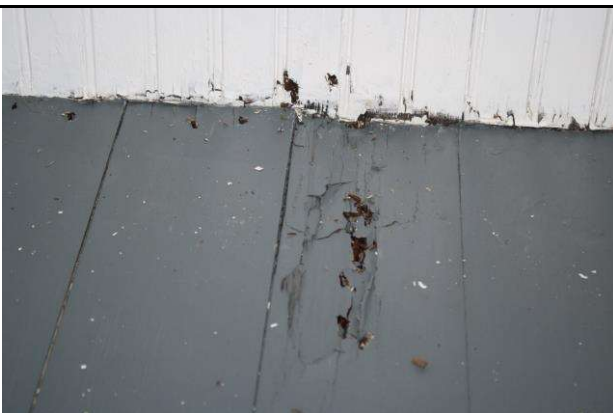
Floorboards rotted

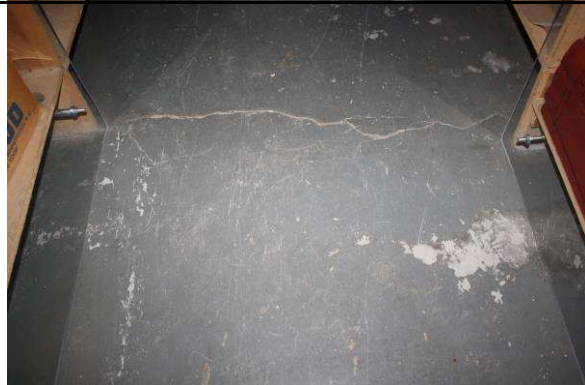
Crack in concrete floor

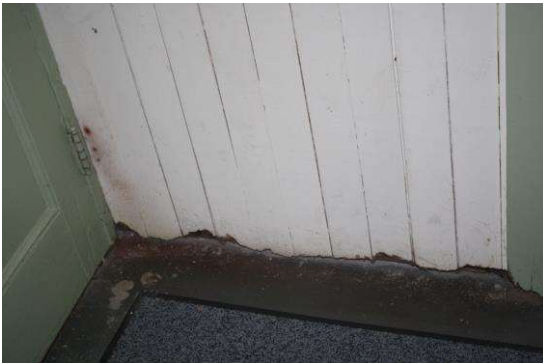
End rot on paneling by kitchen door

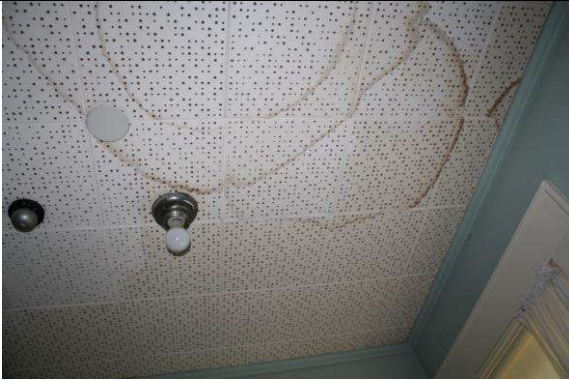
Water stains on bathroom ceiling (Rm. 120)

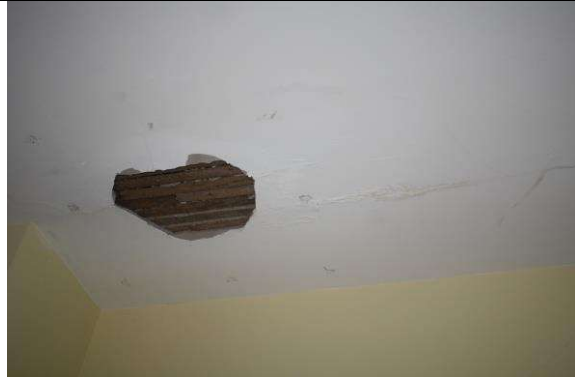
Hole in ceiling of Rm. 104

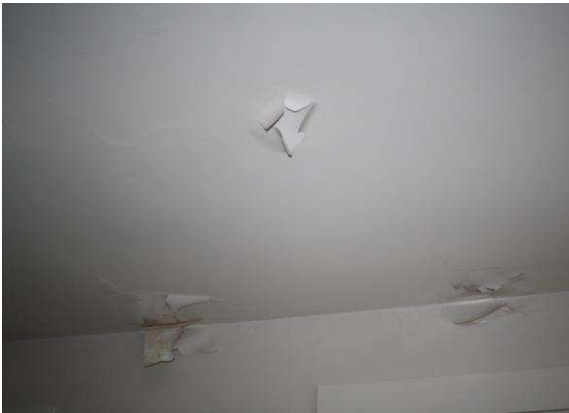
Peeling paint in kitchen

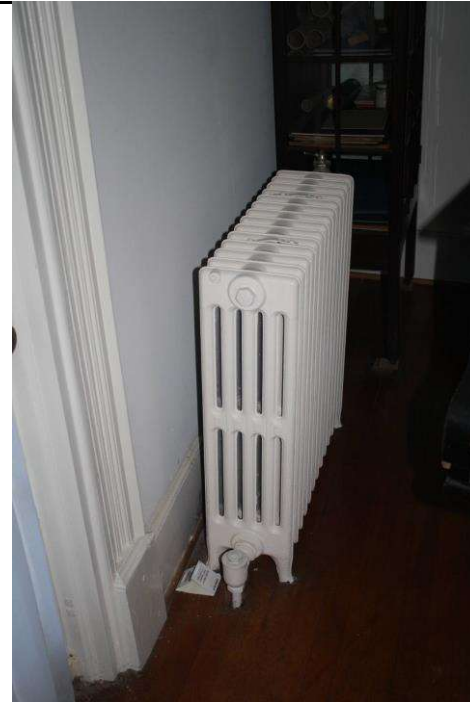
Radiators on each floor
