Carl Sandburg Home National Historic Site

Chicken House/Wash House

Historic Structure Report

September 2007

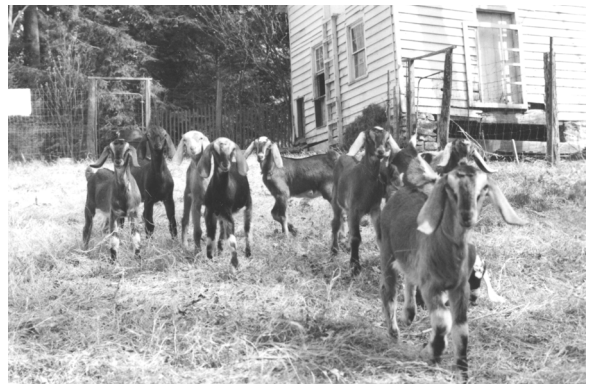
Figure B-5 Nubian kids in Chicken House yard.
Note two small openings added on north elevation.
(CARL3000/44/103P)

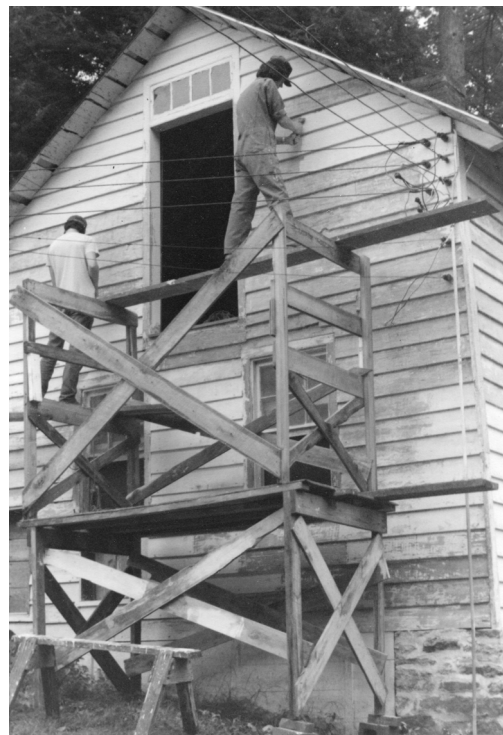
Figure B-14 North elevation being repainted, October 1979 (CARL4004/15-32P)

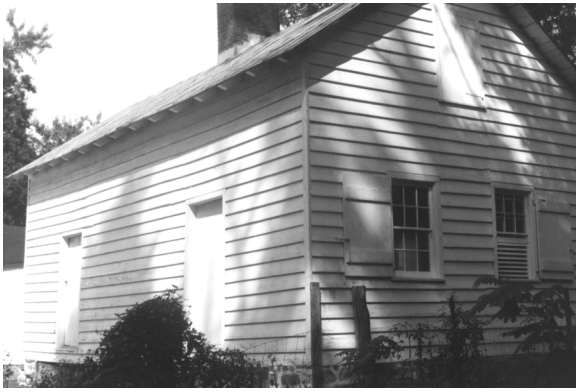
Figure B-18 Southwest oblique of Chicken House, presumably showing completed repairs, 1985 (CARL4004/21-02P)

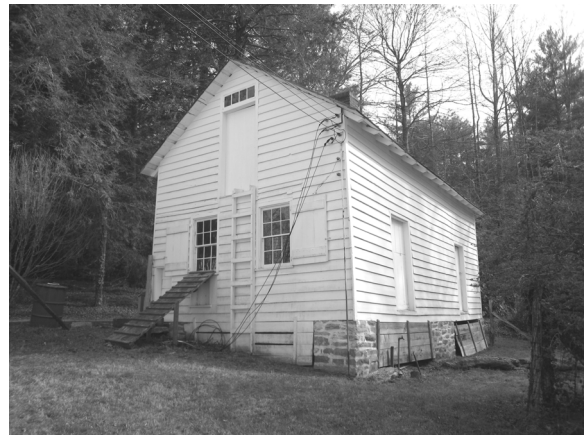
Figure C-1 Northwest oblique of Chicken House/Wash House

The foundation of the building is stone blocks set in mortar, and was entirely rebuilt in the repairs of the late 1970s. Two openings on the west elevation and one on the north provide access to the crawl space under the building; the openings are covered by wood boards set between the stone piers.

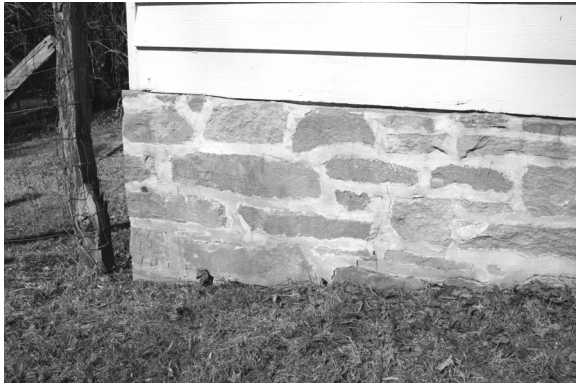
Figure C-3 Stone foundation near west corner of south elevation

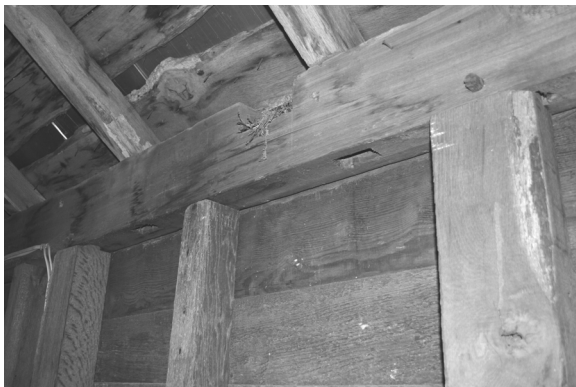
Figure C-5 Larger vertical members mortised into top plate at sides of photo, newer vertical in center toenailed, and empty mortises adjacent

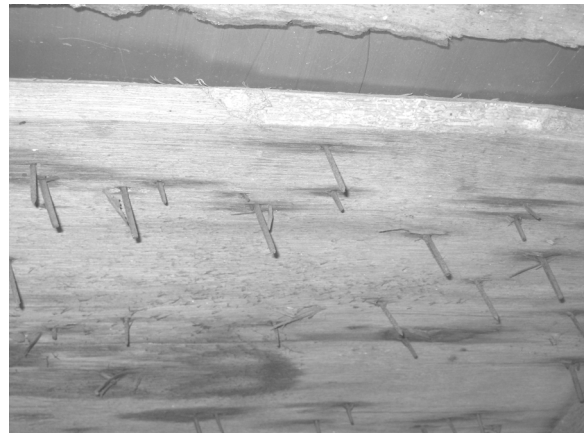
Figure C-7 Roof decking with early nails for wood shingles

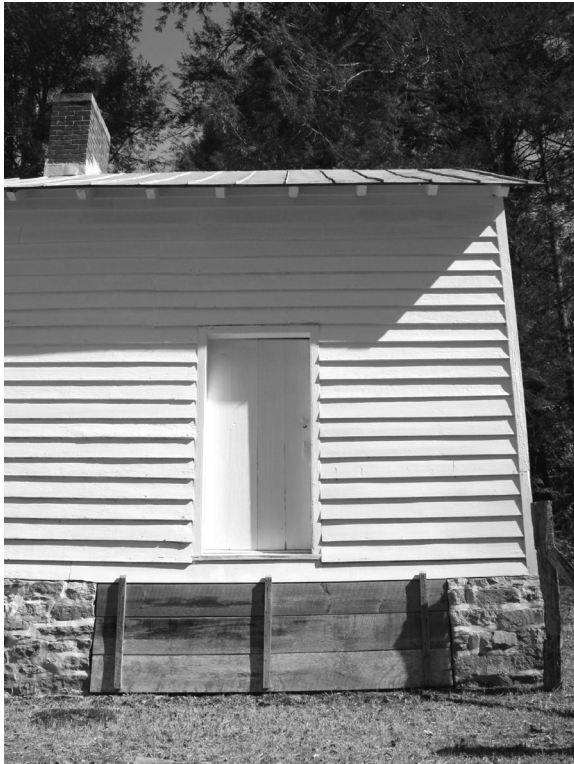
Figure C-9 Wood weatherboard siding and stone foundation walls, west elevation

Walls: The walls of the building are sheathed with painted wood weatherboard siding. The exposure of the siding ranges from 6" to 7". The foundation walls consist of randomly sized blocks of local gray granite set in flush-pointed mortar. The foundation was completely rebuilt in the 1970s repairs, incorporating reinforced concrete footings. It is not known if the original stone was re-used, though it is likely.

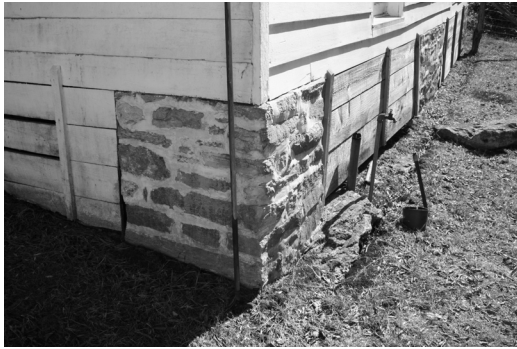
Two large openings in the west foundation wall and one on the north lead to the crawl space below the building. Each opening is covered by a modern wood panel built of three horizontal boards connected with three vertical battens. The panels are nailed in place to the frame walls through the top of the battens. The horizontal boards are spaced slightly to allow ventilation to the crawl space. These wood panels are unpainted on the west elevation and painted on the north elevation. The panels are 1970s replacements for earlier, deteriorated board panels visible in Sandburg-era photographs.

Figure C-27 Northwest corner of building showing wooden panels at foundation level

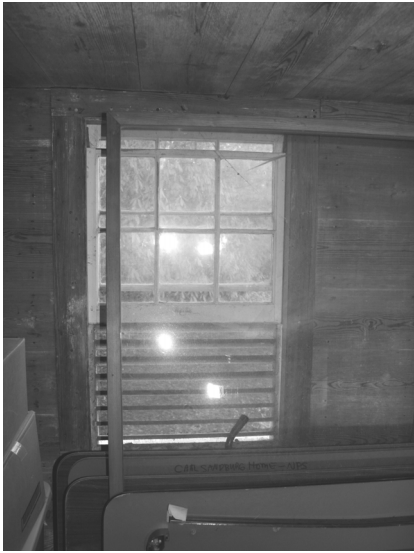
A wooden louver is in place at the window near the southeast corner of the building. The bottom sash of the window is in a raised position, with the louver in its place underneath. The louver was installed by the NPS in the 1970s repairs.

Figure C-33 Interior of louvered window

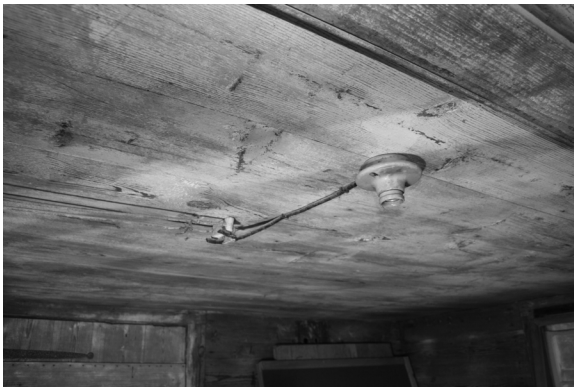
Electrical Systems: None are present. This room appears to have been historically lit by a ceramic light socket on the ceiling of Room 101B, placed close to the ghost mark from the original dividing wall.

Figure C-34 Ceramic light socket in Room 101B

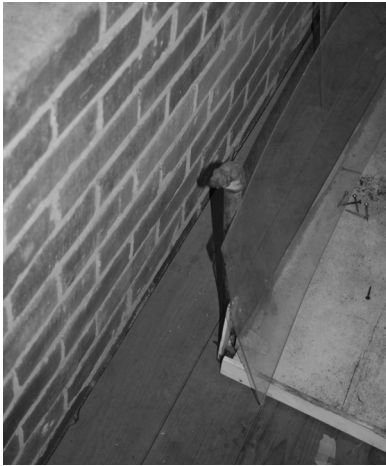
Figure C-39 Galvanized pipe adjacent to wash tubs

Plumbing Systems: A galvanized pipe near the firebox likely provided water for the wash tubs. It is no longer functional.

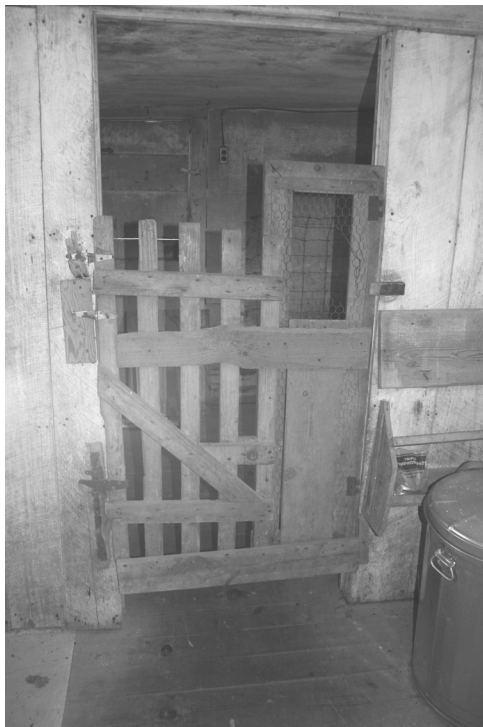
Figure C-45 Door opening with wooden gate on west wall of Room 102B

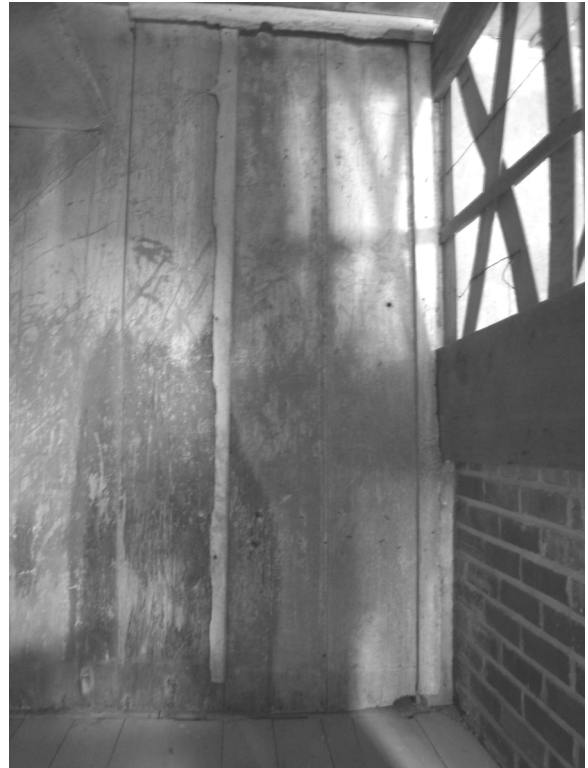
Figure C-46 Door at south wall of Room 102B

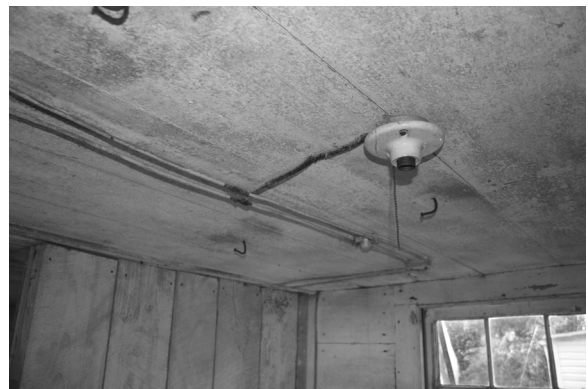
Figure C-47 Ceramic light socket and knob-and-tube wiring in Room 102B

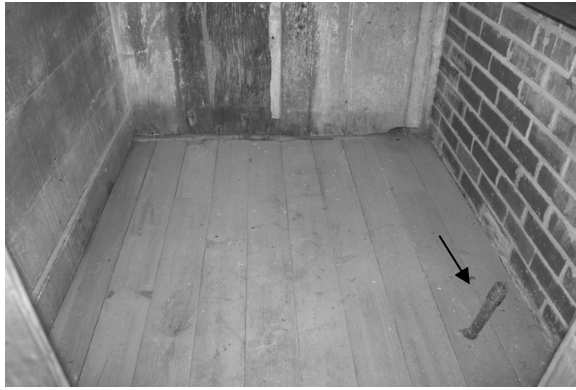
Figure C-48 Galvanized pipe and interior of closet

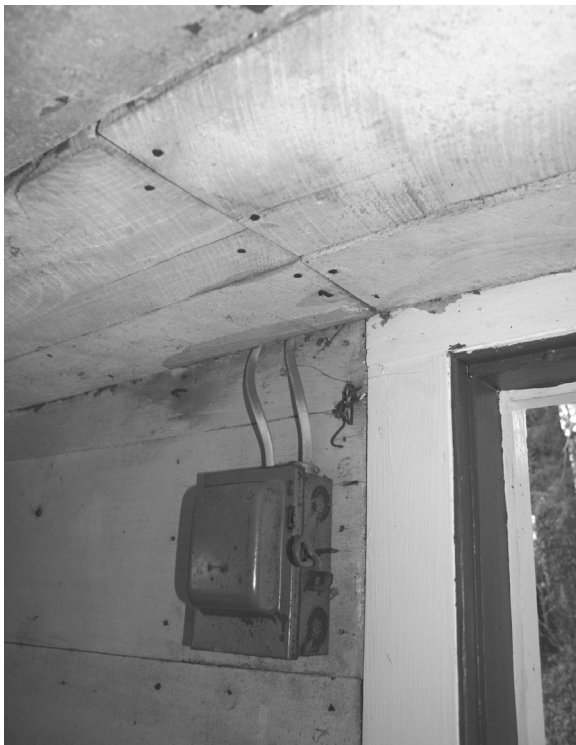
Ceiling: The ceiling is sheathed in what is probably the original tongue-and-groove boards measuring 3/4" thick by 10 3/4" wide, with some 11" wide boards. Two ceiling boards nearest to the east wall are newer circular-sawn boards measuring 6" and 9 1/2" wide by 7/8" thick. It is assumed that these ceiling boards were replaced when the adjacent electrical disconnect box was added in 1976.

Figure C-49 Disconnect box on east wall of Room 102B, with adjacent replacement ceiling boards

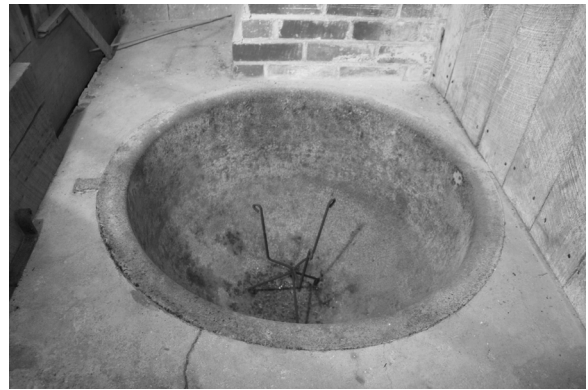
Figure C-51 Wash tub in Room 102B

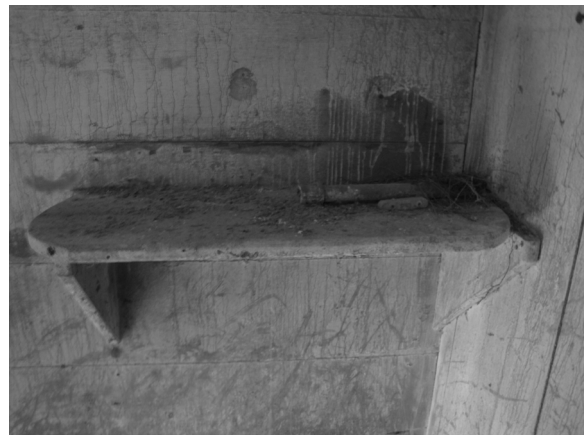
Figure C-52 Early shelf on east wall

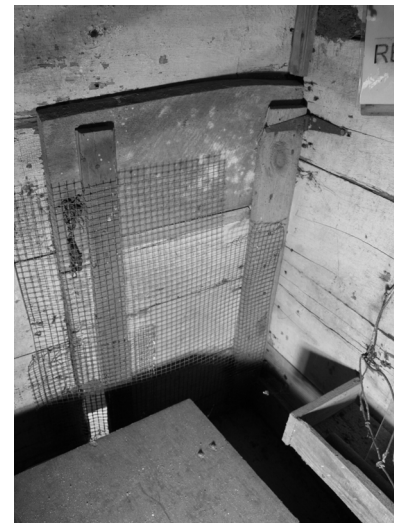
Figure C-53 Hinged goat door on north wall of Room 102B with adjacent feed trough

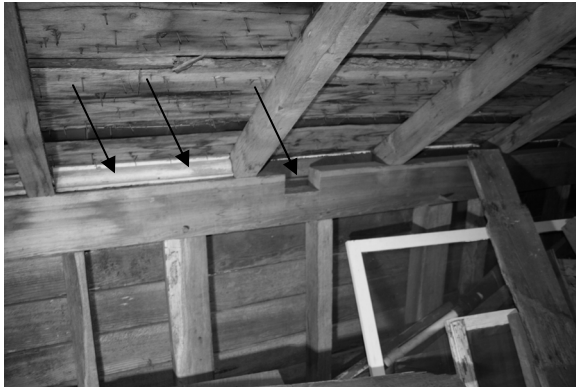
The second floor is a half-story area with exposed wall and roof framing. Wall studs extend up from the floor about 3'-9" to a 4" by 7 5/8" plate supporting the roof rafters. Two large notches in the plates suggest that large tie beams were intended to connect the east and west walls; however, it appears that they were never installed.

Figure C-54 Notches in top plate suggest collar ties; note painted sections of crown moulding along parts of top plate

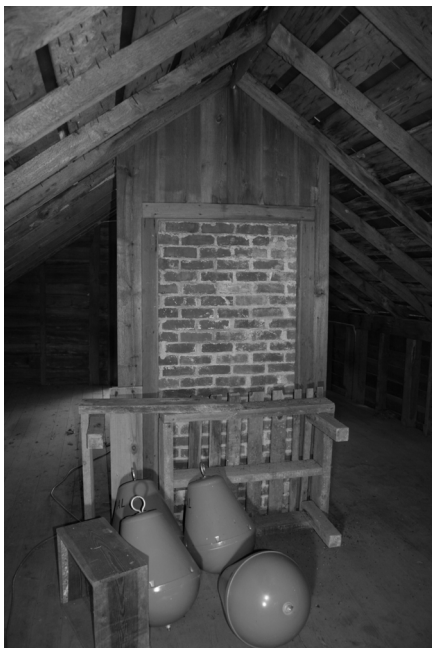
Figure C-56 Room 201A looking north to early door opening and vertical board wall

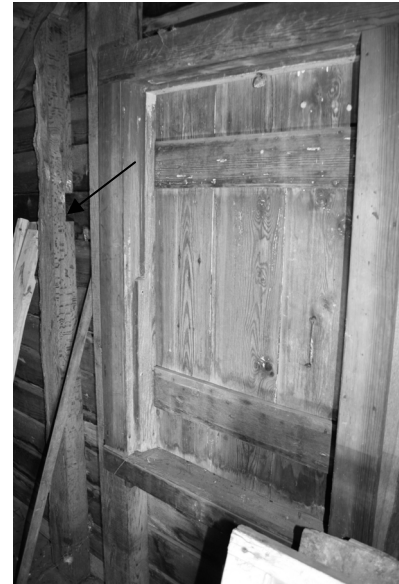
Figure C-57 Window opening at south wall of Room 201A, with shutter closed and stud notch indicated

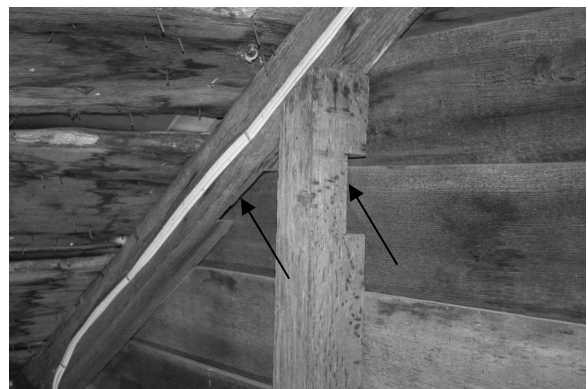
Figure C-59 Notches in studs at north gable end

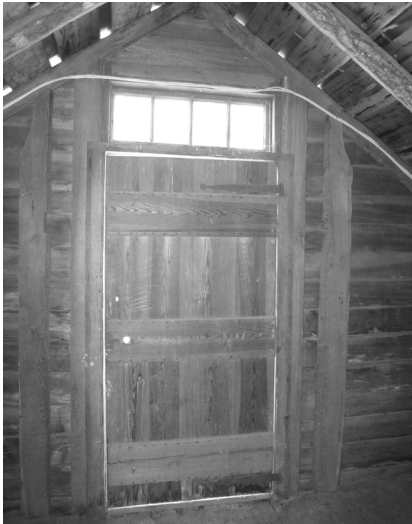
Figure C-60 Door opening and transom on north wall of Room 201B

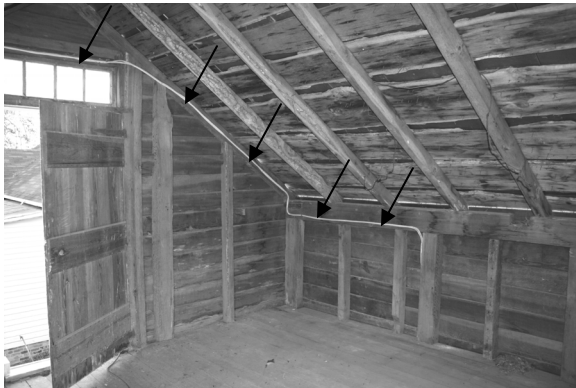
Figure C-61 Romex wiring leading from service point to disconnect box below

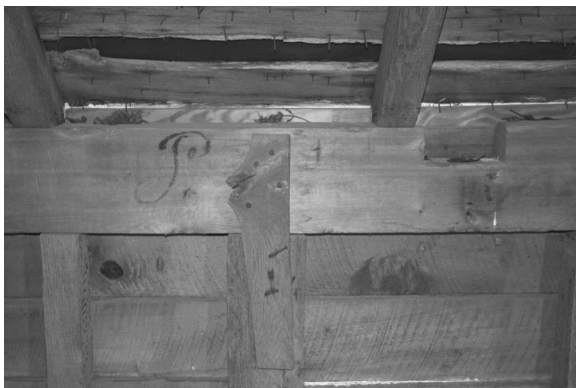
Figure C-62 Letter “P” inscribed on west top plate

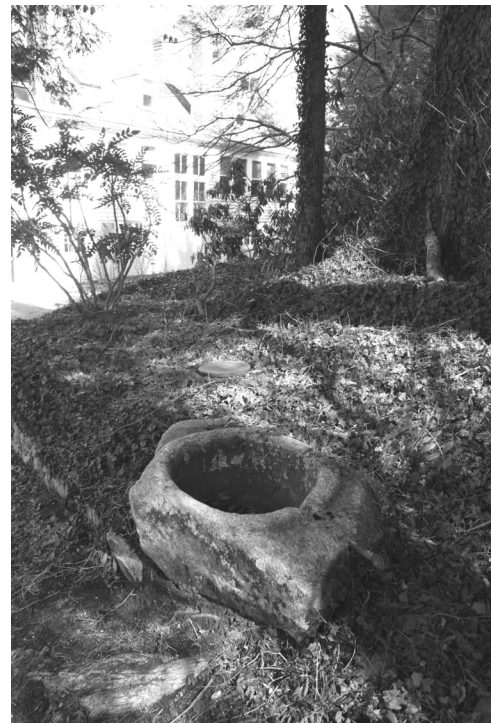
Figure C-64 Stone basin at early well just east of Chicken House/Wash House

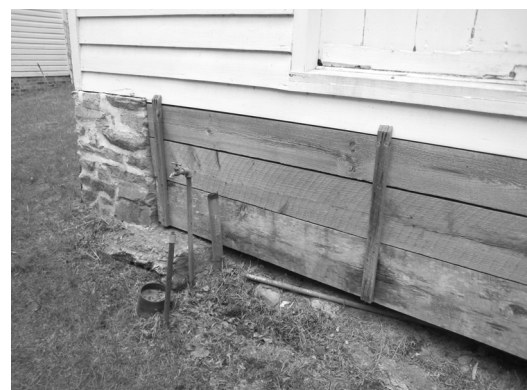
Figure C-65 Hose bib at west elevation

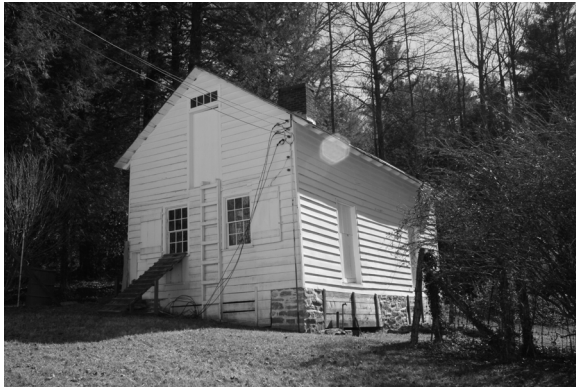
Figure B-1 Northwest oblique of Chicken House/Wash House, February 2007
