historic structure report
architectural data section
volume 2: appendixes

MARTIN VAN BUREN

NATIONAL HISTORIC SITE / NEW YORK

LINDENWALD

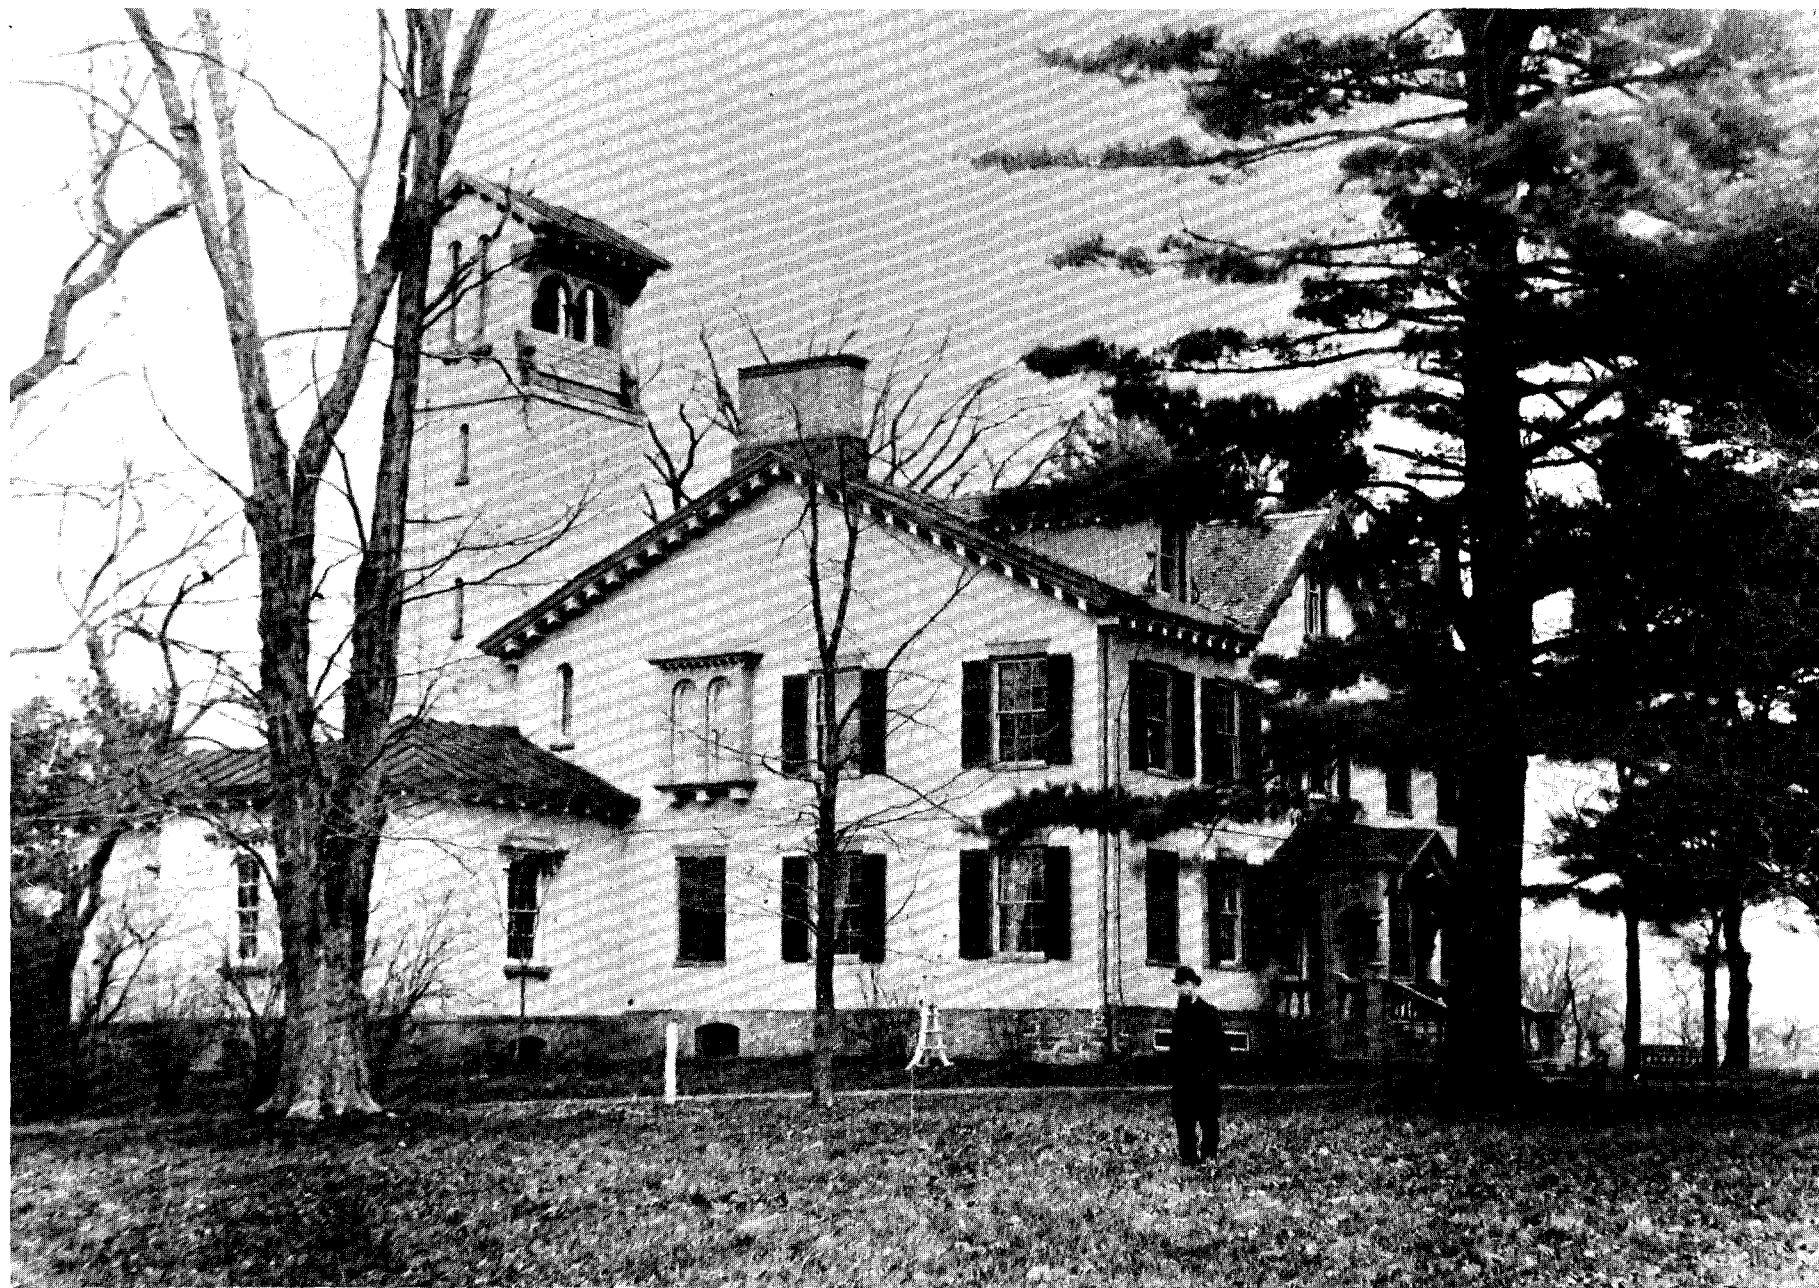
HP5. Lindenwald, ca. 1890-1900. This photograph of the south and east sides is dated ca. 1890-1900 on the basis of recollections of the donor, Hazel Whitbeck, a long-time resident in the vicinity. The following details should be noted:

The chimney base and cap are a dark tone--either dark paint or unpainted brick.

The southeast corner of the foundation appears to have been repointed.

Visible lawn furniture consists of a cast iron-bench, a rustic chair, a tripod trellis, and a hitching post.

The small tree in the foreground (directly in front of the trellis) is considerably smaller here than in HP6.

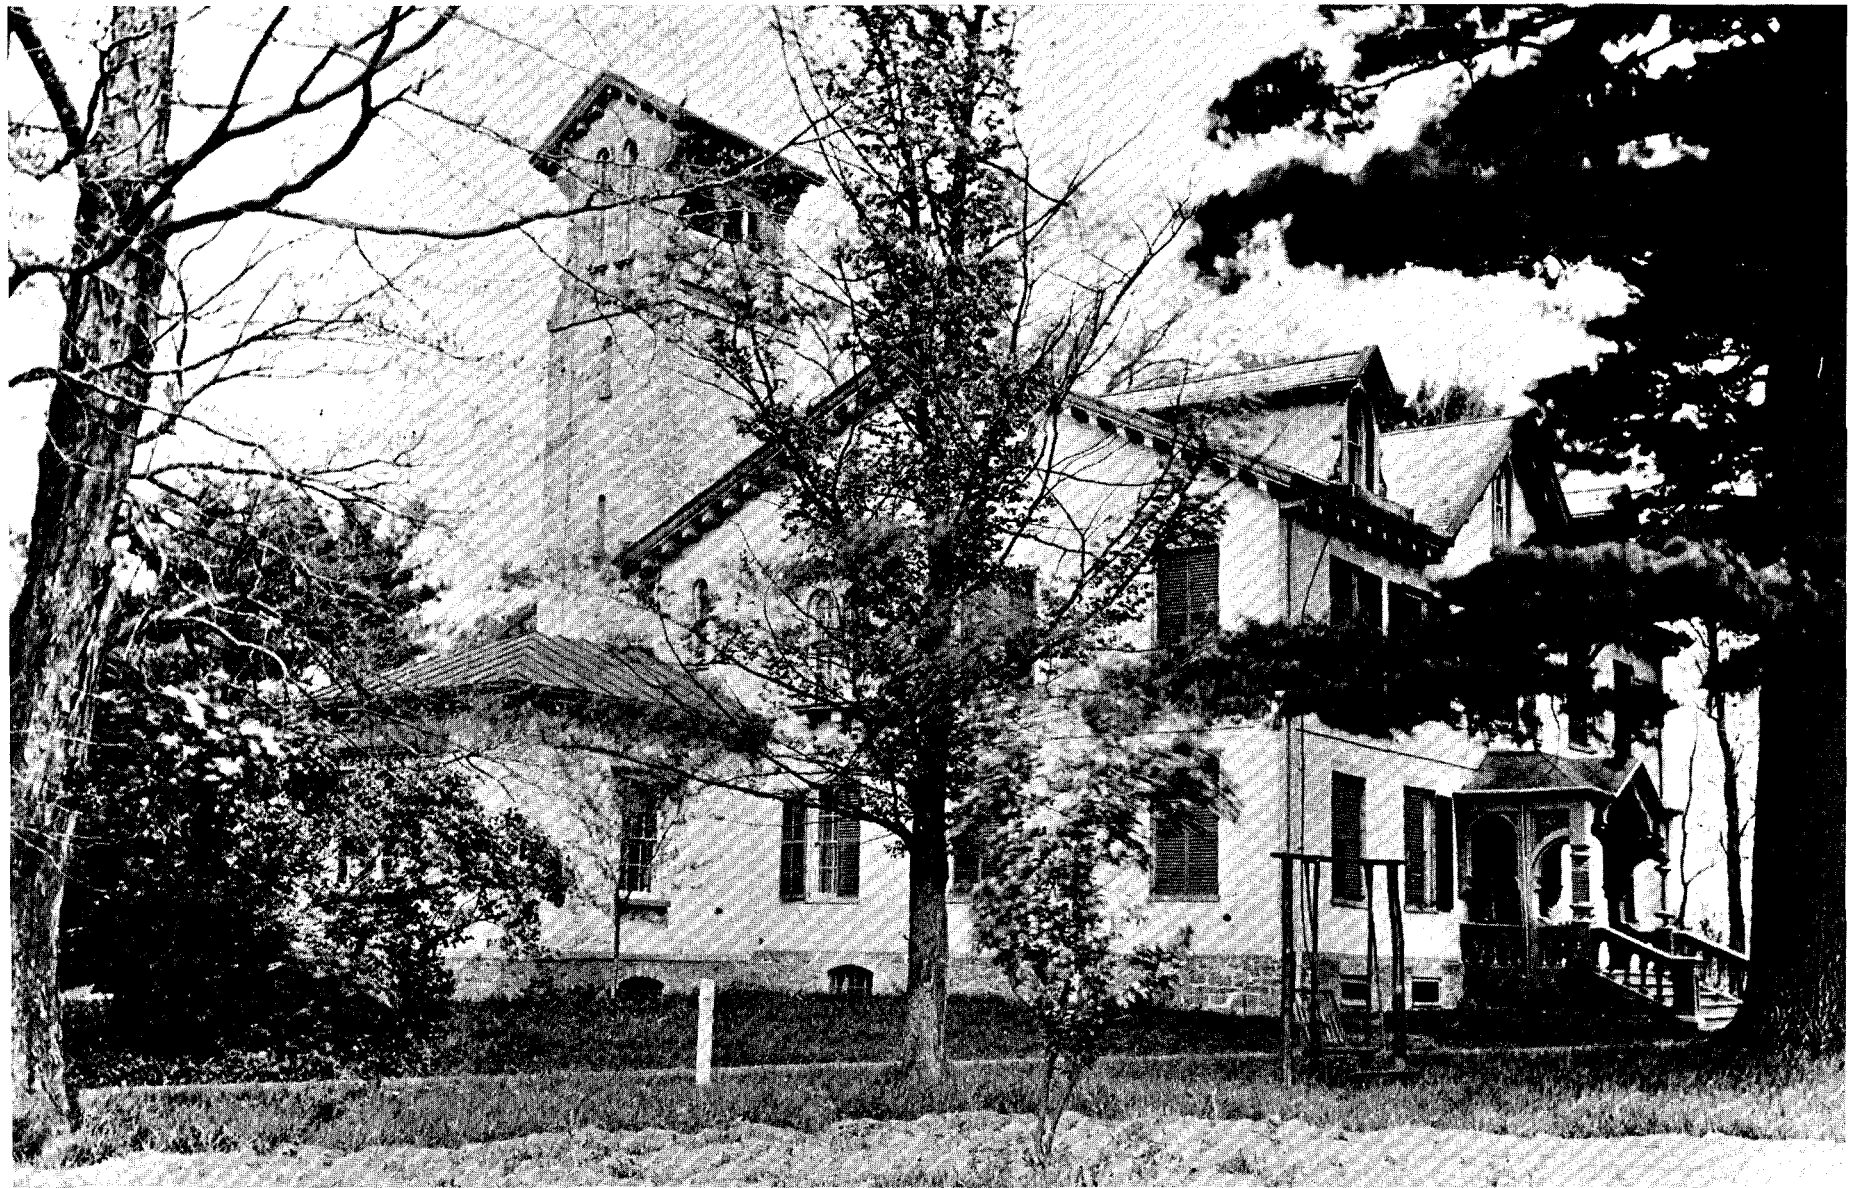
HP6. Lindenwald, ca. 1900. The date of this photograph is approximate because it is based on the growth of the small tree in the foreground compared to its size in HP5. The following details should be noted:

The dormer sill return is missing.

A rustic chair on the front porch, a glider, and a hitching post constitute the visible items of lawn furniture. The tripod trellis seen in HP5 may be hidden behind the small tree in the foreground.

There is a row of small bushes or ferns along the cheek of the front porch (not present in HP5).

Basement window frames are painted a dark tone.

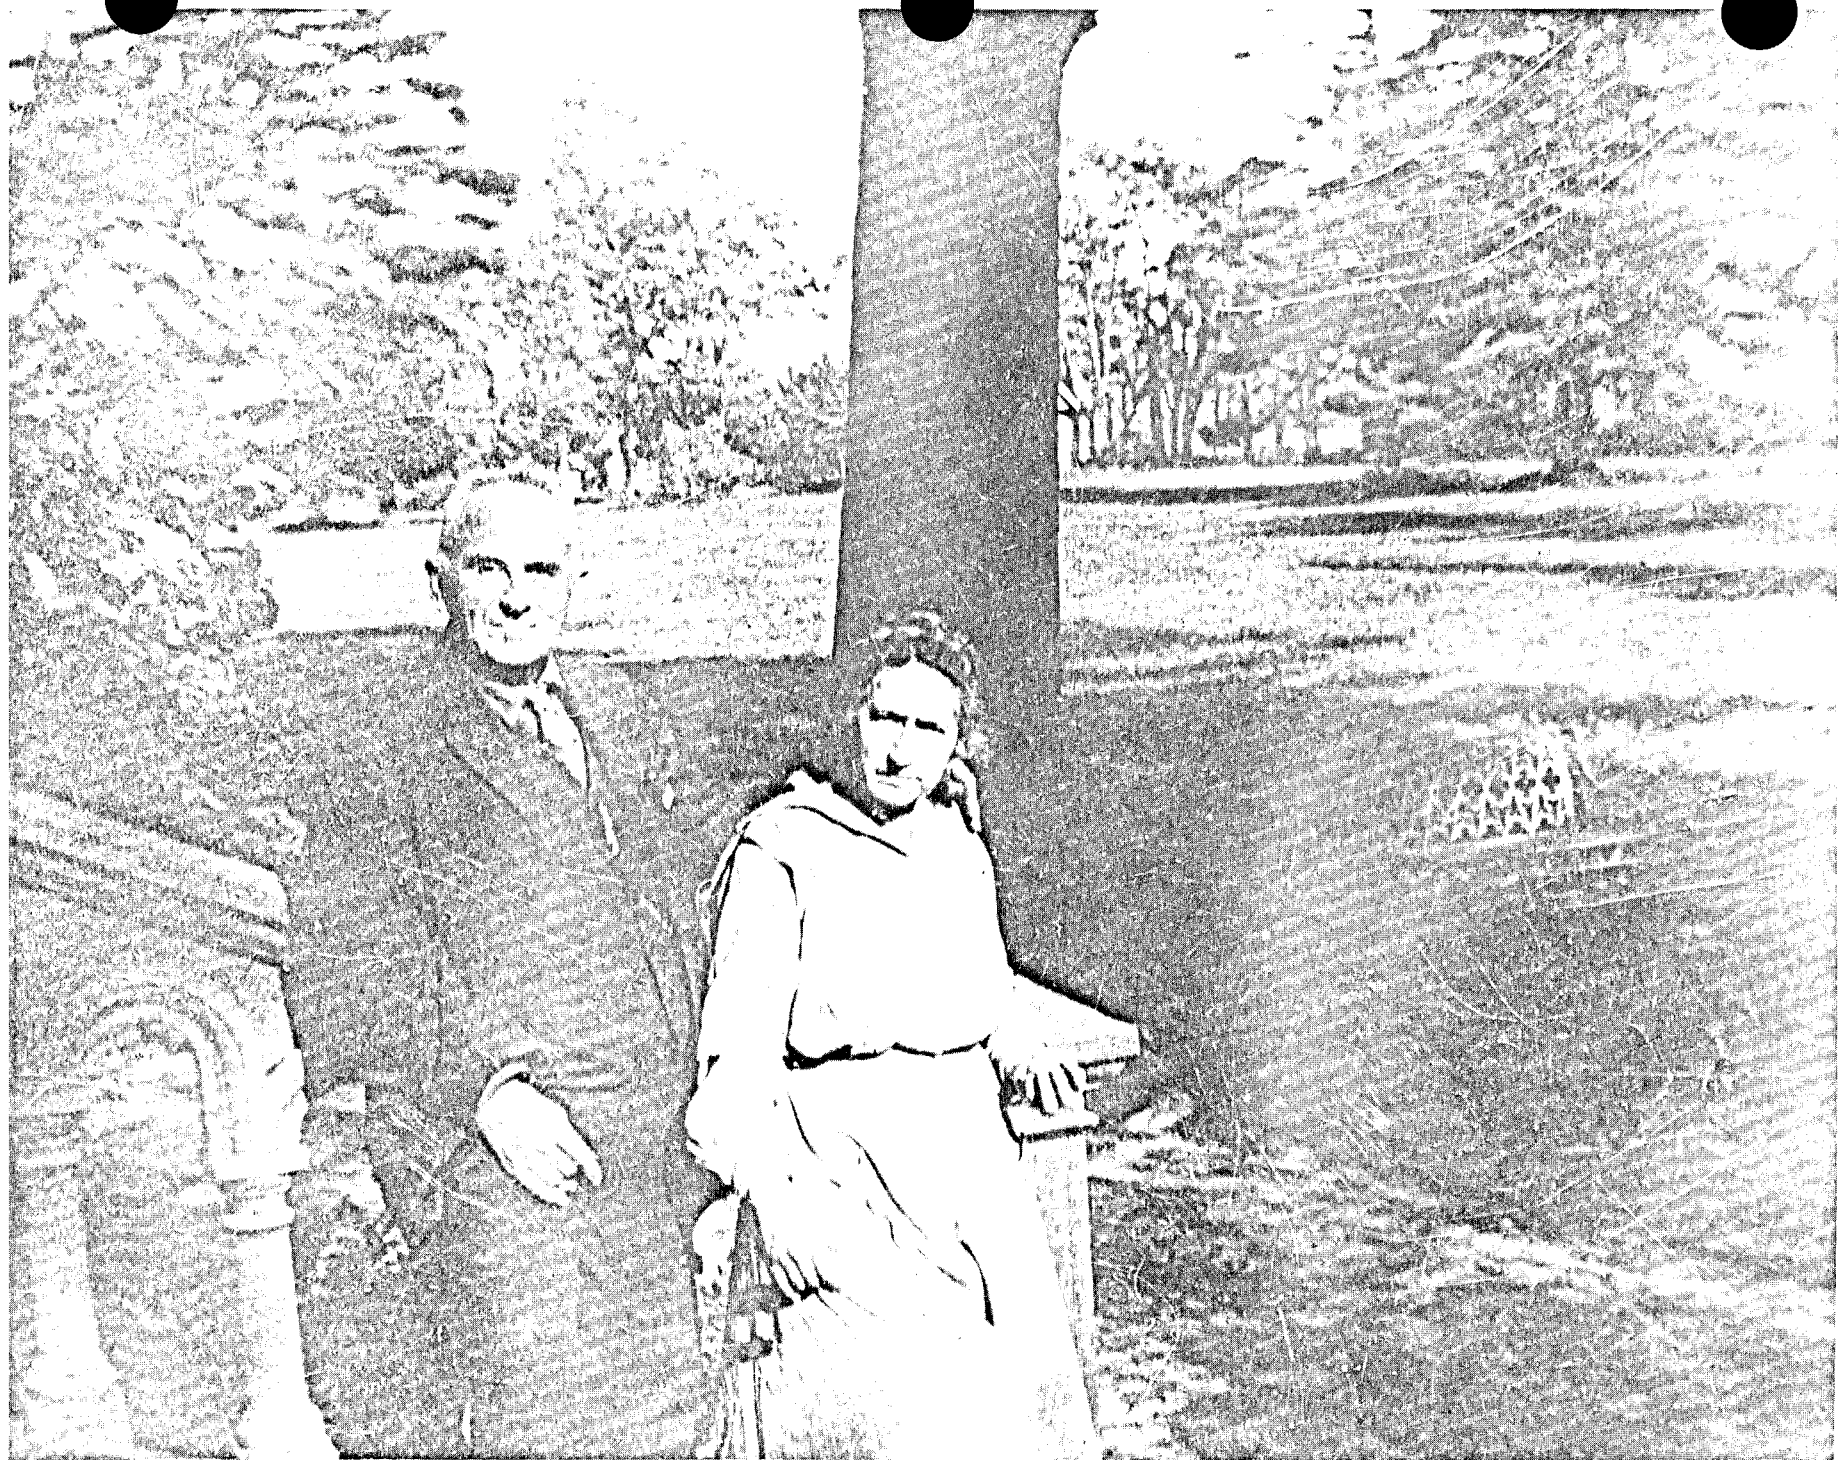
HP7. The Wagoners in Front of Lindenwald. This photograph probably predates 1917 because the subjects are Mr. and Mrs. Wagoner. Note the detail of the cast-iron bench and the expanse of lawn.

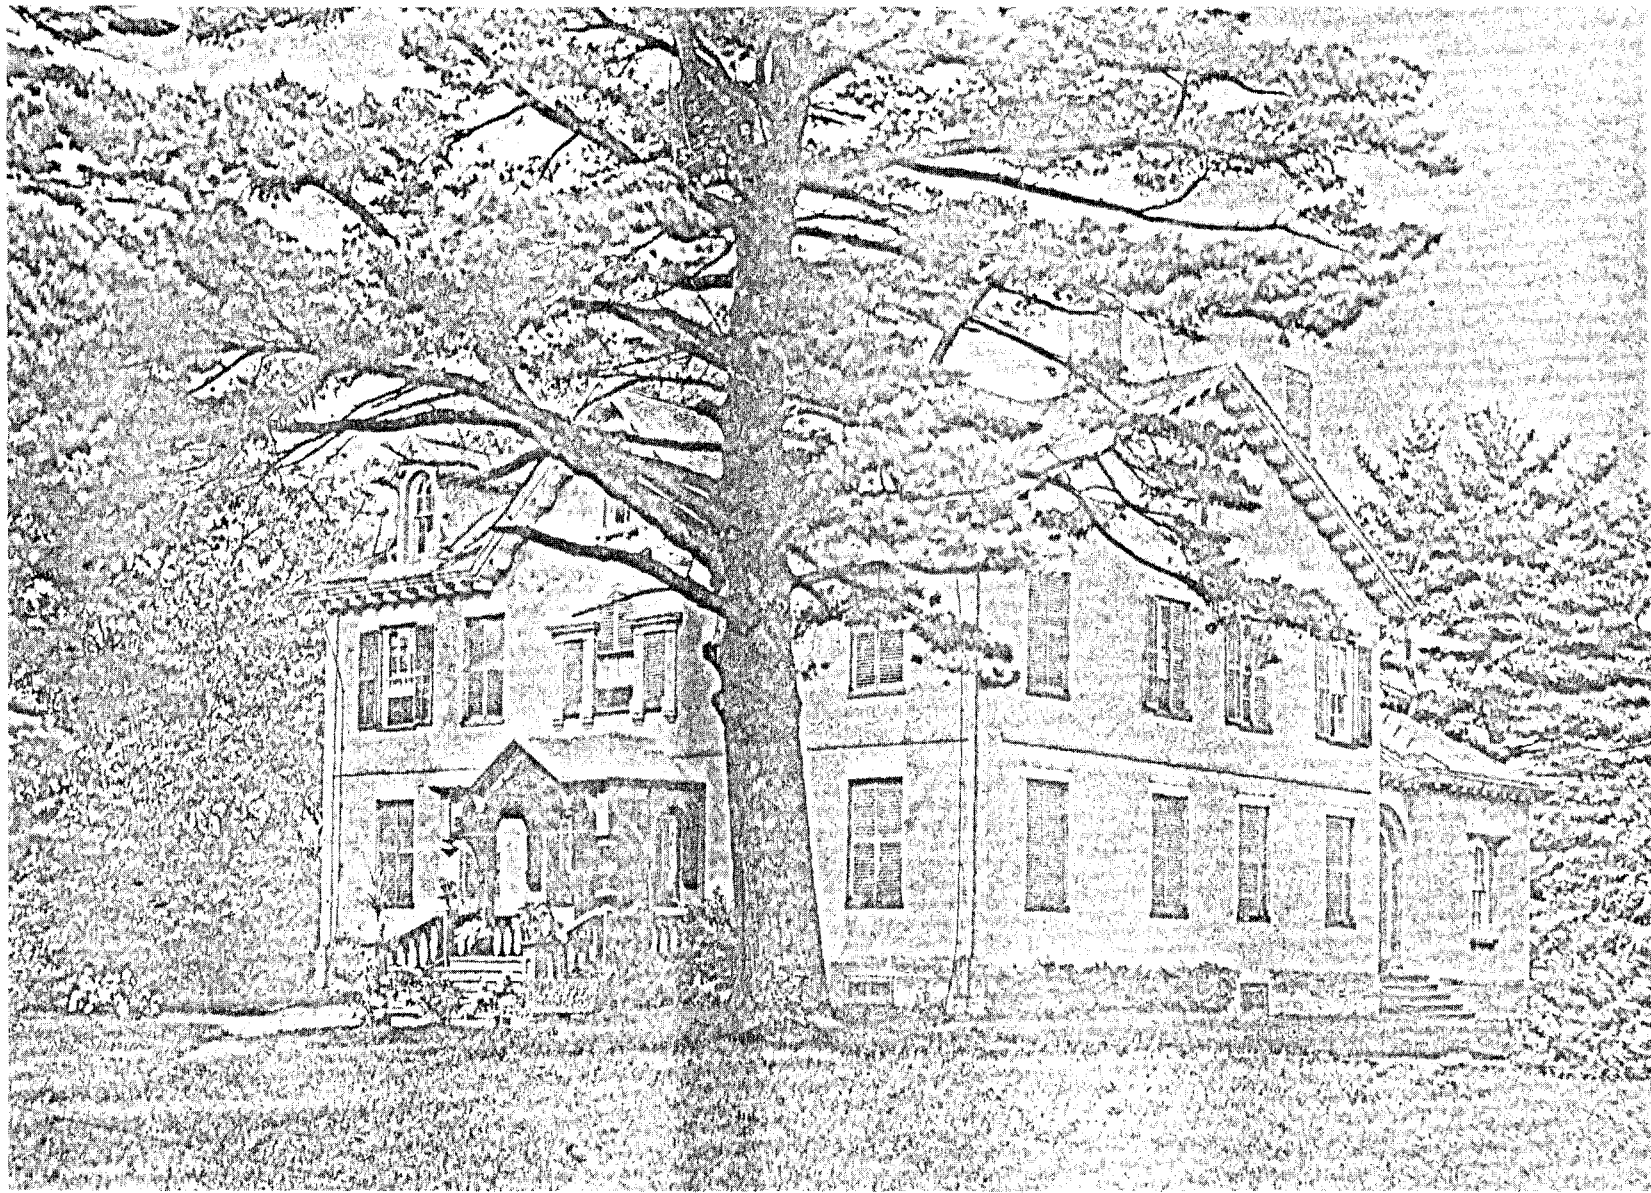
HP10. Lindenwald, East Elevation, ca. 1913. This photograph is from the New York State Archives, glass plate number 82, negative number 10643. The glass plate is dated 1913. The print presented here is an enlargement of the central part of the glass plate. Landscape features visible on the glass plate, but not included in this print, are the farm office, partially visible at the extreme left (south) side, an adjacent fence, the hitching post, the glider, a cauldron (cast iron?) at the base of the south pine tree, another cast-iron bench near the south pine tree, an outbuilding northwest of the house, and an extensive lawn with trees and shrubs. Within the area of this print, the following details should be noted:

Lightning rods and conductors are present.

There are two rustic chairs on the porch and a cast-iron bench under the north pine tree.

The foundation, window frames, shutters, and front porch seem to be painted a dark tone. Sash, bricks, and cornice appear to be painted a lighter tone.

The dark area at the base of the north foundation may be the ferns present in HP9.

The south dormer sill box is askew. The north end of the north dormer sill box is detached.

Sheet-metal gutters have been added to the level eaves of the south dormer.

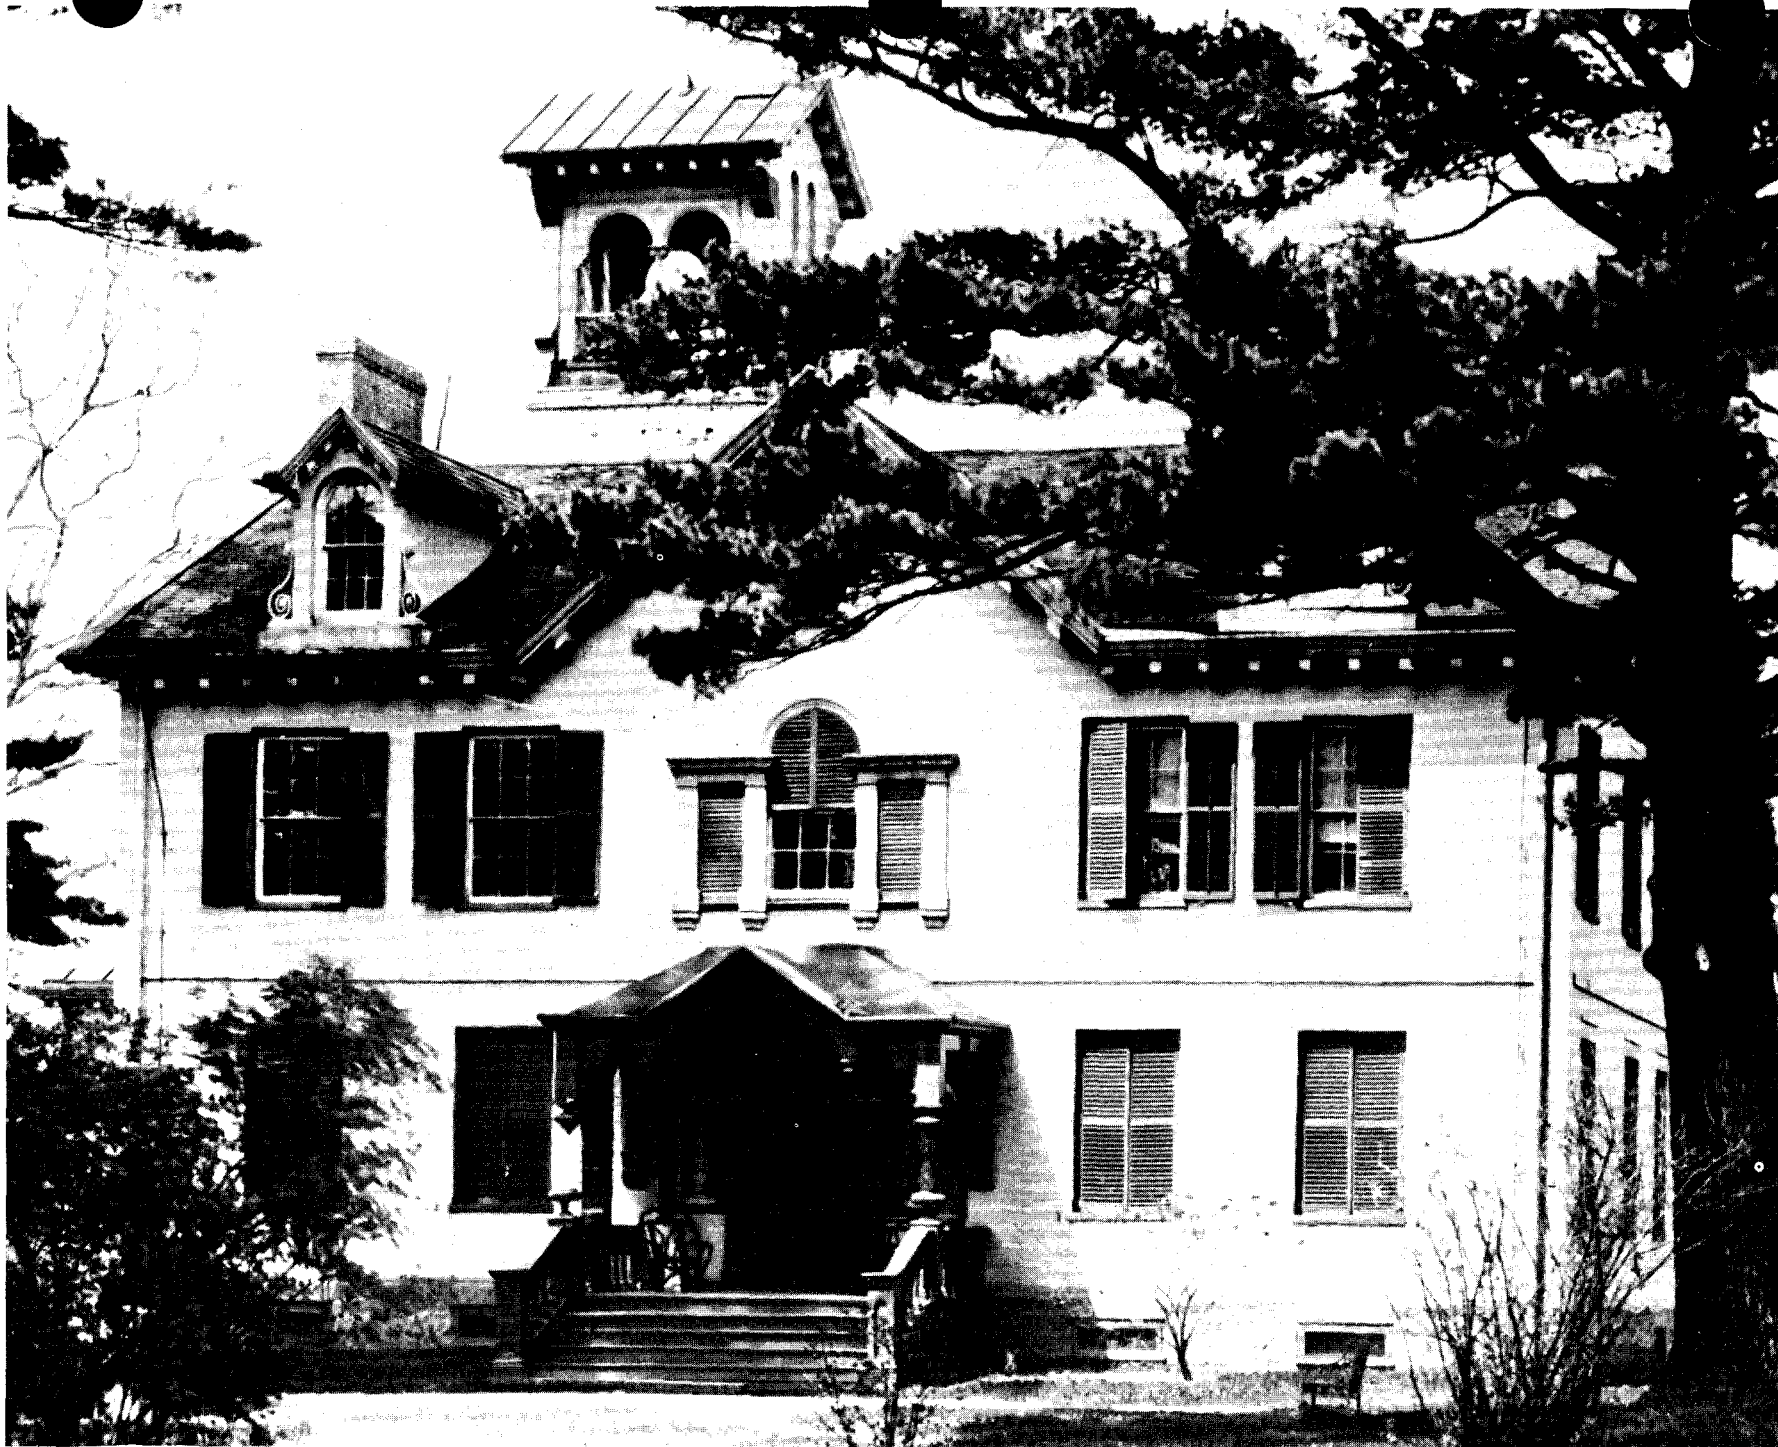
HP11. Lindenwald, East Elevation, ca. 1913-1917. This date is based on similarities with HP10, the fact that the hydrangeas are slightly larger, the state of deterioration of the dormer sill boxes, the continued presence of lightning rods, and the wood shingle roof. The following details should be noted:

The foundation window frames, shutters, and front porch appear to be painted a darker tone. Sash, bricks, and cornice appear to be painted a lighter tone.

The north hydrangea is 7' to 8' tall and the south one 4' to 5' tall. Two rustic chairs and a wicker rocker can be seen on the front porch. Two cast-iron benches are placed in the shade of the north and south pine trees. A row of potted plants lines a path or drive parallel to the front of the house. A cluster of similar potted plants is to the east of this line and on axis with the front door. What may be a cast-iron cauldron appears in the left foreground under the south pine tree.

There is a rainwater diverter at the east end of the north gable capping board.

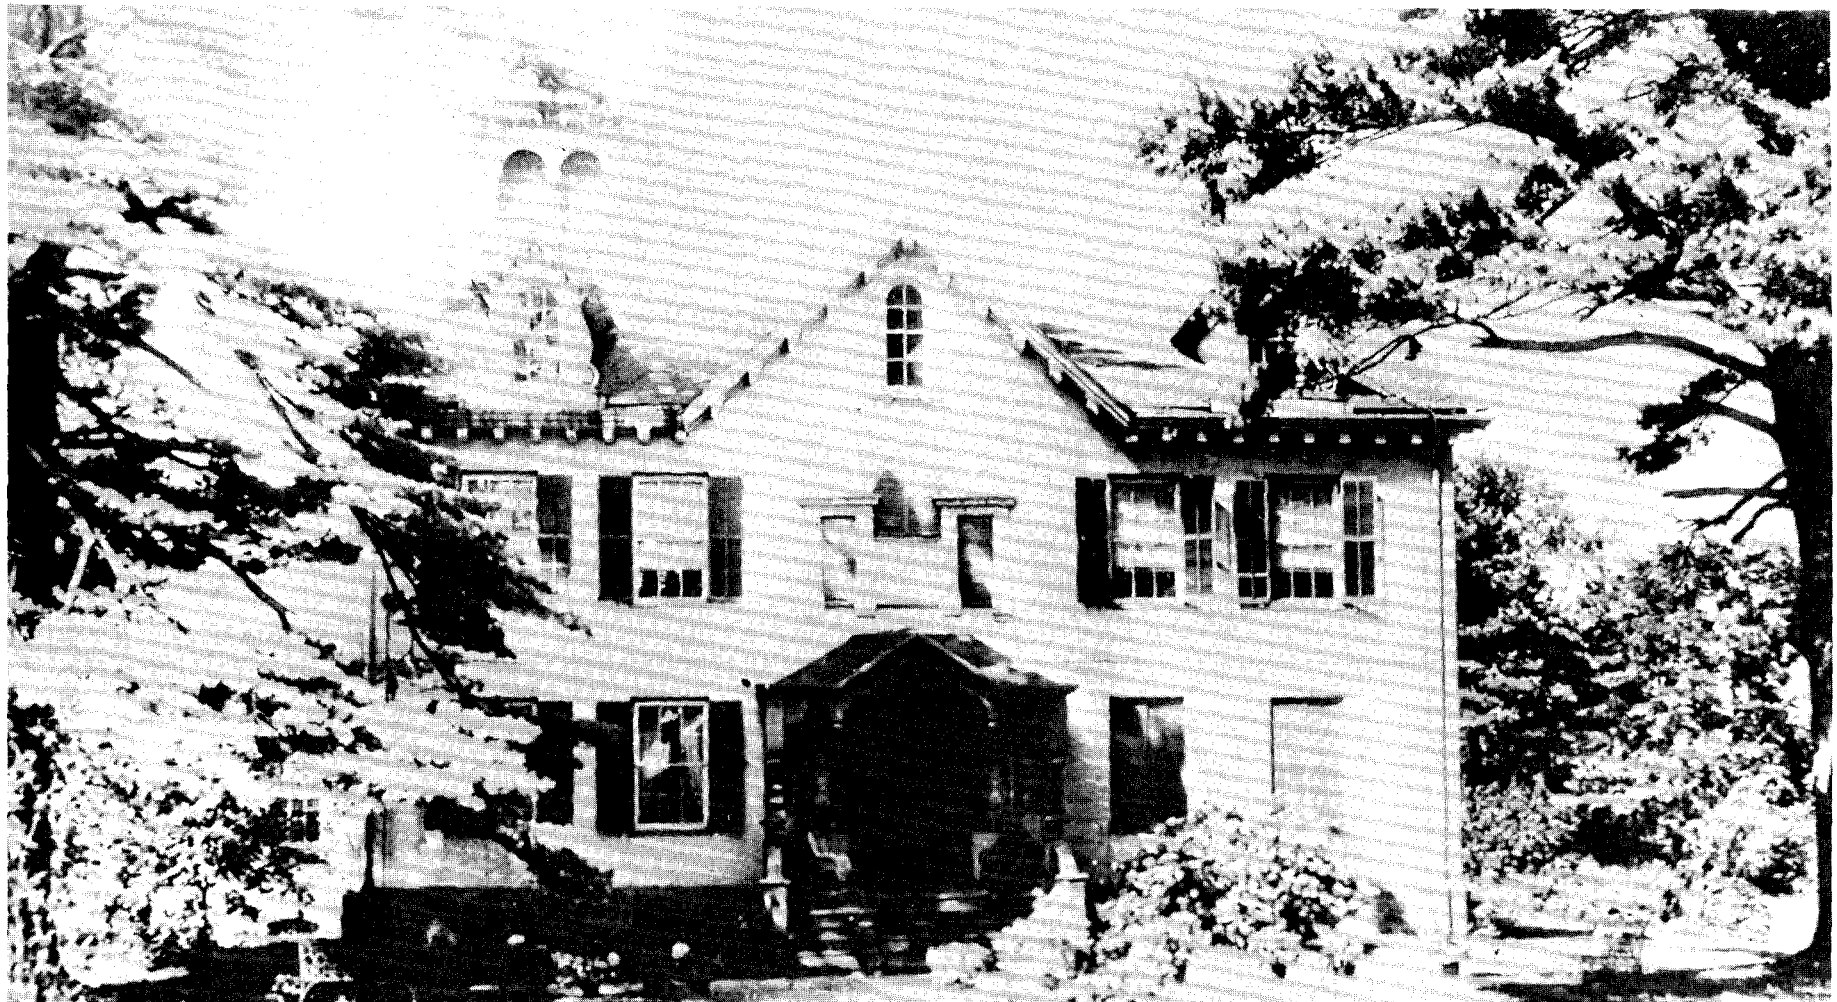
HP12. Mrs. Bascom Birney at Lindenwald, after 1917. This photograph was probably taken after the Birneys' acquisition of Lindenwald in 1917. The following details should be noted:

The foundation and trim appear to be painted a dark tone. Brickwork has been painted a light tone but is now quite weathered. Window frames are painted a lighter color.

The replacement cornice on the door pediment is in place.

The downspout appears to be a replacement consisting of lengths of stock corrugated pipe and a wooden board and trough to direct rainwater away from the foundation.

There is a grate over window well 011.

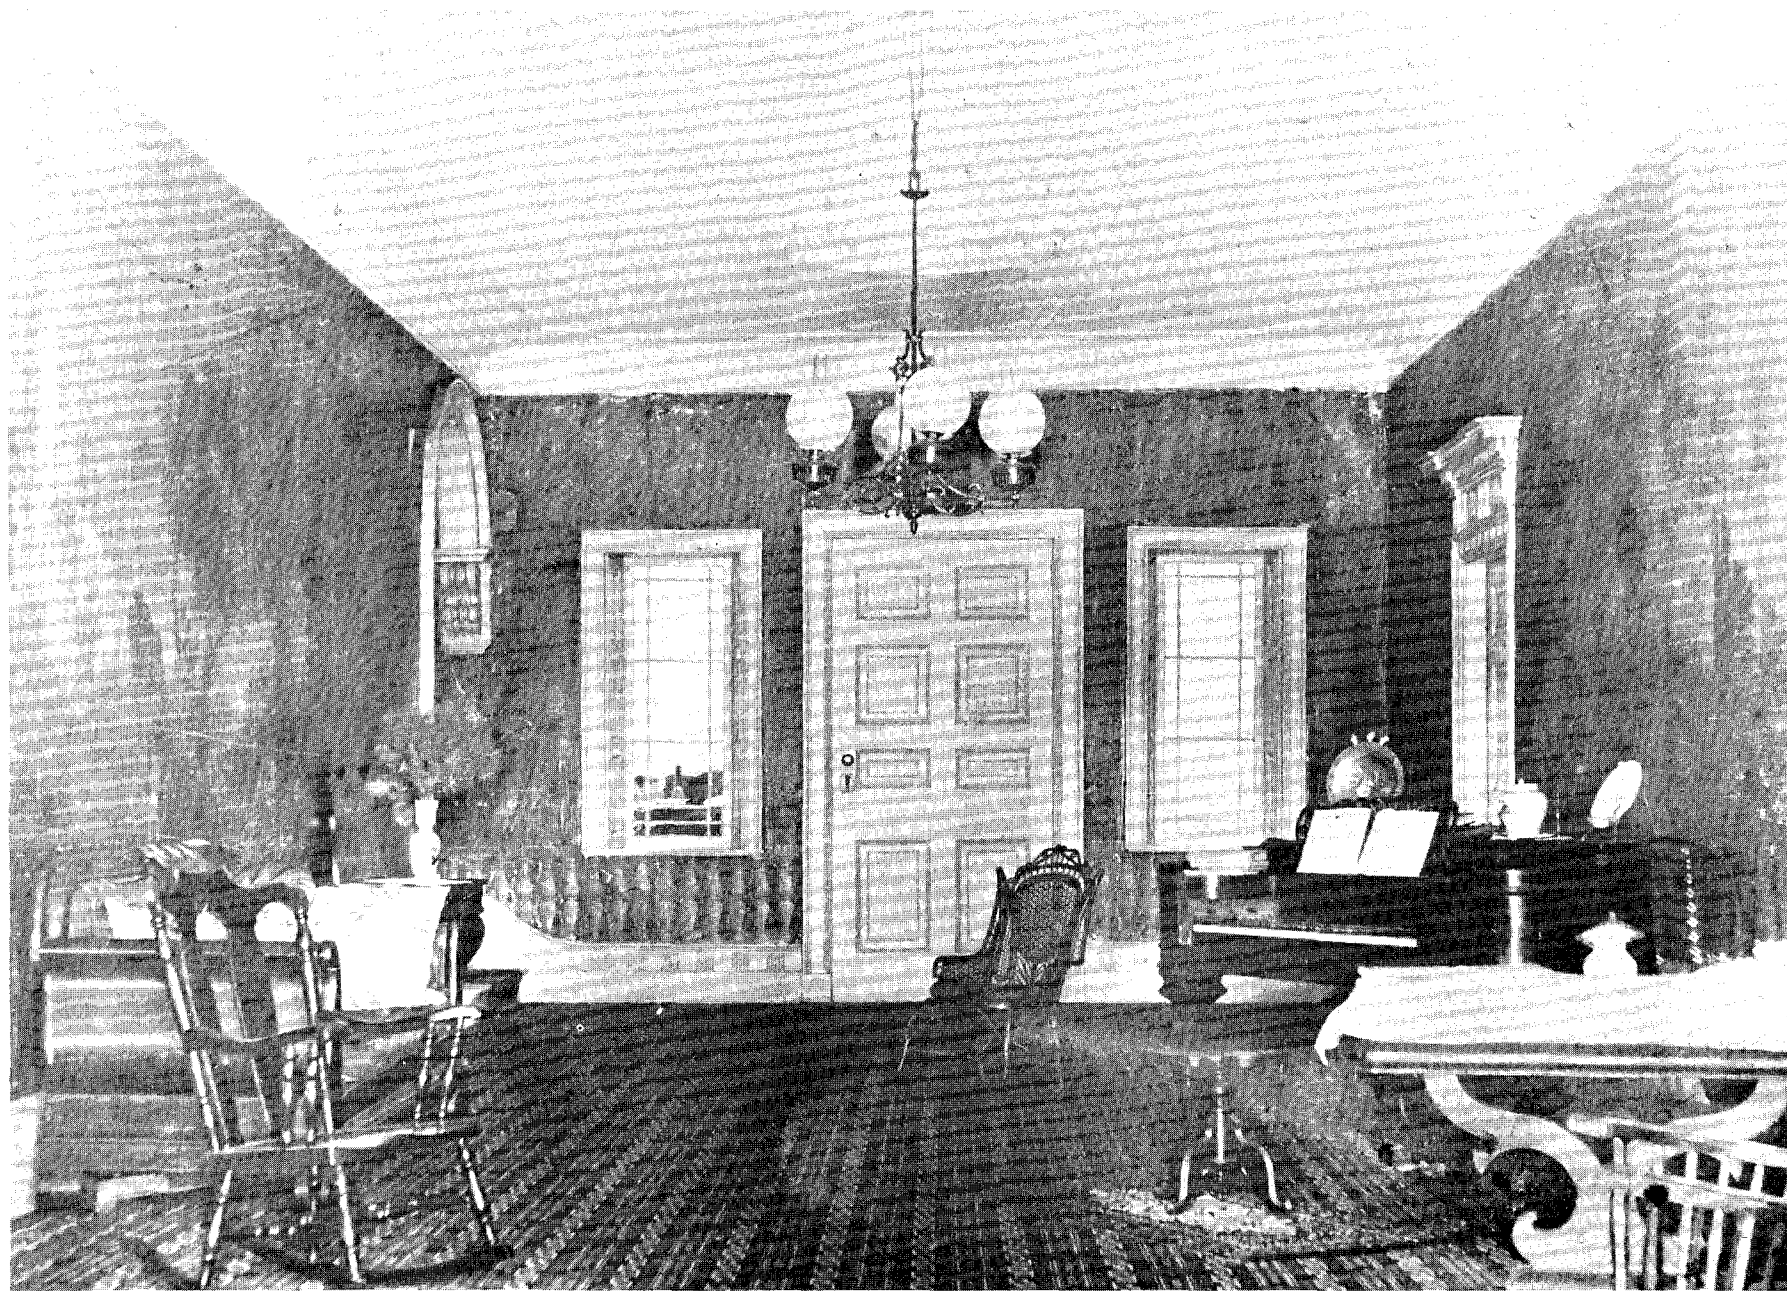
HP14. West Slope of ca. 1797 Roof, ca. 1918-1920. This photograph shows Dr. Bascom Birney removing wood shingles in preparation for the slate roof. Family tradition dates this event to the early years of their ownership of Lindenwald, probably before 1920. Note the following details:

condition of sheathing boards

missing and broken plaster keys over room 307

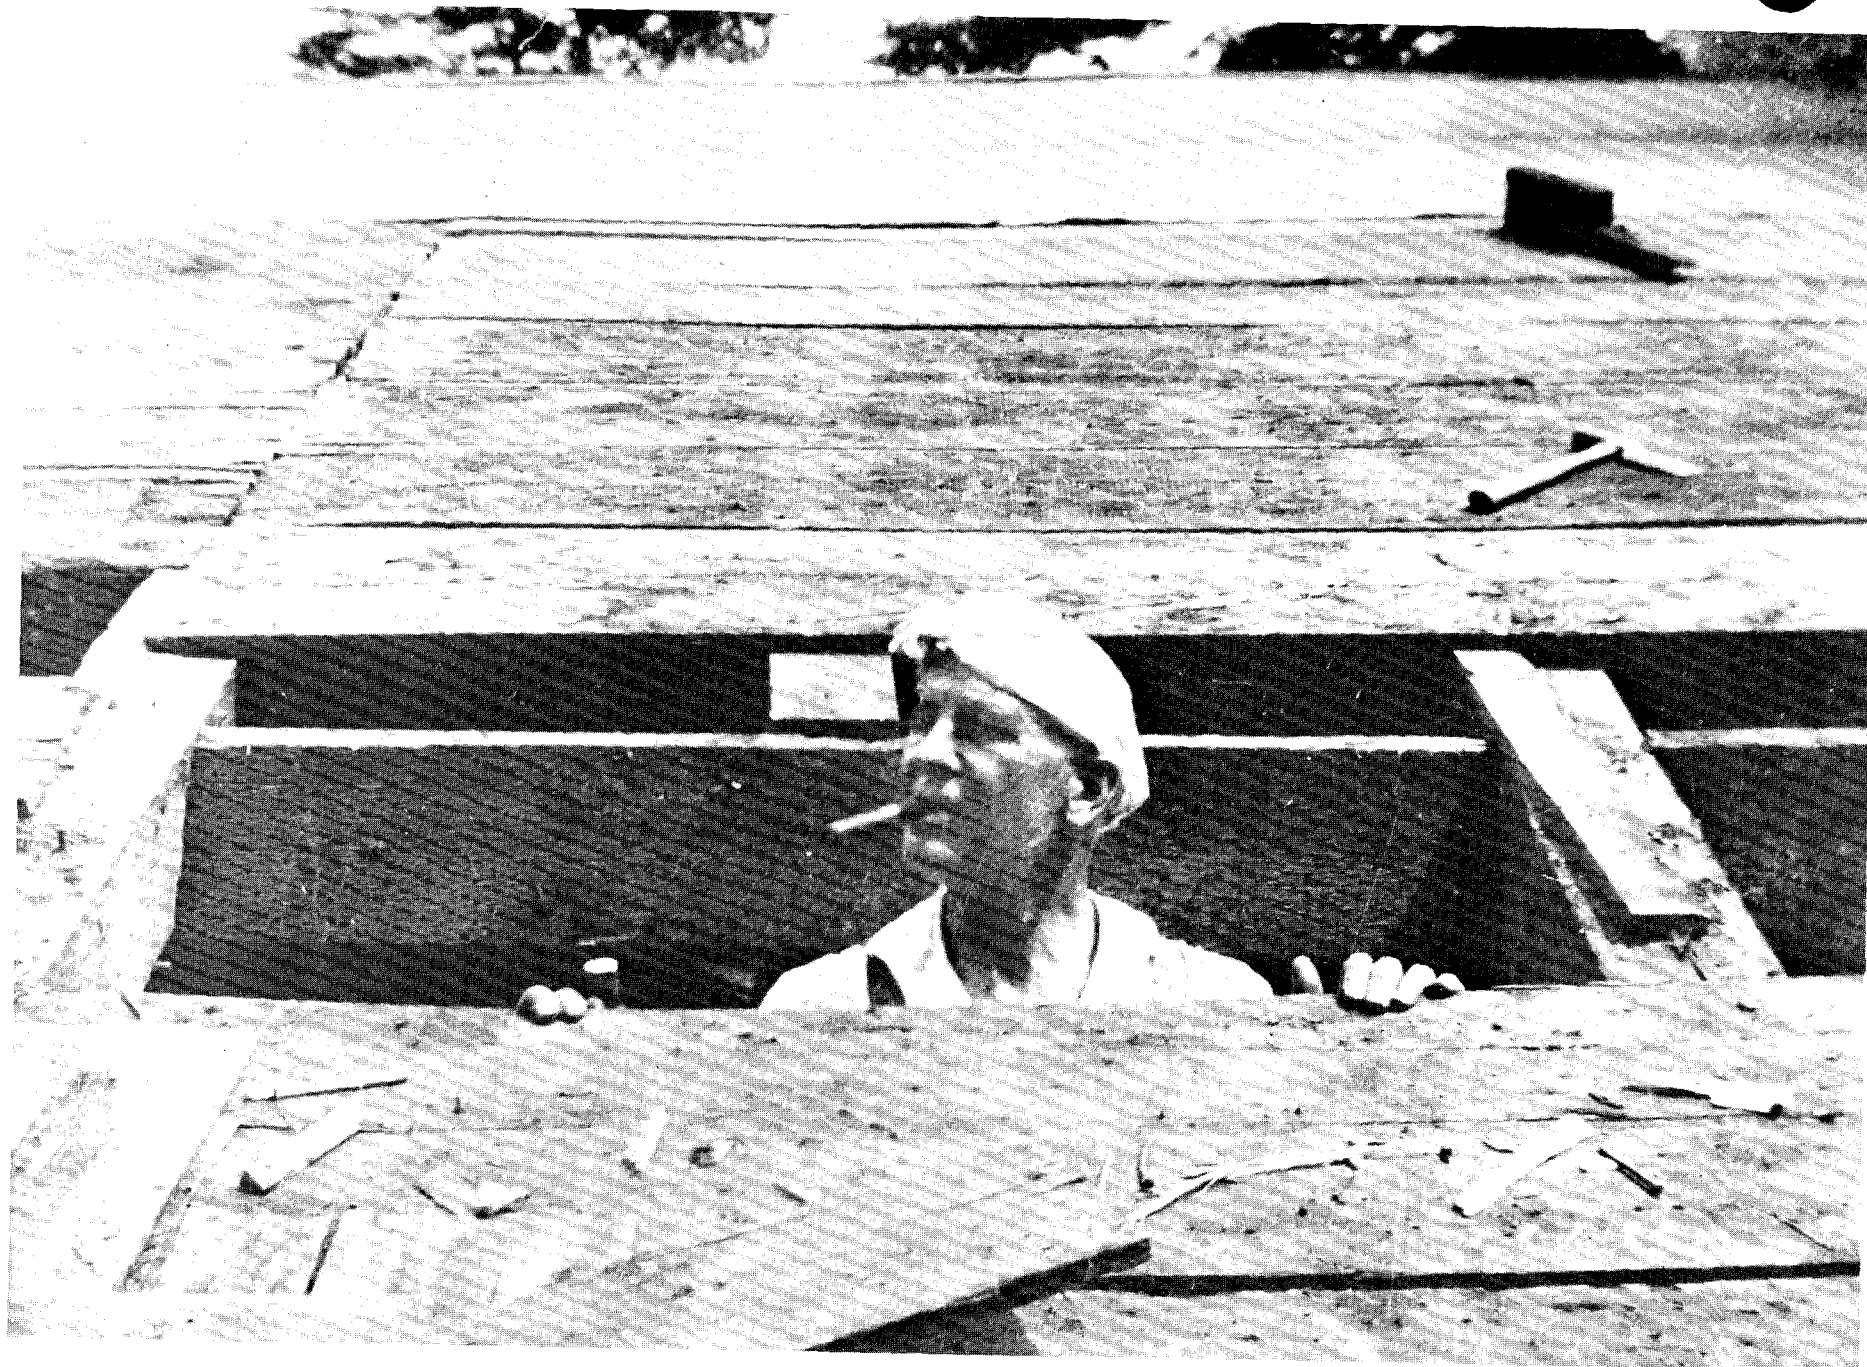
HP15. This photograph again shows Dr. Bascom Birney in the process of removing shingles from the west slope of the ca. 1797 roof. Note the roofing bracket near the top right corner of the photograph.

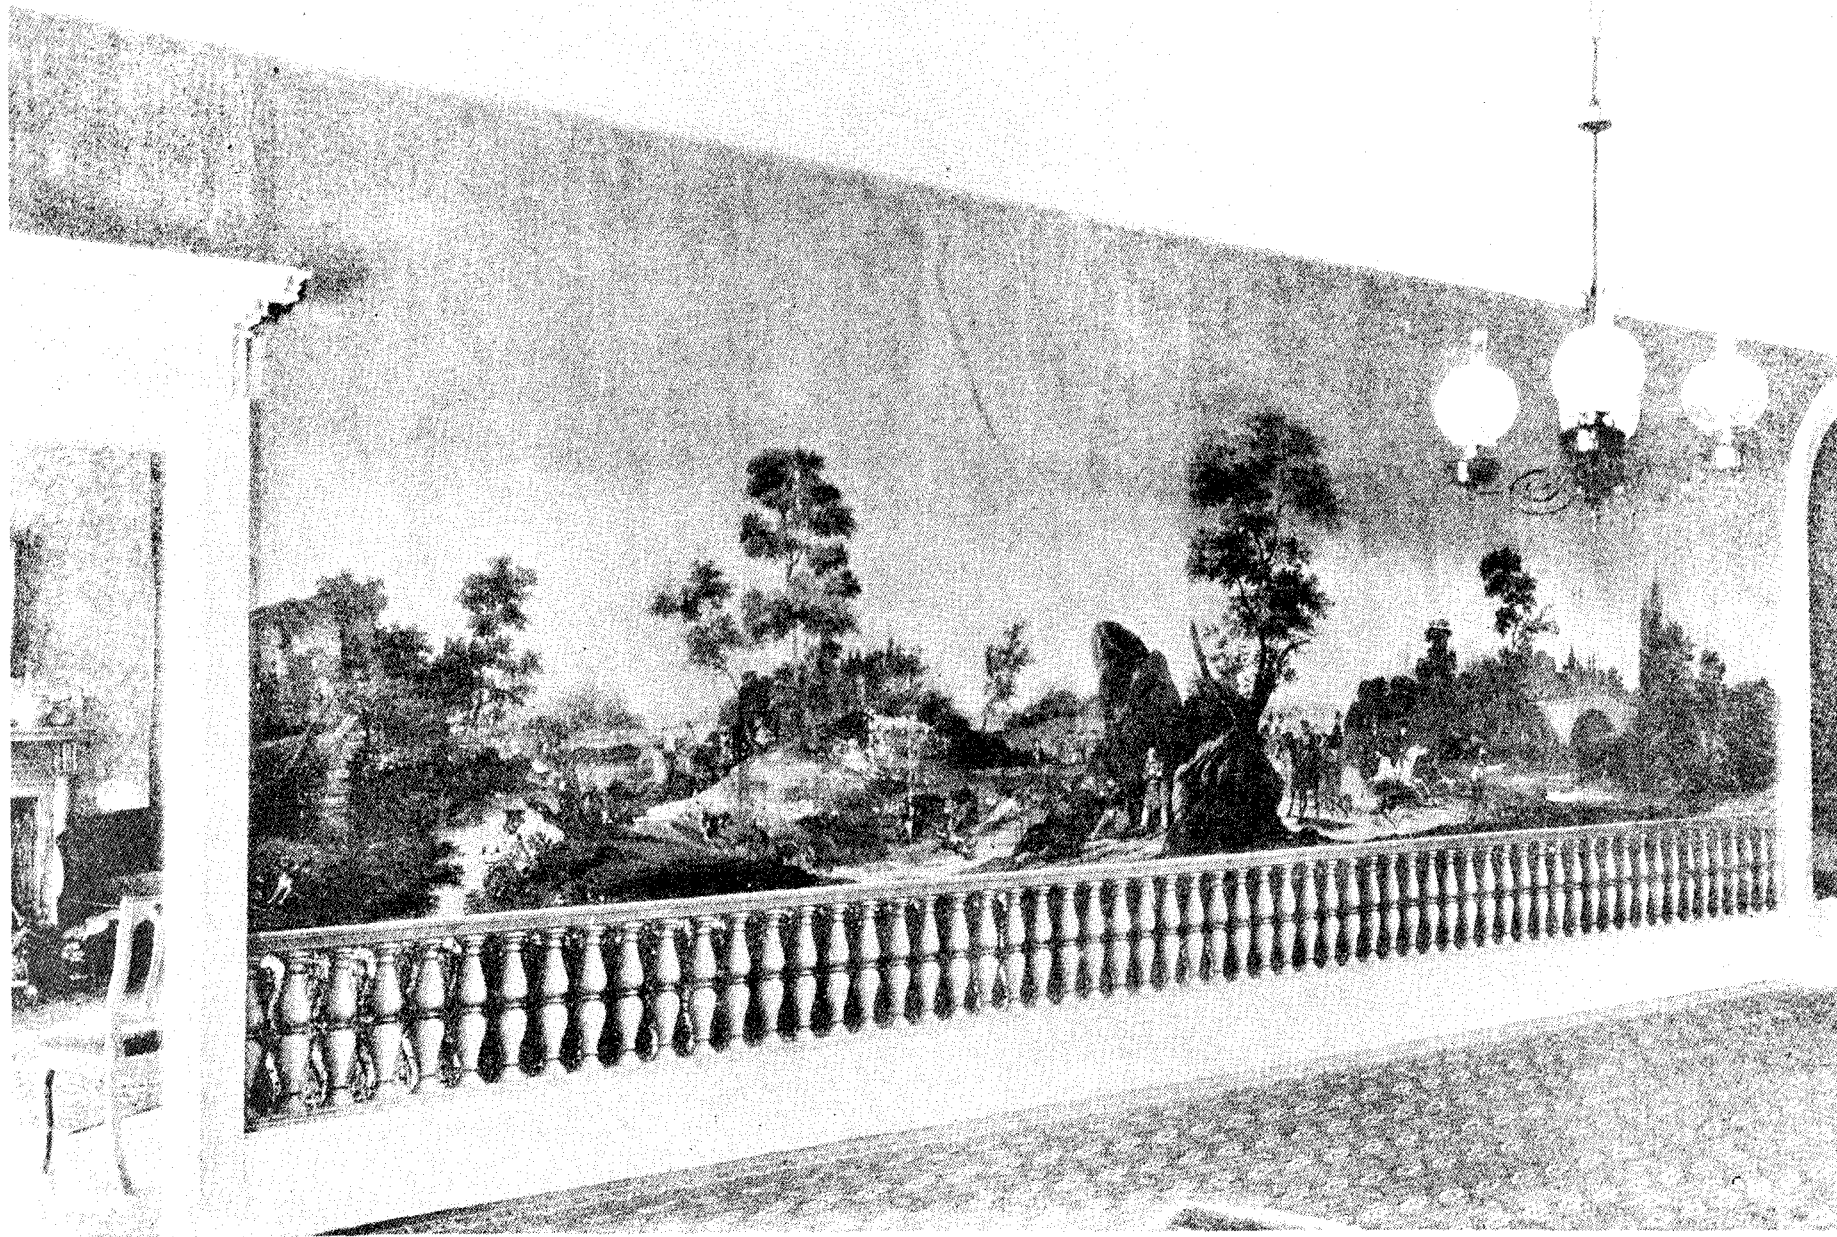
HP16. South Wall of Room 105, ca. 1924. This photograph was published in 1924 in Historic Wallpapers from their Inception to the Introduction of Machinery, by Nancy V. McClelland. Note particularly the glass shades on the kerosene chandelier and the absence of the bell pull wire that appears in HP13.
