historic structure report
architectural data section
volume 2: appendixes

MARTIN VAN BUREN

NATIONAL HISTORIC SITE / NEW YORK

LINDENWALD

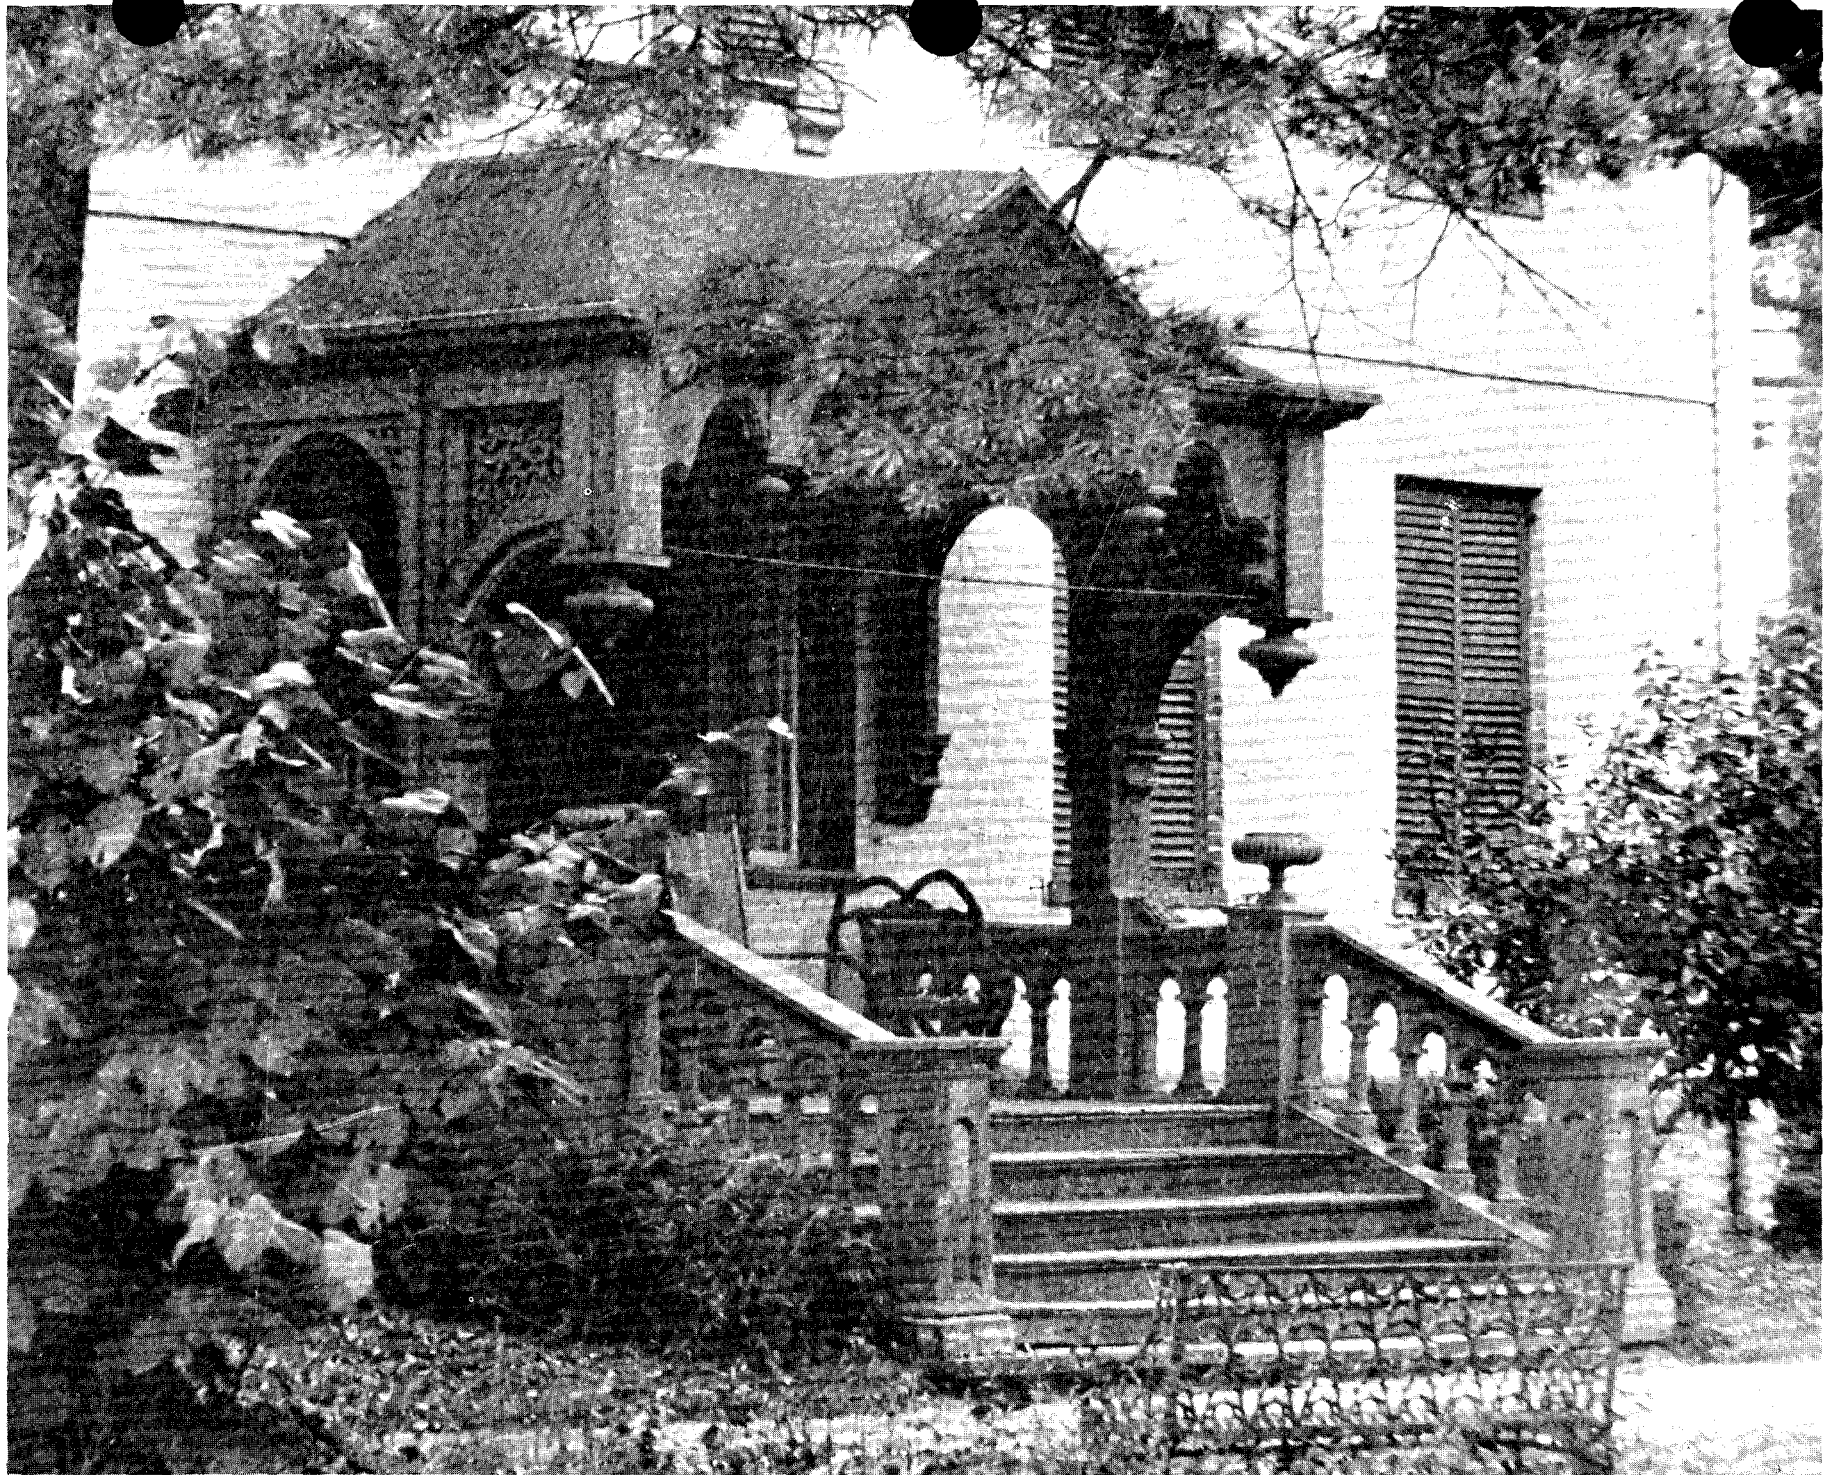
HP19. This photograph is a detail of HP18.

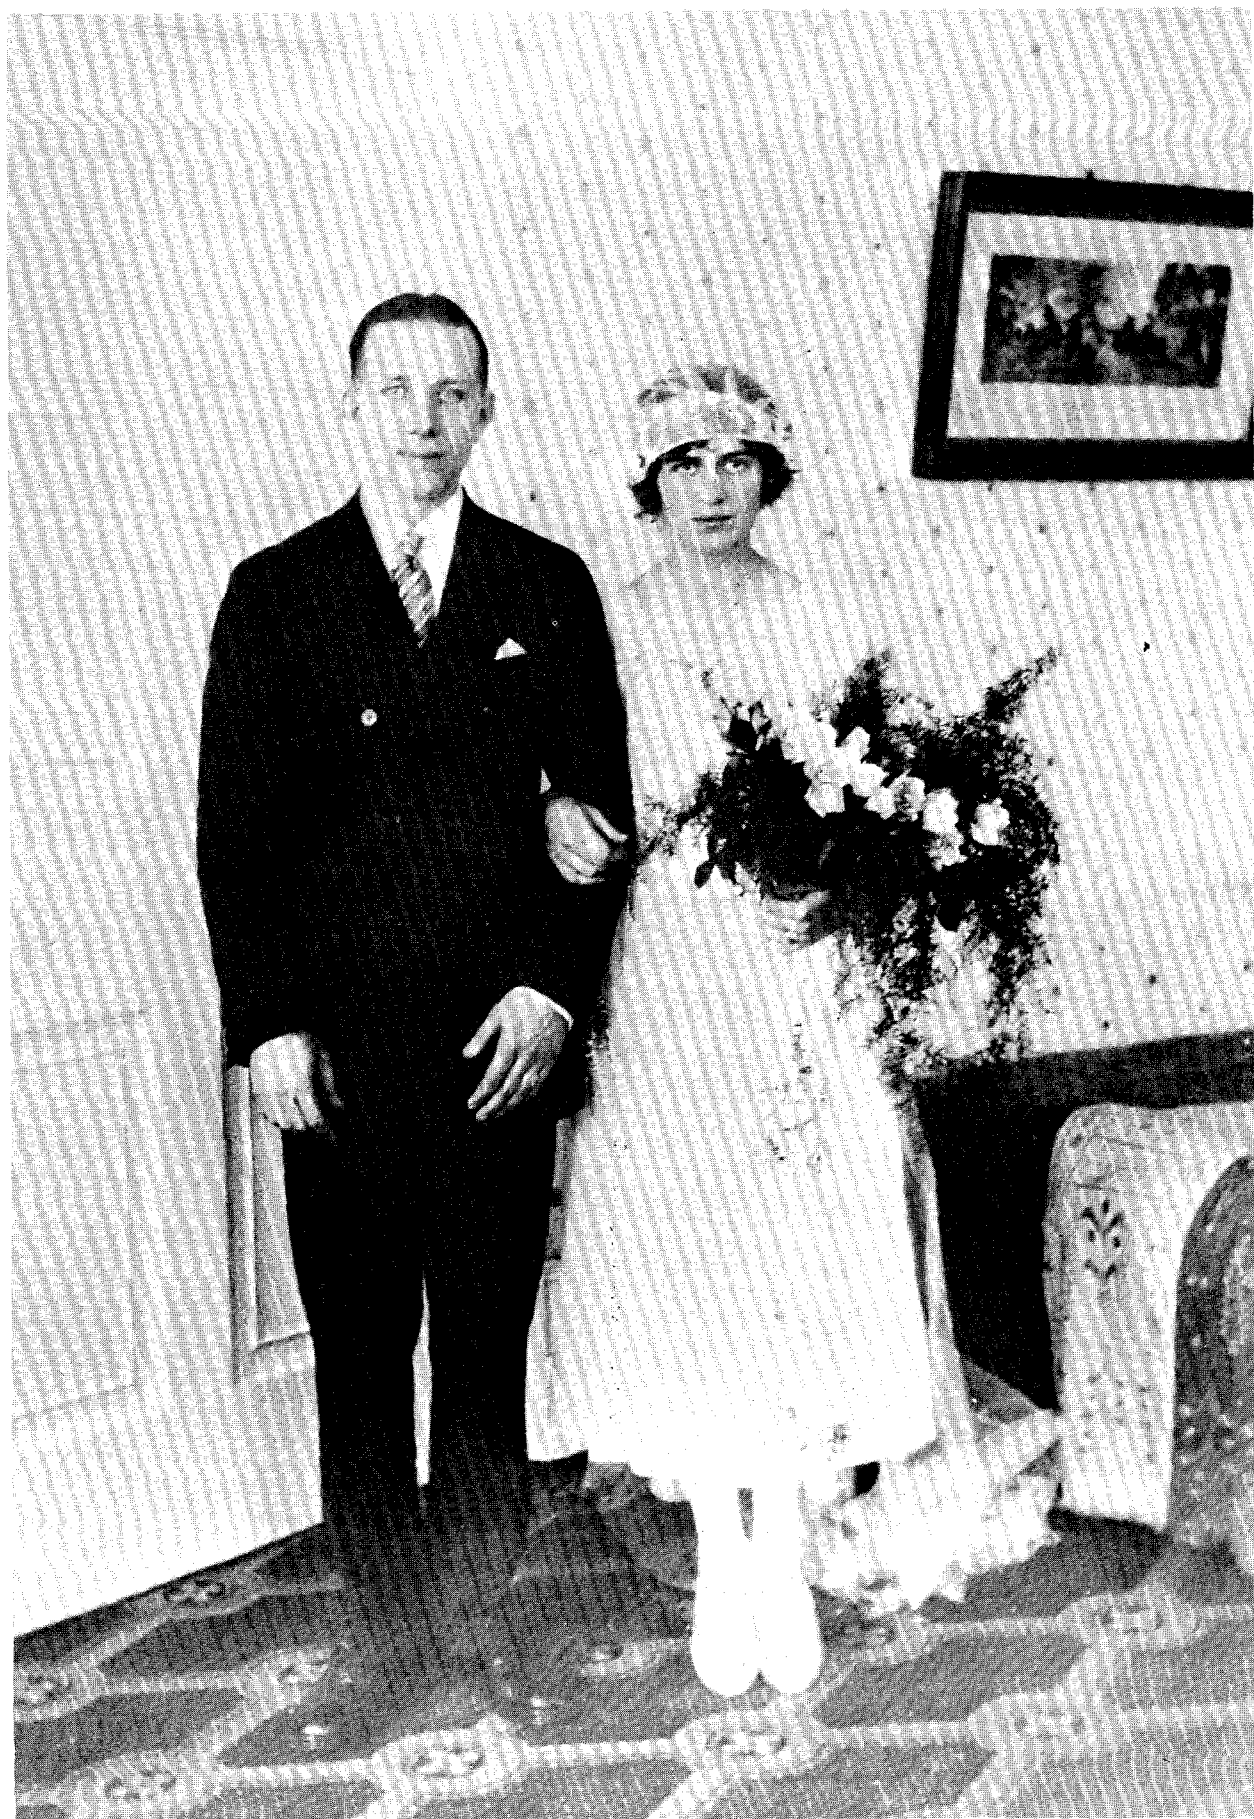
HP21. Clementine Birney and William DeProsse in Room 104, 1925. This photograph was taken at the time of their wedding in 1925. The background is the south wall of the room and door 102. Note the white-painted woodwork, the historic Brussels carpeting, the historic wallpaper, and the bed.

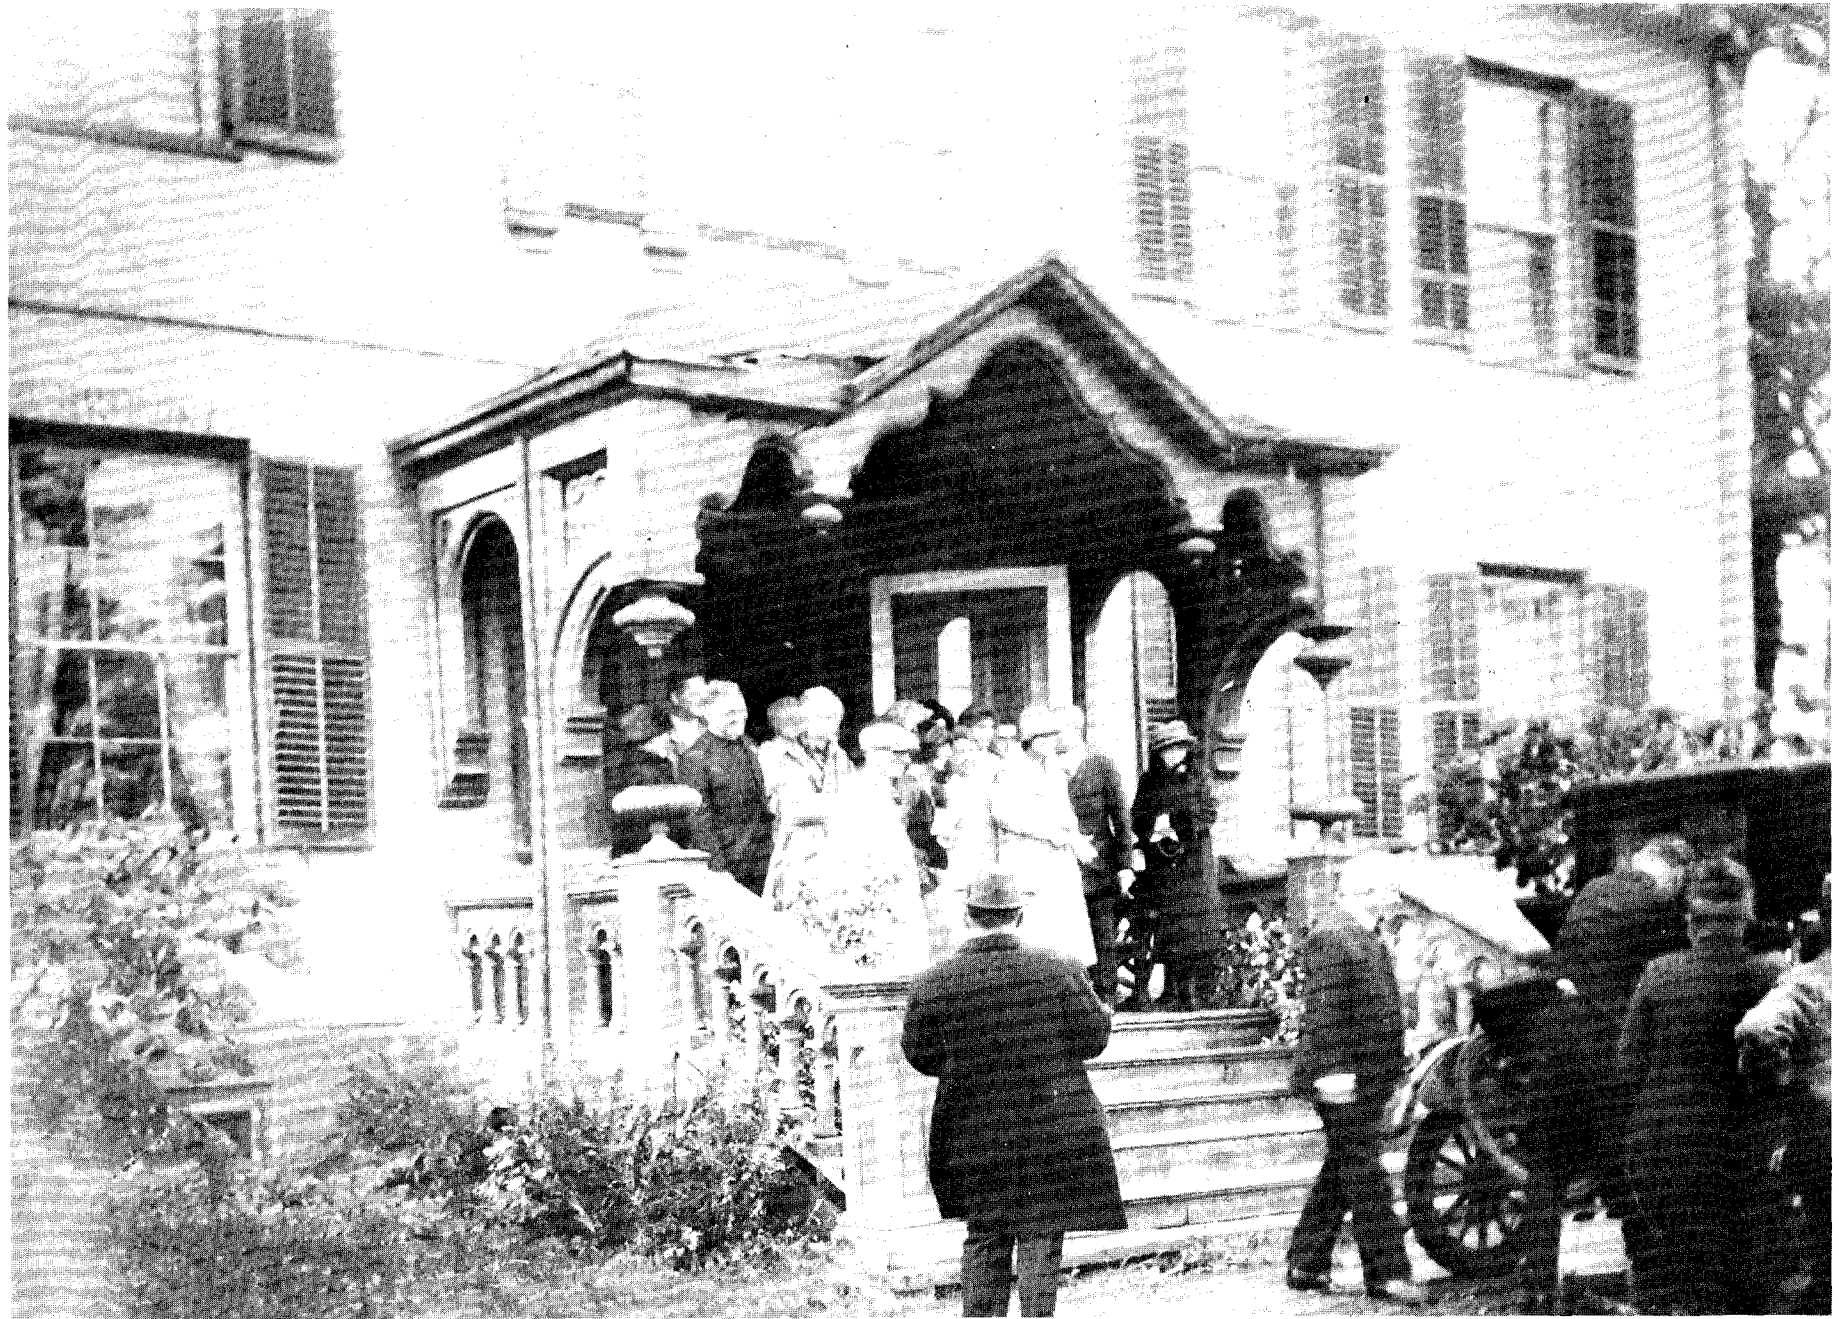
HP22. East Elevation of Lindenwald, 1925. This photograph was taken on the occasion of the Birney-DeProsse wedding. The following details should be noted:

There are no shutters on the Venetian window.

The northeast lightning rod is missing.

Brickwork, cornice, sash, and window frame reveals are painted a light tone. Foundations, front porch, and exterior faces of window frames are painted a dark tone. Shutters are painted an even darker tone.

There is a white-painted wooden screen door.

Ferns are growing along both sides of the front porch. The south hydrangea is about 6' tall and the north one is 8' to 9' tall (comparable to HP18).

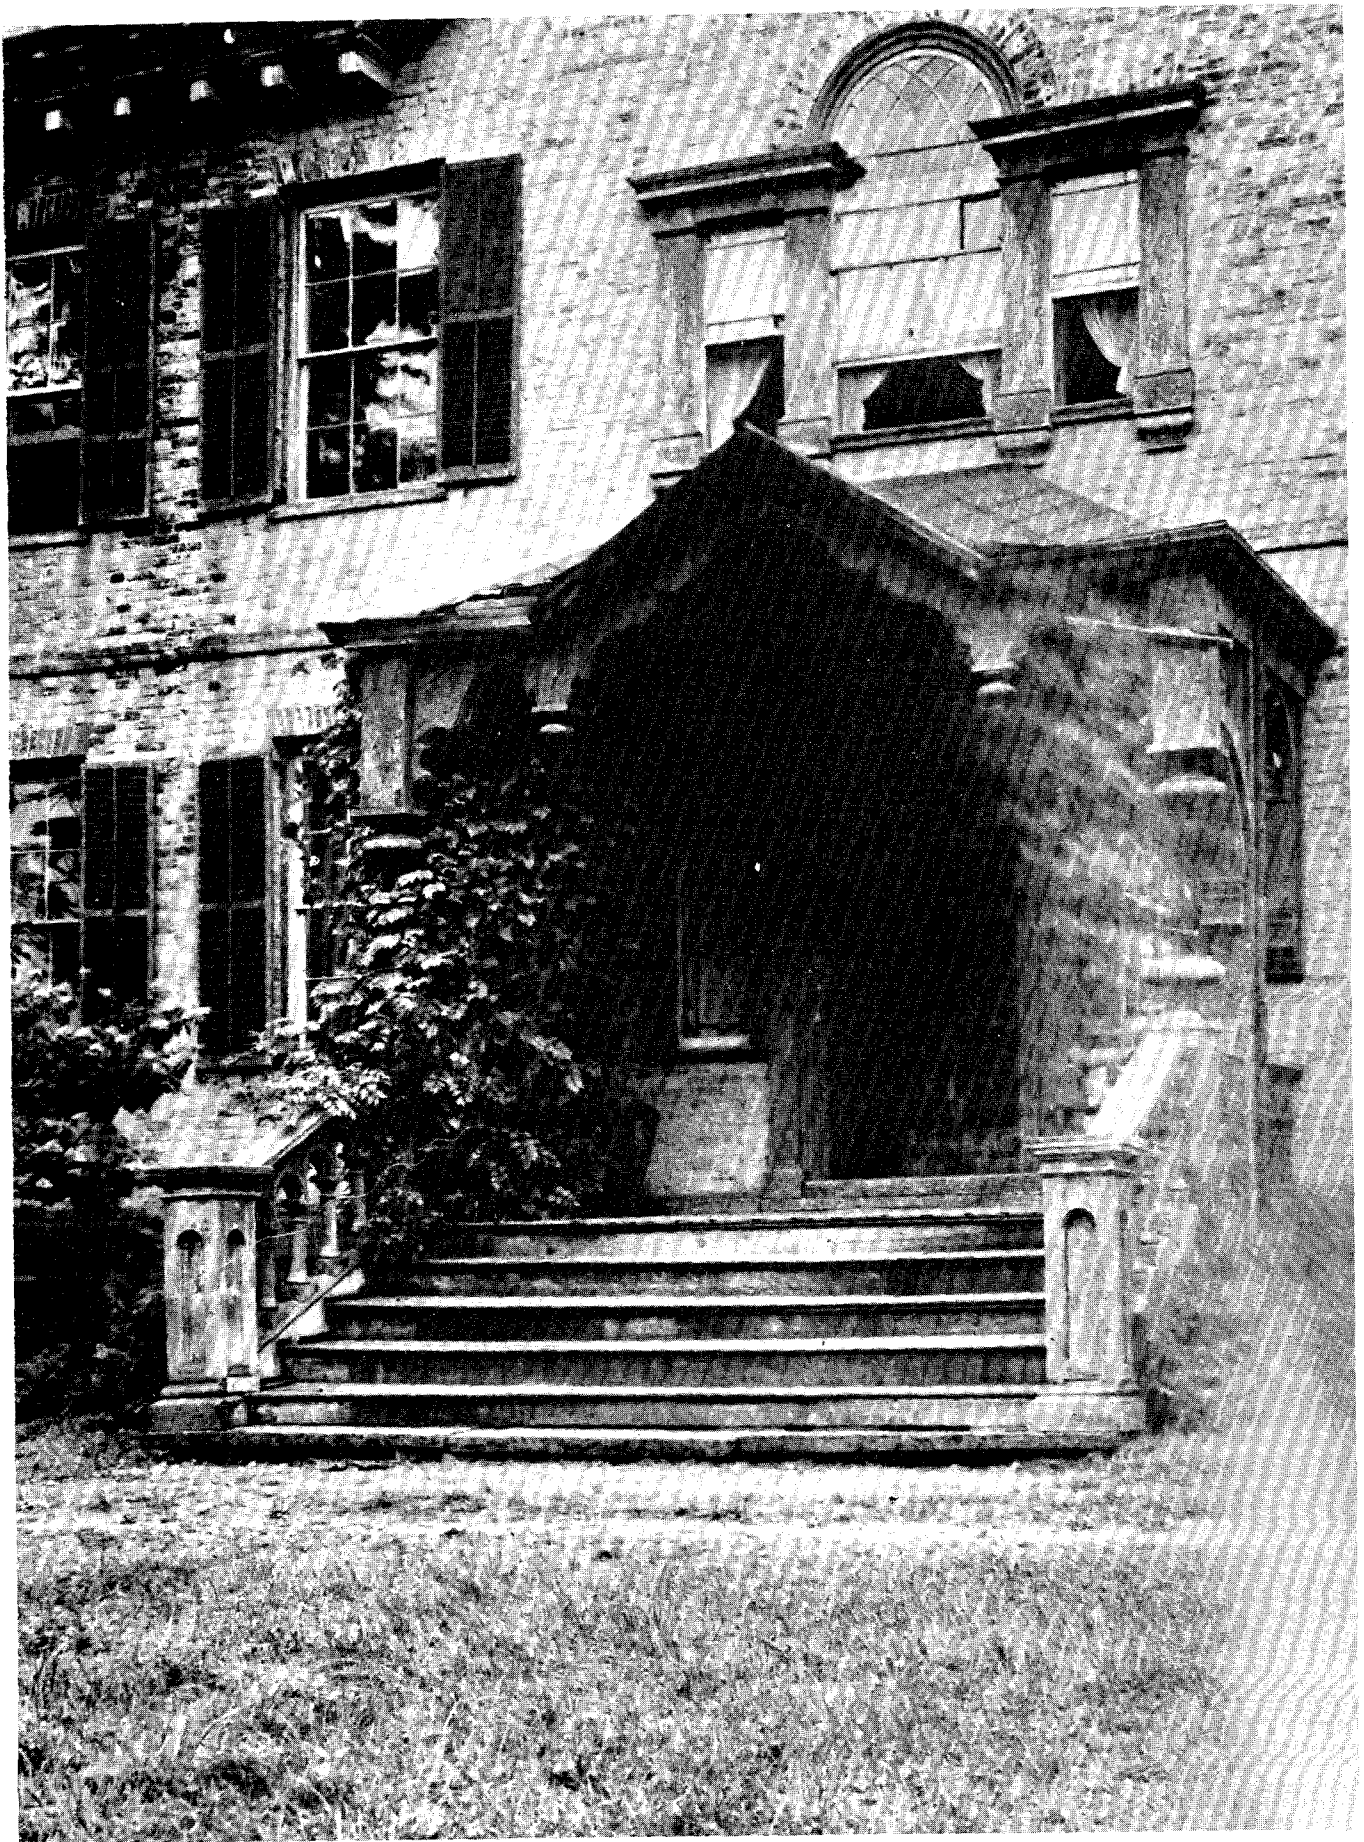
HP25. Ca. 1850 Front Porch, 1936. This photograph was taken by Melvin Weig on August 3, 1936. The following details should be noted:

rustic chairs

vine on south side of porch

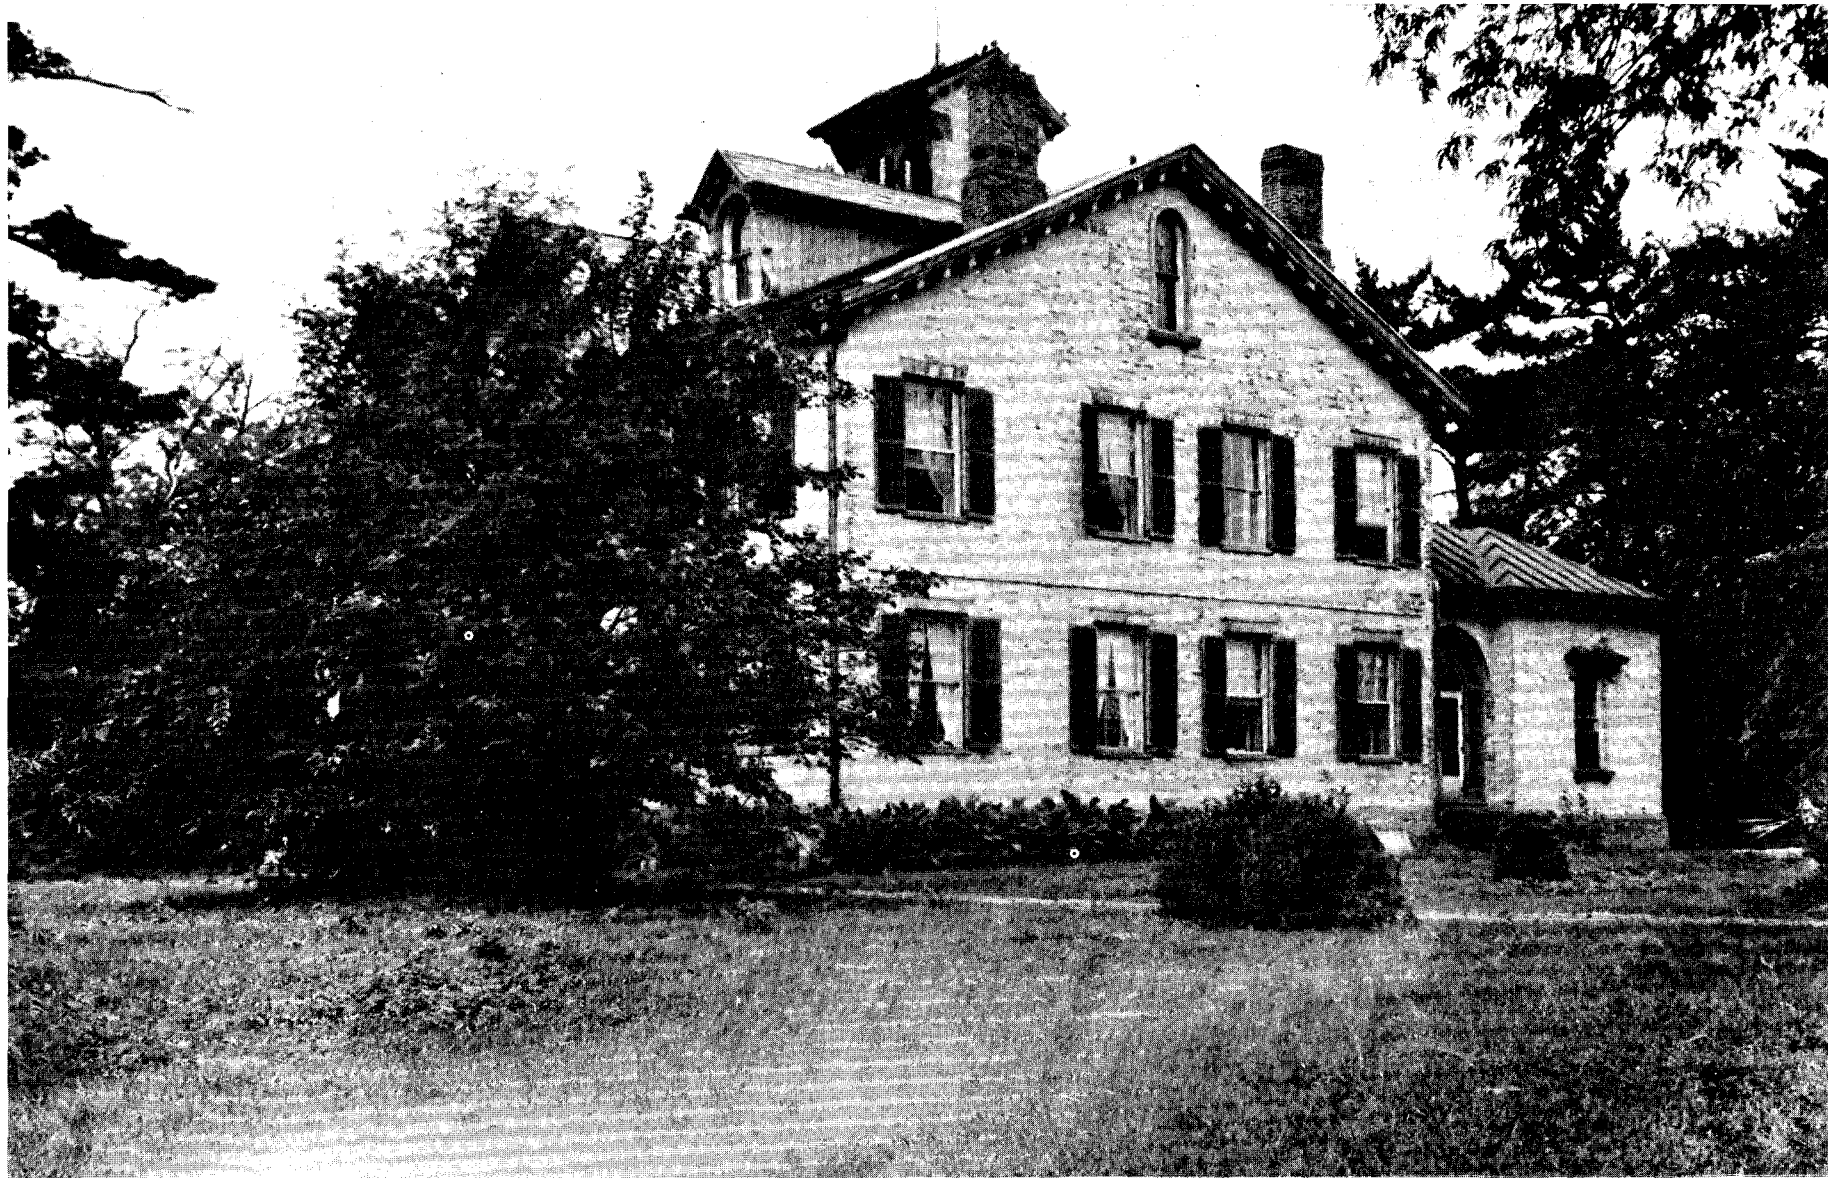
HP26. North Side of Lindenwald, 1936. This photograph was taken by Melvin Weig on August 3, 1936. The following details should be noted:

There is new flashing on the north gable capping board and a rainwater diverter at east end.

The paint scheme is the same as that observed in HP23.

The brick coursing on northeast and northwest chimneys above the stone water table consists of five courses to the tops of the stone corbels (ledges), twelve straight courses, and a five-course corbeled cap.

The ferns adjacent to the north wall are 3' to 3' 6" high.

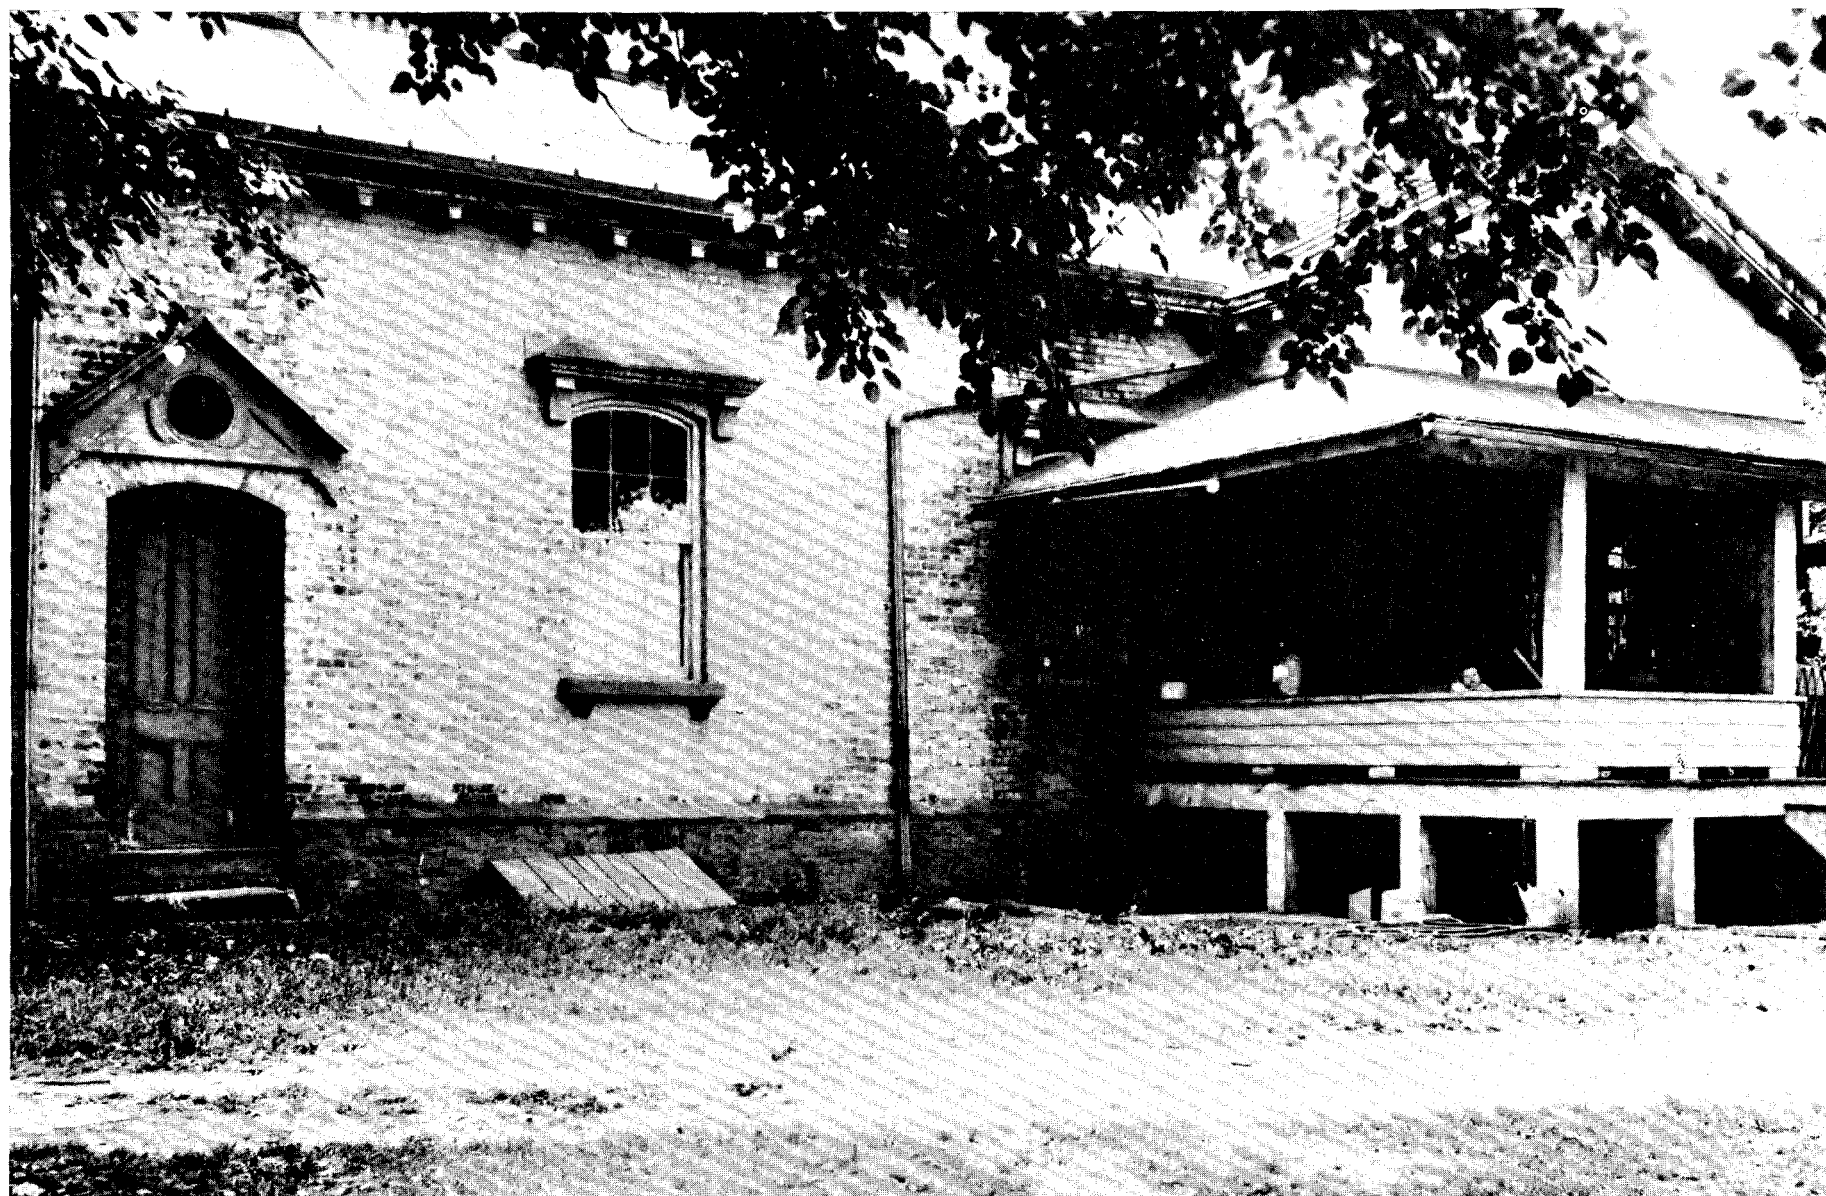
HP28. Lindenwald, West Elevation, 1936. This photograph was taken by Melvin Weig on August 3, 1936. The following details should be noted:

There are modillions on the skylight cornice.

There are steps at door 112.

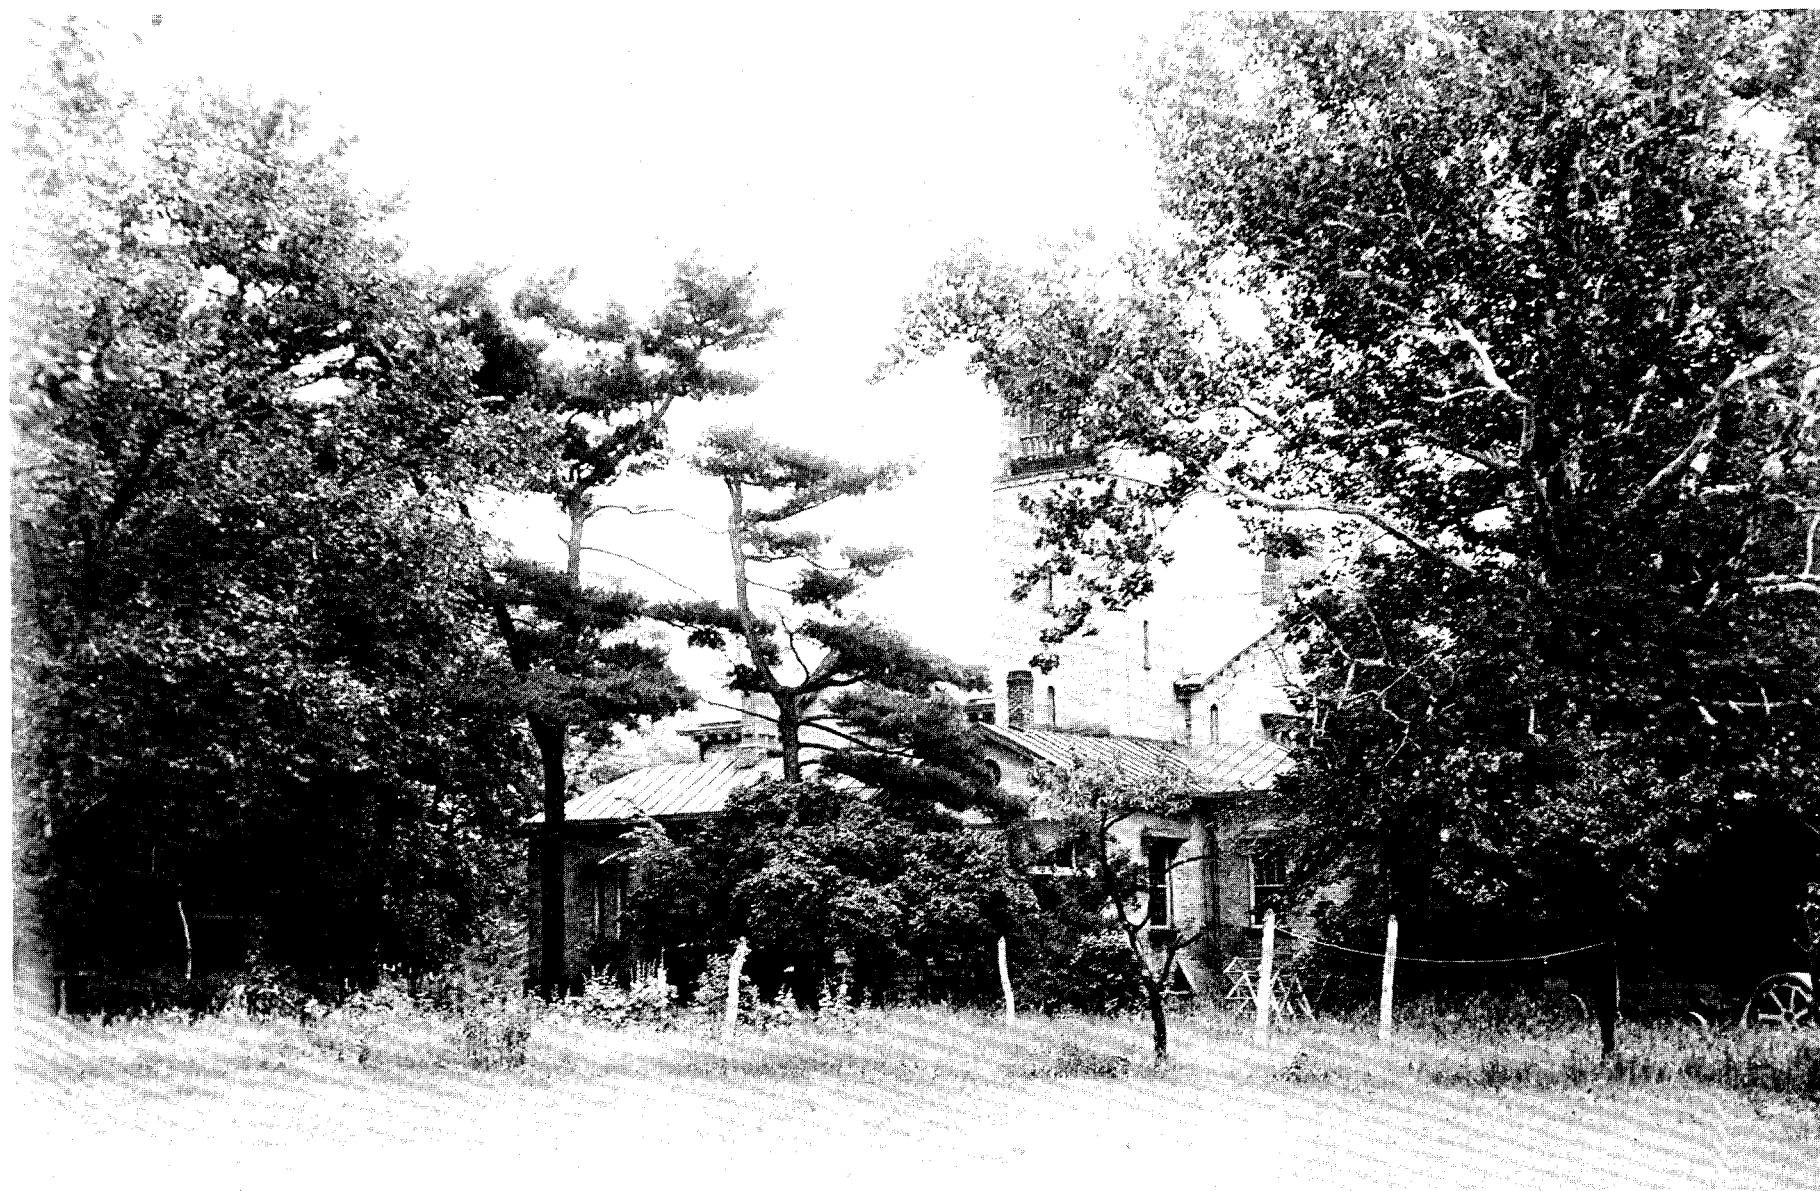
HP29. Lindenwald from the Southwest, 1936. This view was taken by
Melvin Weig on August 3, 1936. The following details should be noted:

outbuilding in deep shade at left side of photograph

paint scheme and condition

farming equipment at right side of photograph

clothes-drying rack

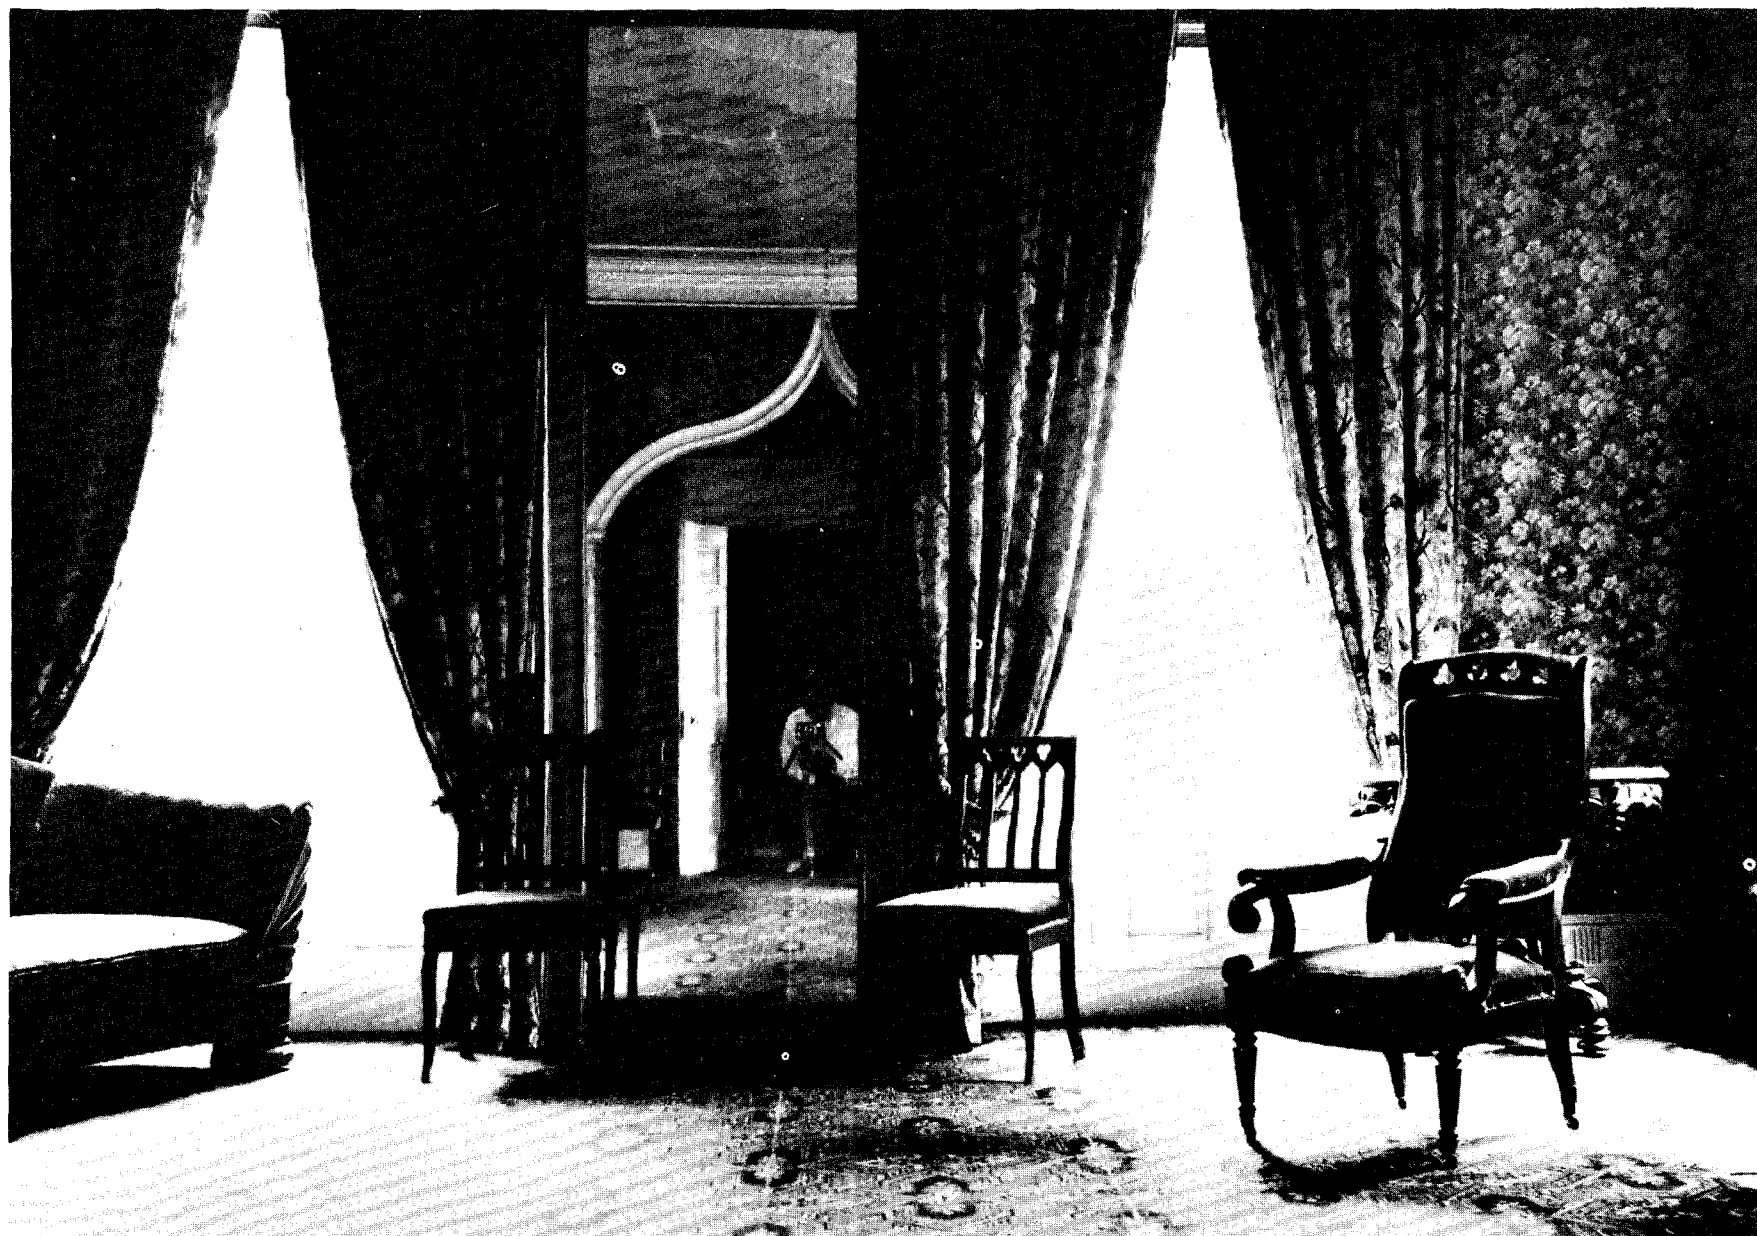
HP30. East Wall of Room 106, 1936. This photograph was taken by
Melvin Weig on August 3, 1936. The following details should be noted:

Brussels carpeting

furniture

condition of plaster ceiling

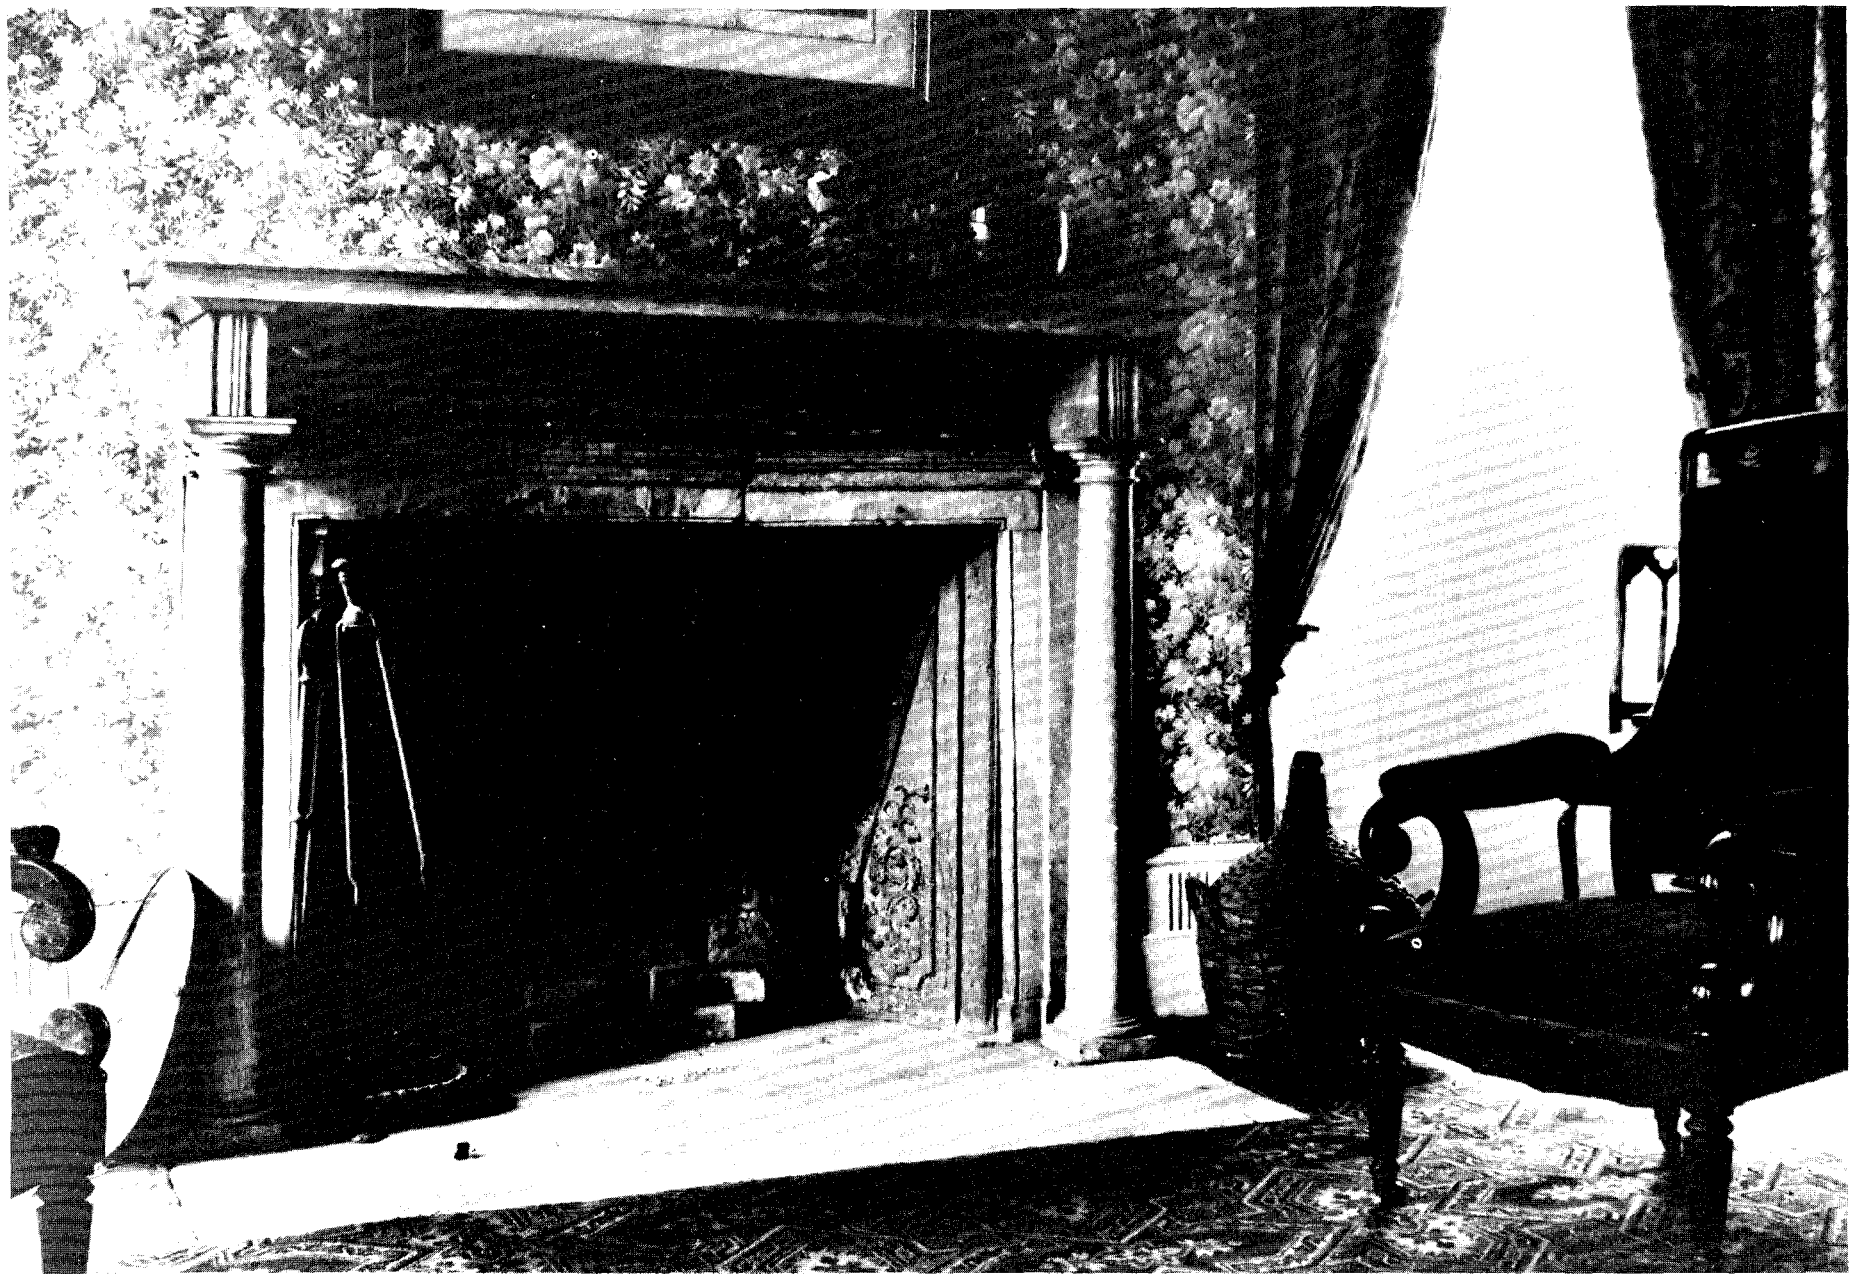
HP31. Fireplace and Part of the South Wall of Room 106, 1936. This photograph was taken by Melvin Weig on August 3, 1936. The following details should be noted:

Brussels carpeting

draperies

furniture
