historic structure report
architectural data section
volume 2: appendixes

MARTIN VAN BUREN

NATIONAL HISTORIC SITE / NEW YORK

LINDENWALD

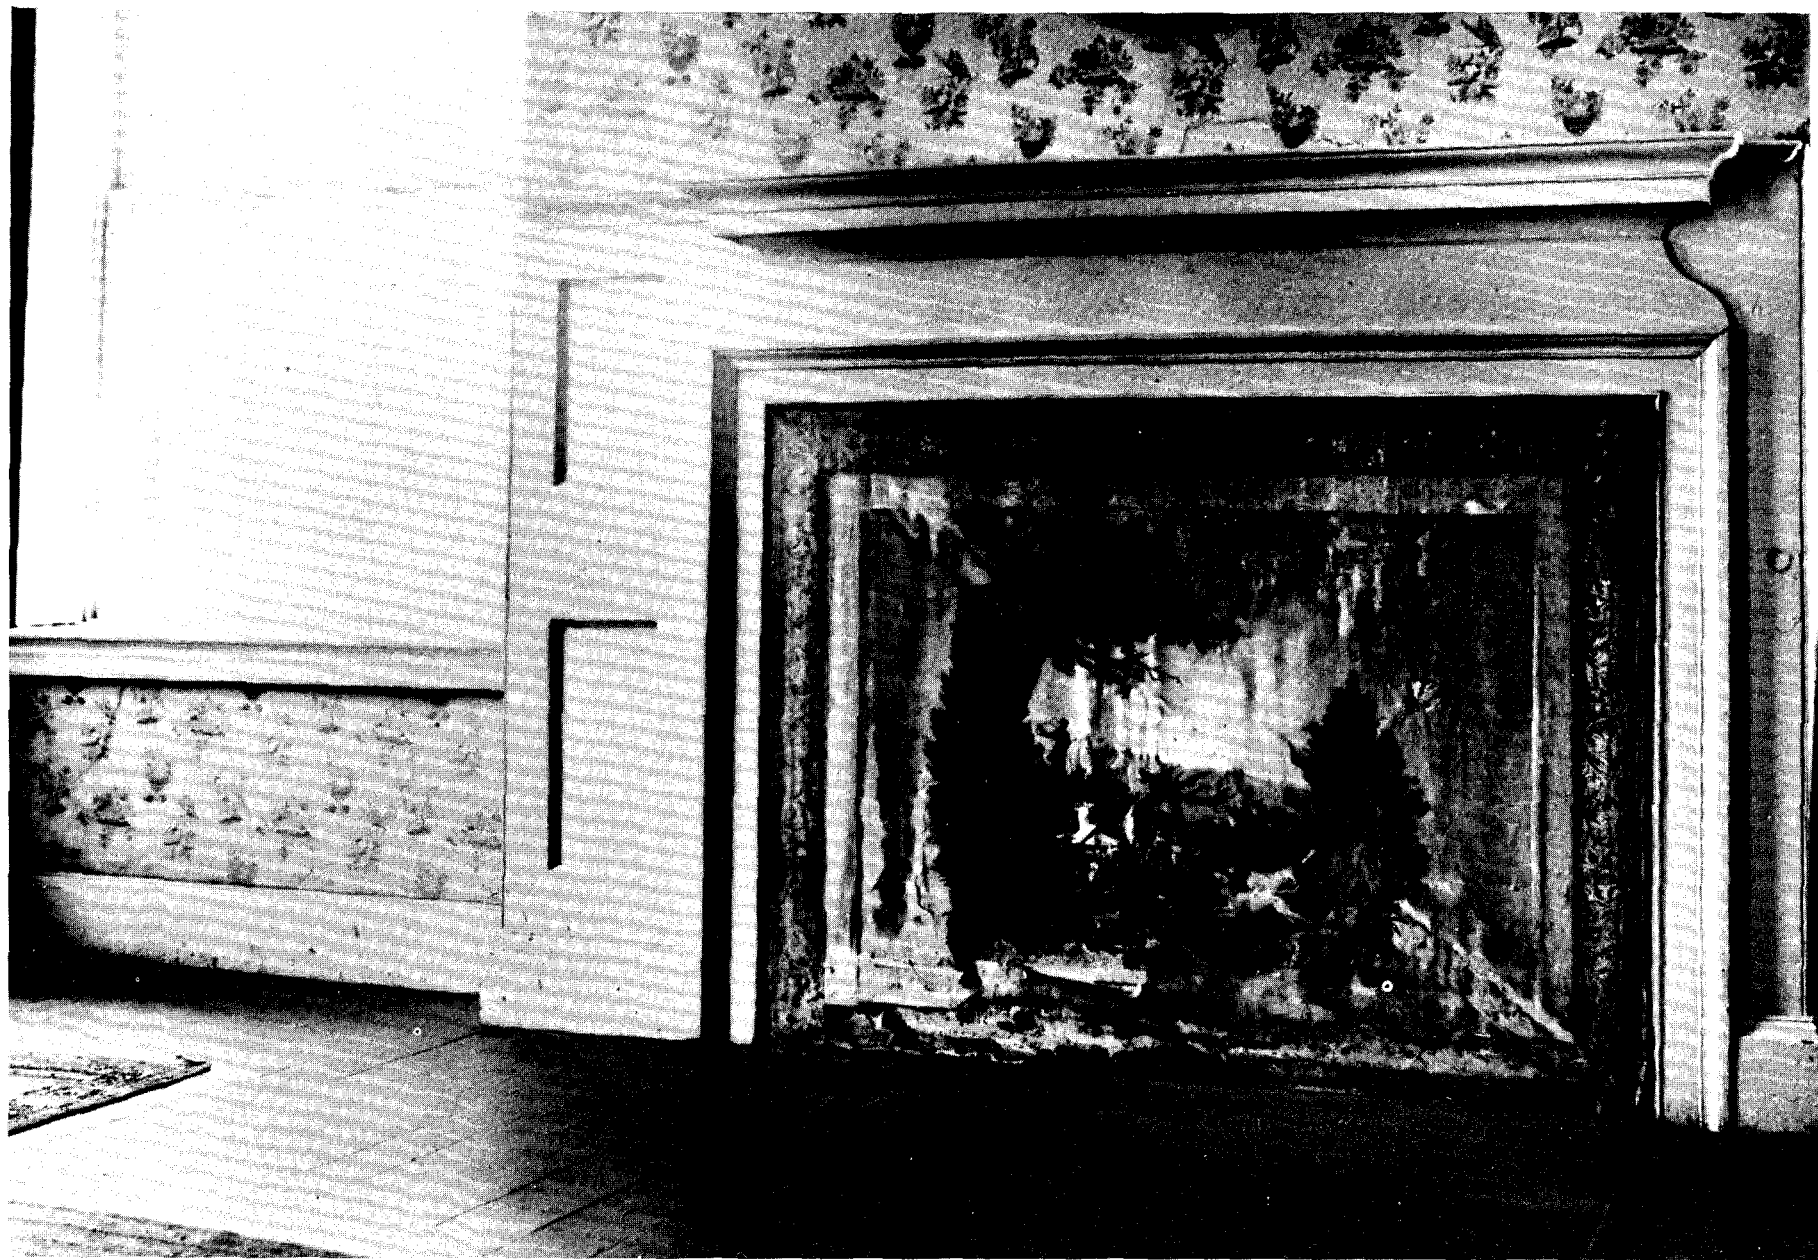
HP32. Fireplace and Part of South Wall of Room 209, 1936. This photograph was taken on August 3, 1936, by Melvin Weig. The following details should be noted:

The wallpaper is probably not historic.

The fireboard has a stag hunt scene with a foliate border.

The floor covering seems to consist of oriental rugs.

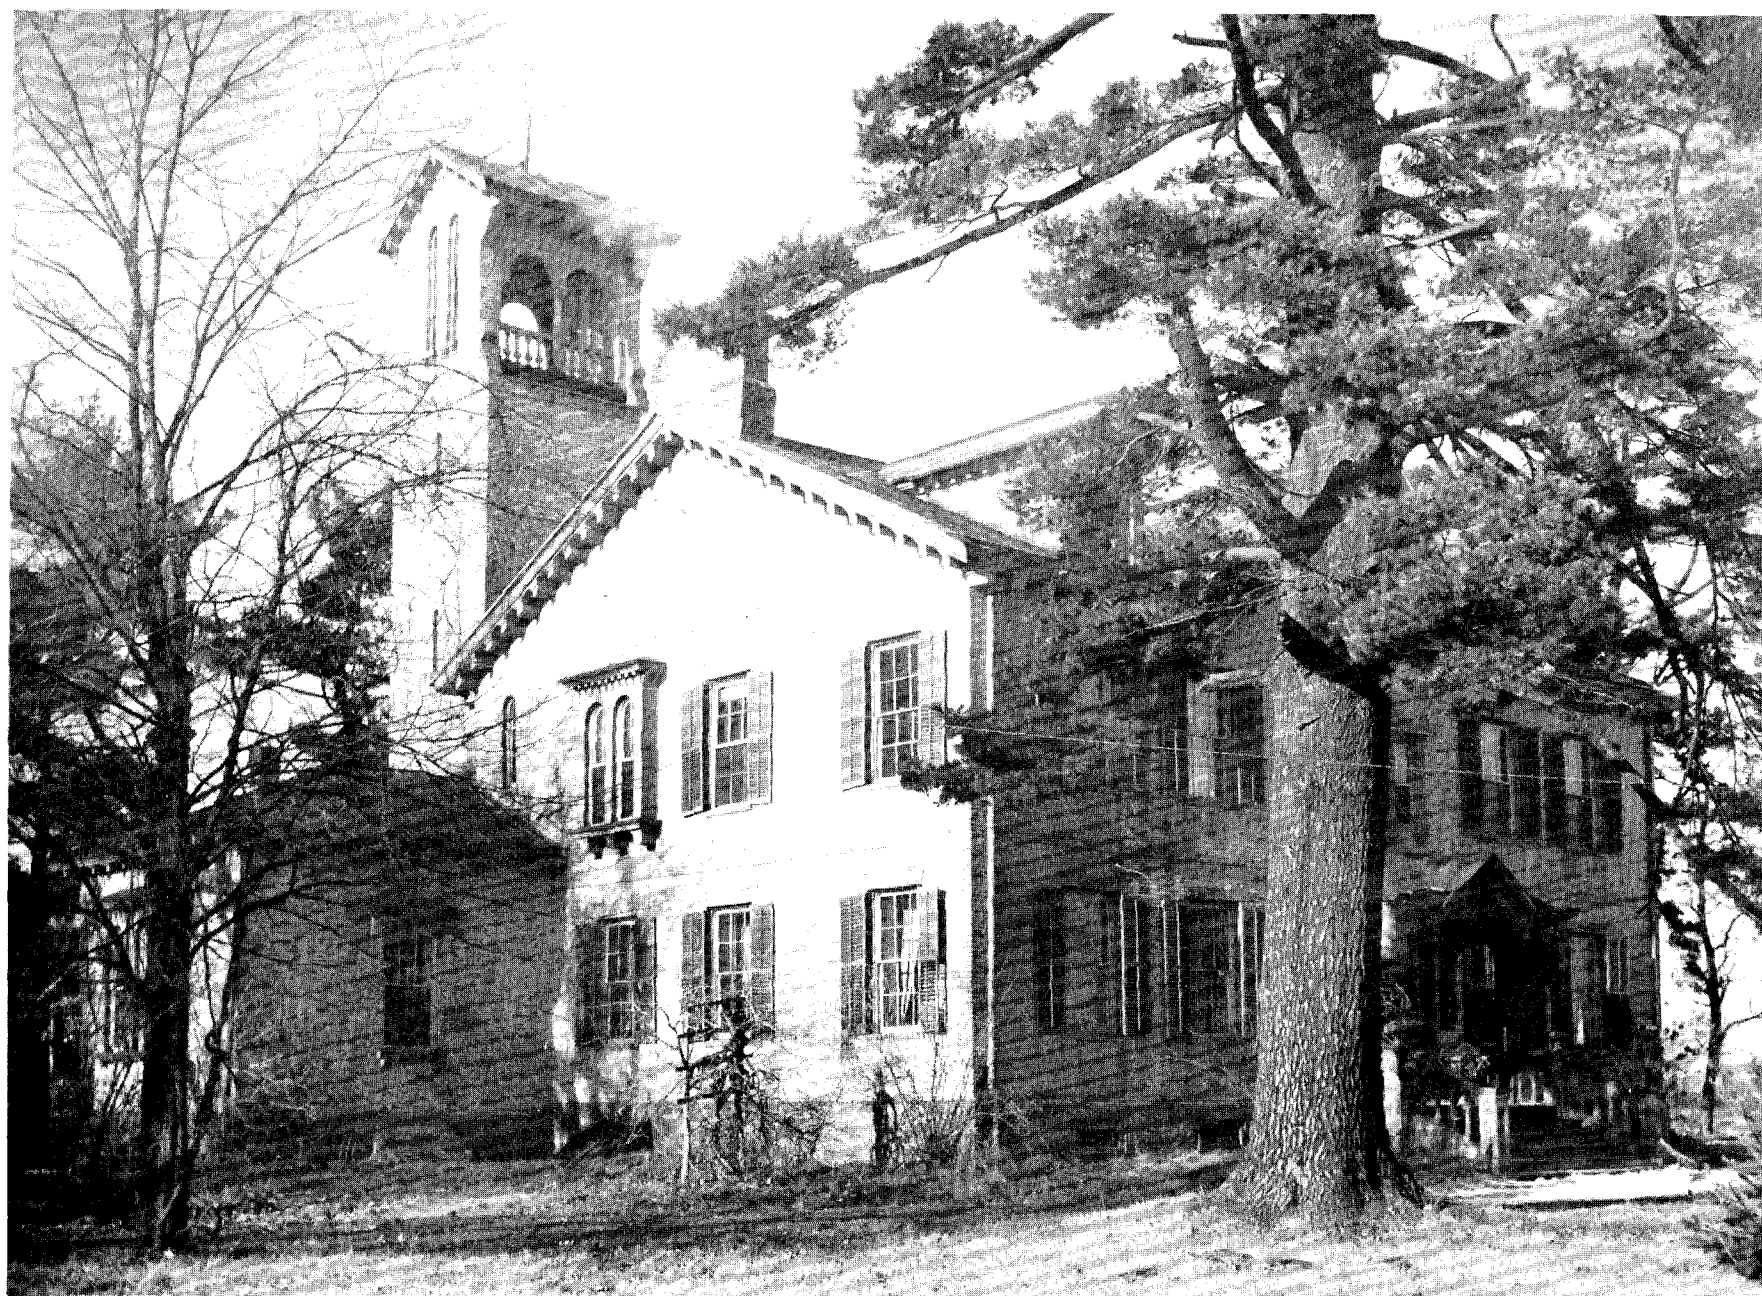
HP33. Lindenwald, 1937. This and the three following photographs were taken by Historic American Buildings Survey photographer Nelson E. Baldwin in January 1937. The following details should be noted:

electrical wire (separated from insulator on tree trunk)

paint scheme and condition (comparable to Melvin Weig's photographs)

loose bricks over window 127

lack of shutters on Venetian window

twelve brick courses above the stone water table on the south chimney and a five-course corbeled cap

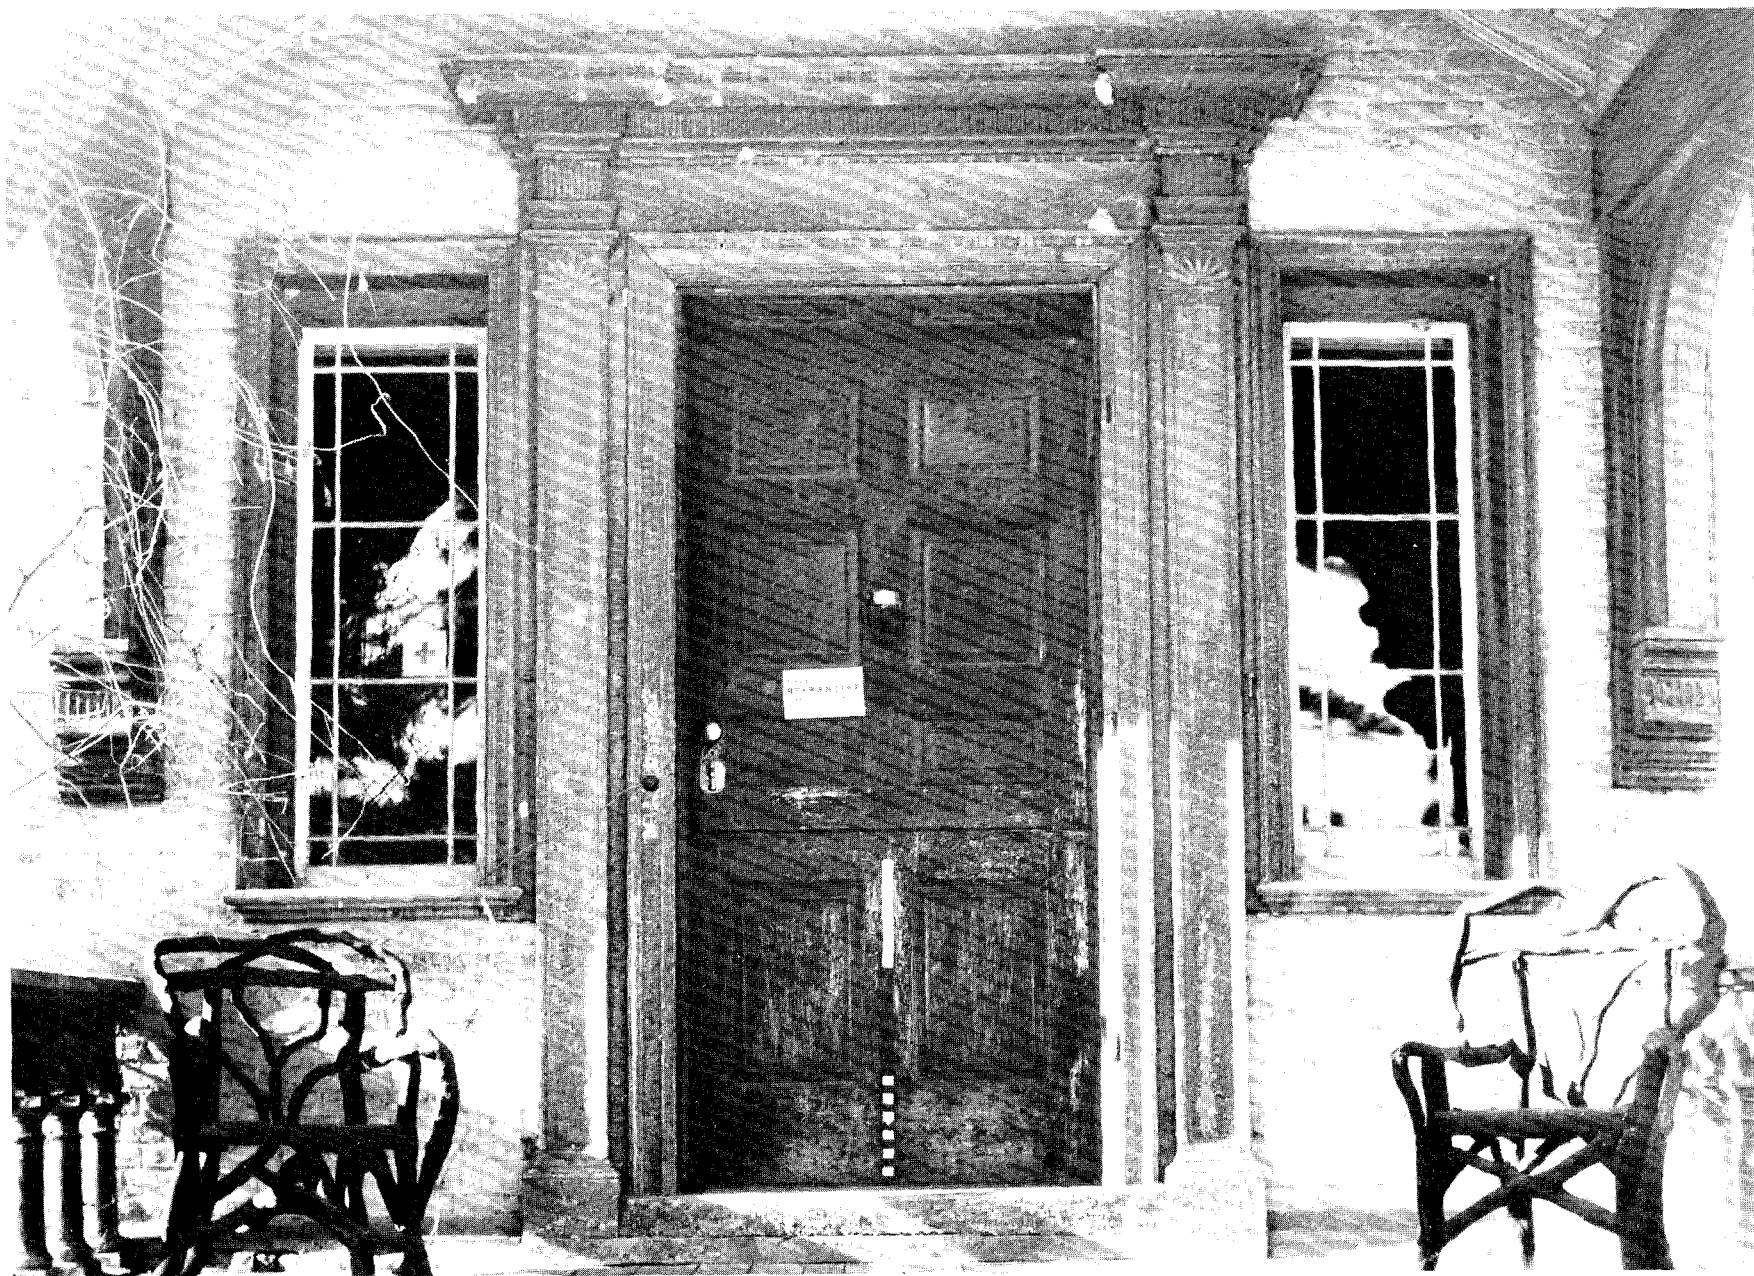
HP35. Front Door of Lindenwald (Door 101), 1937. This photograph was taken by Nelson Baldwin in January 1937. The following details should be noted:

There are rustic chairs on the porch.

There are stuccoed areas over windows 103 and 104.

Vines are growing on the south side of the porch.

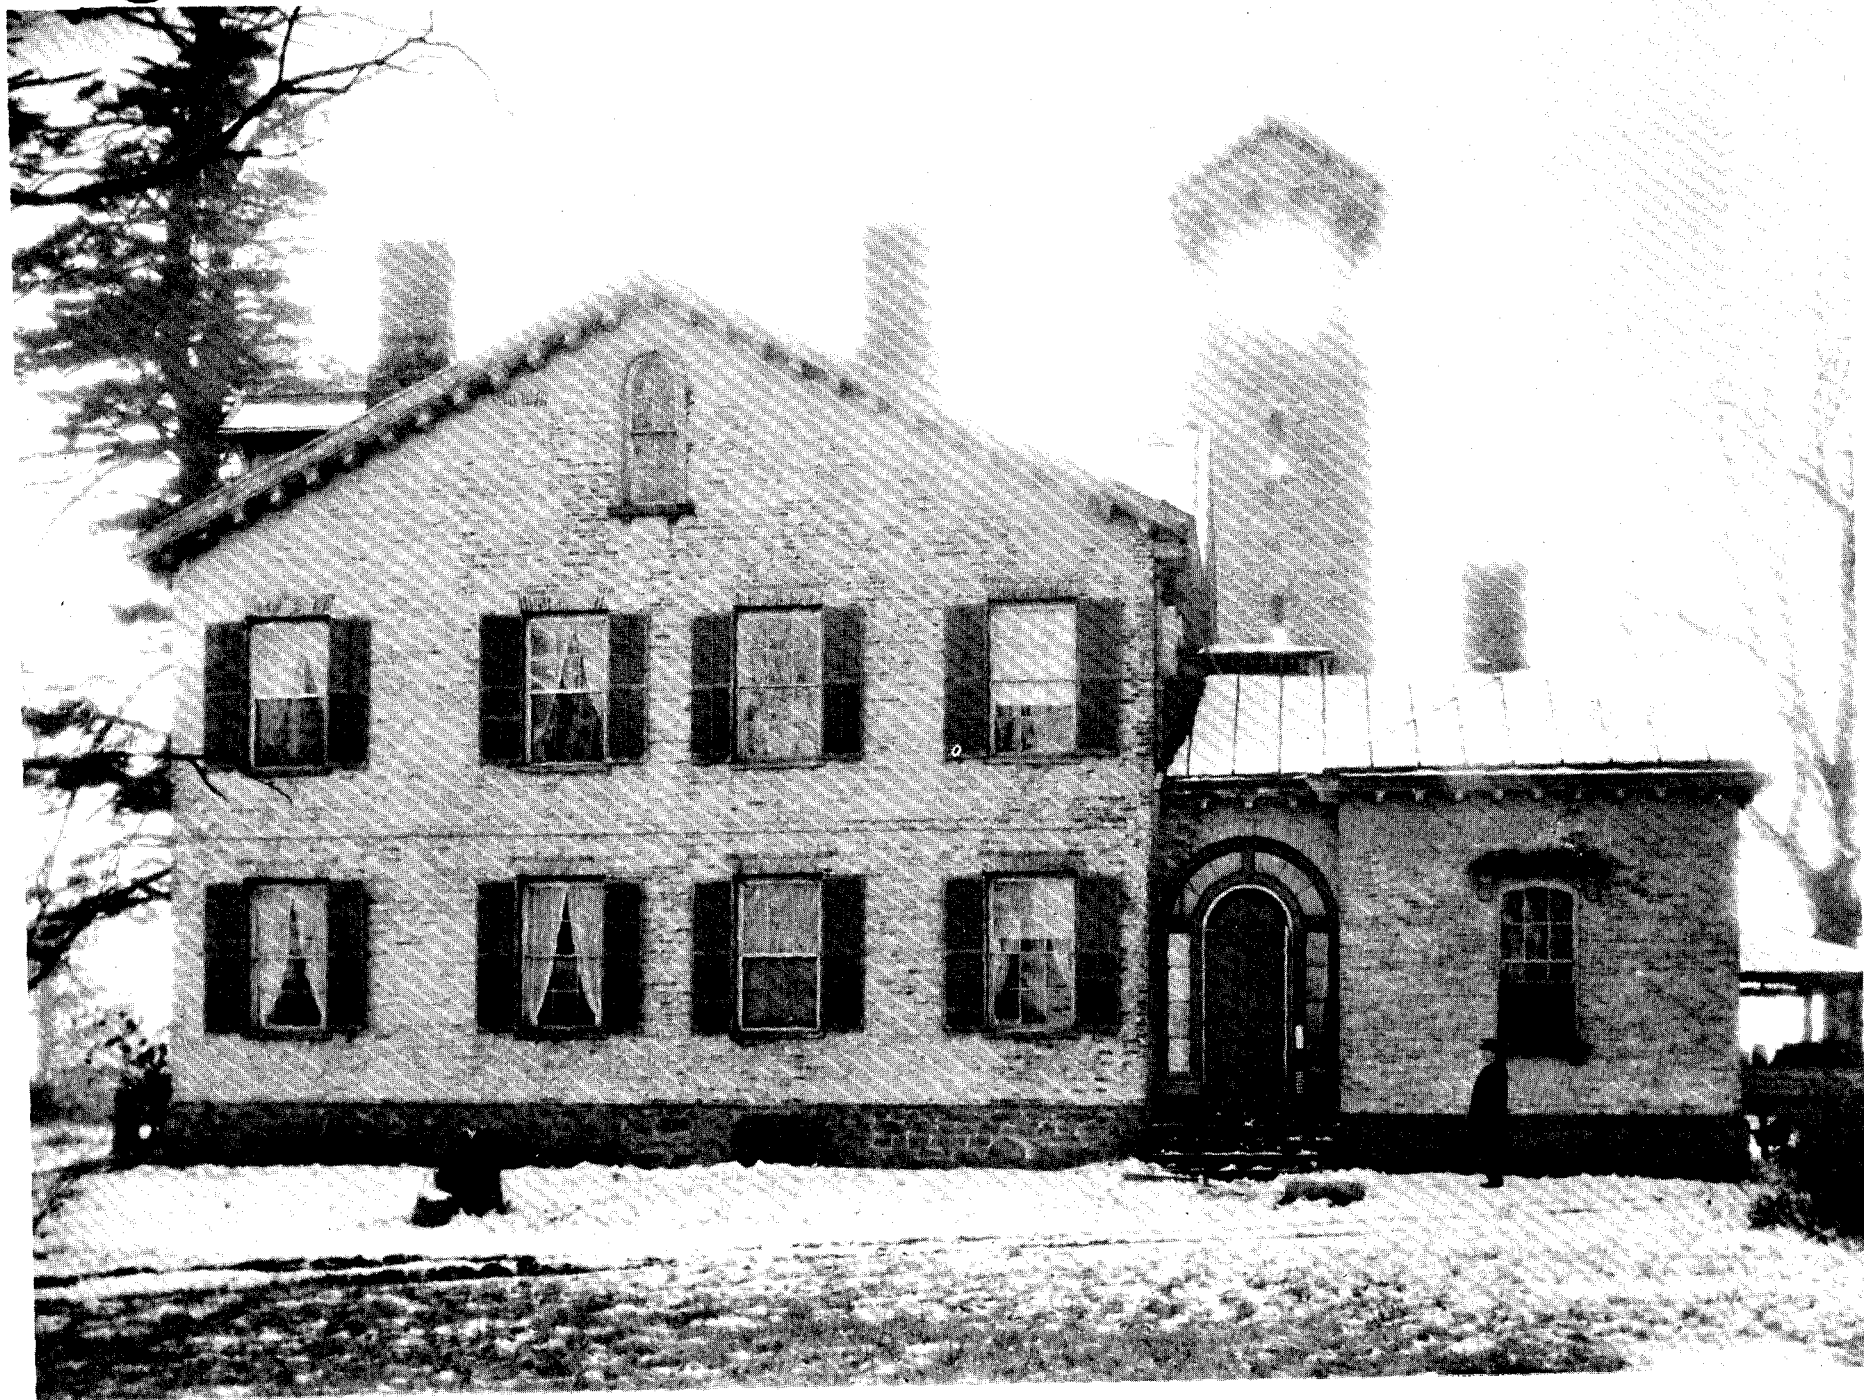
HP36. North Elevation of Lindenwald, 1937. This photograph was taken by Nelson Baldwin in January 1937. The following details should be noted:

The paint scheme is the same as in HP33.

Remnants of ferns are present at the east end of the north foundation wall.

There is a cover over window 007.

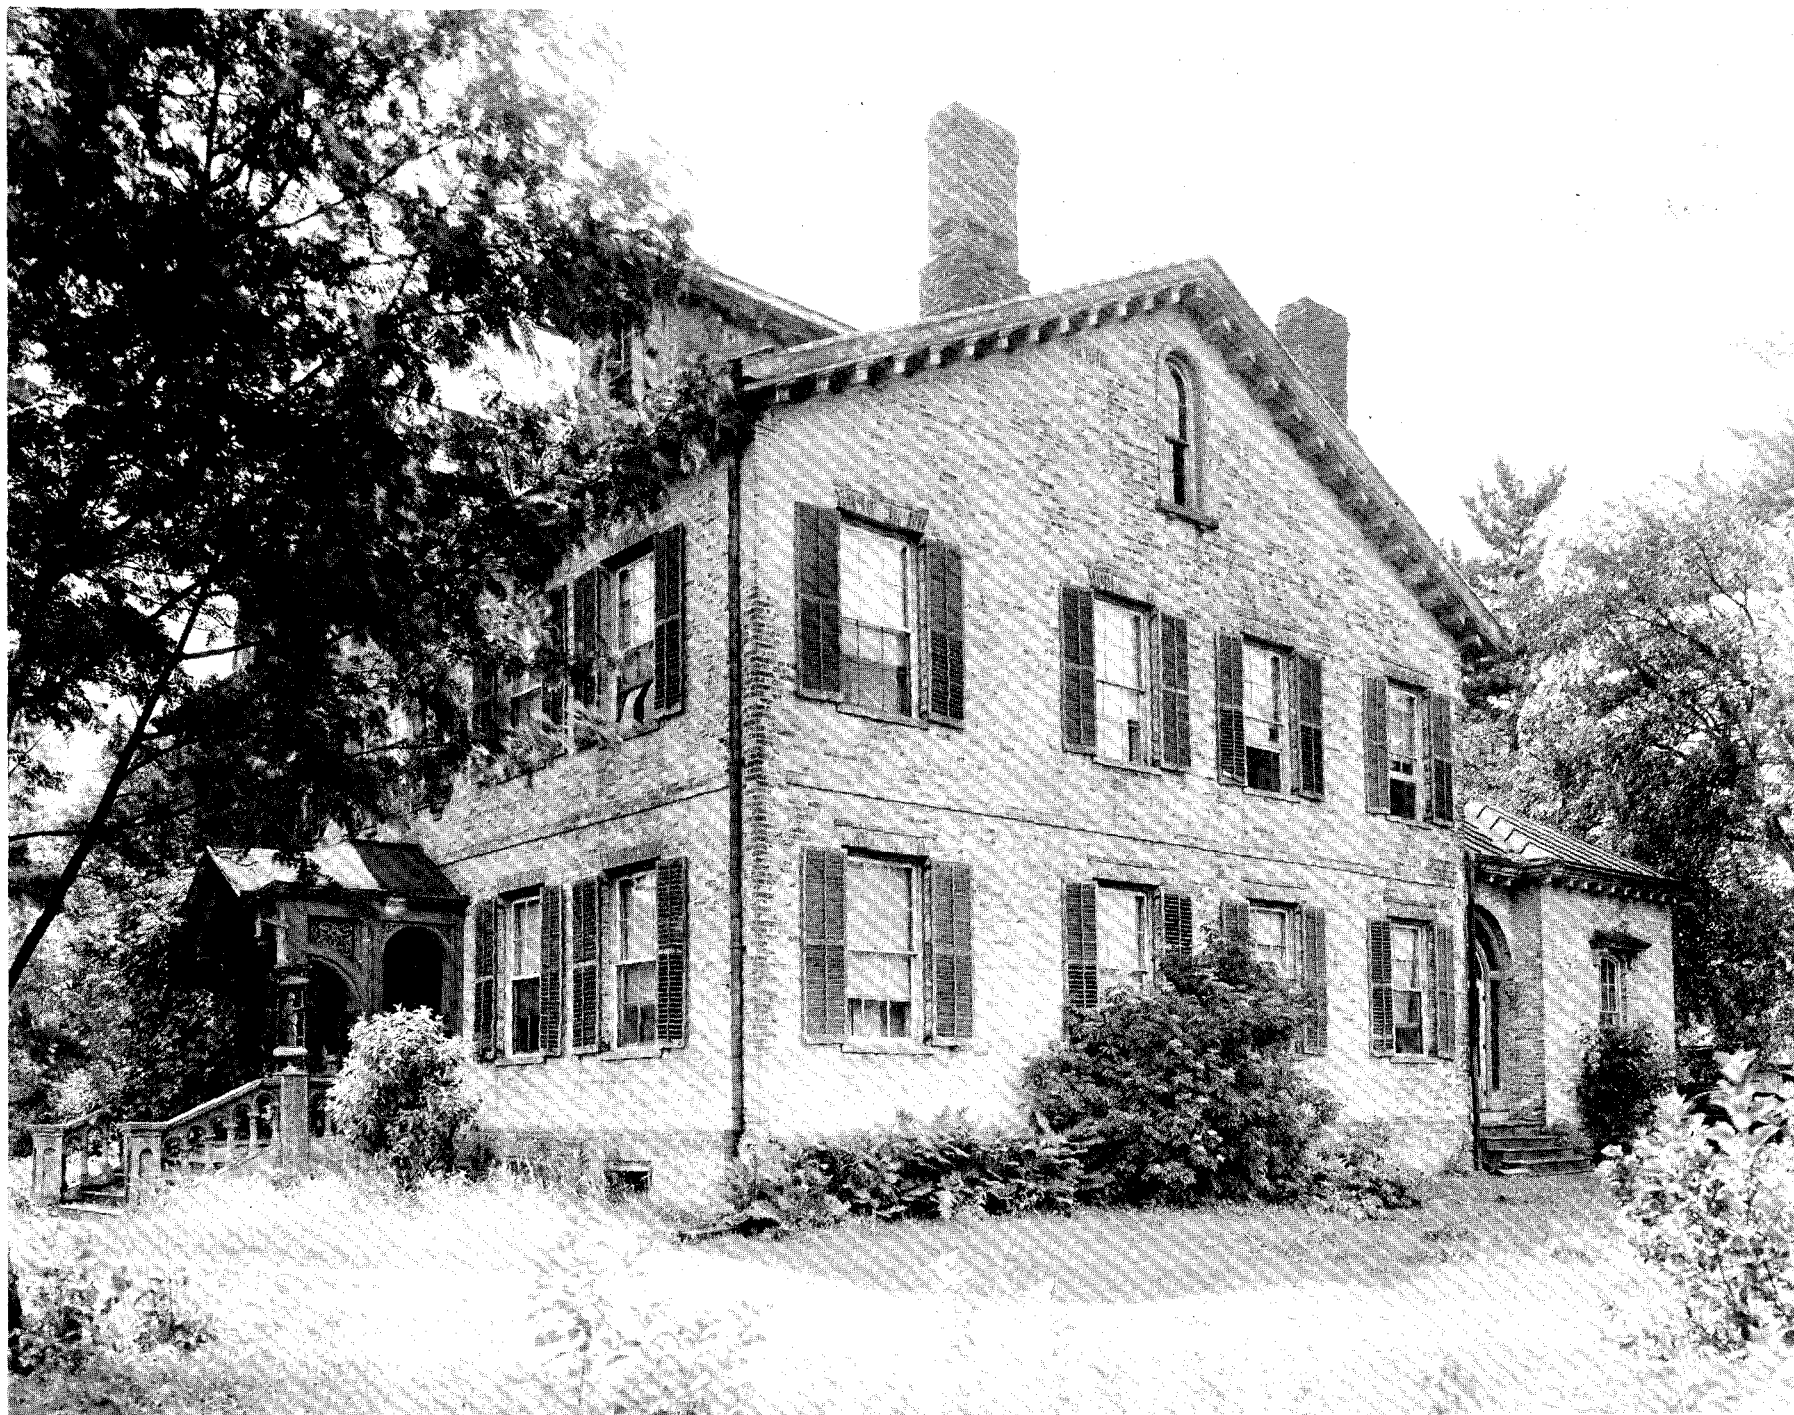
HP37. North and East Facades of Lindenwald, ca. 1942-1946. This photograph is from the Rowles Studio Collection. There is no documented date for the photograph so we must assign an approximate date based on comparisons with other photographs. The presence of an electrical supply wire, faintly visible at the left side, definitively dates the photograph after 1936. The size of the bush in the middle of the north wall suggests that the photograph was made at least 3 to 5 years after HP36 (therefore suggesting a date of ca. 1942). The hydrangea must have been pruned after 1937 and before this photograph. The advancing deterioration of several wooden elements confirms that this photograph postdates HP36 and predates HP41. The wire (probably a radio antenna) stretched between the south chimney and the north chimney in this photograph and in HP41, but not in HP34 or HP36, provides further evidence of this sequence. HP41 is conclusively dated after HP37 by the new paint on window and door frames and by the absence of dormer scrolls. DeProsse family recollections date this repainting to 1946 (W.N. Jackson, "Oral History Report," September 5, 1979). Thus, a date of ca. 1942-1946 is assigned. The evidence for the latter date is discussed in conjunction with HP41.

The following details should also be noted:

The chimney brick coursing matches that described in HP36.

There is a splashblock at the northeast corner.

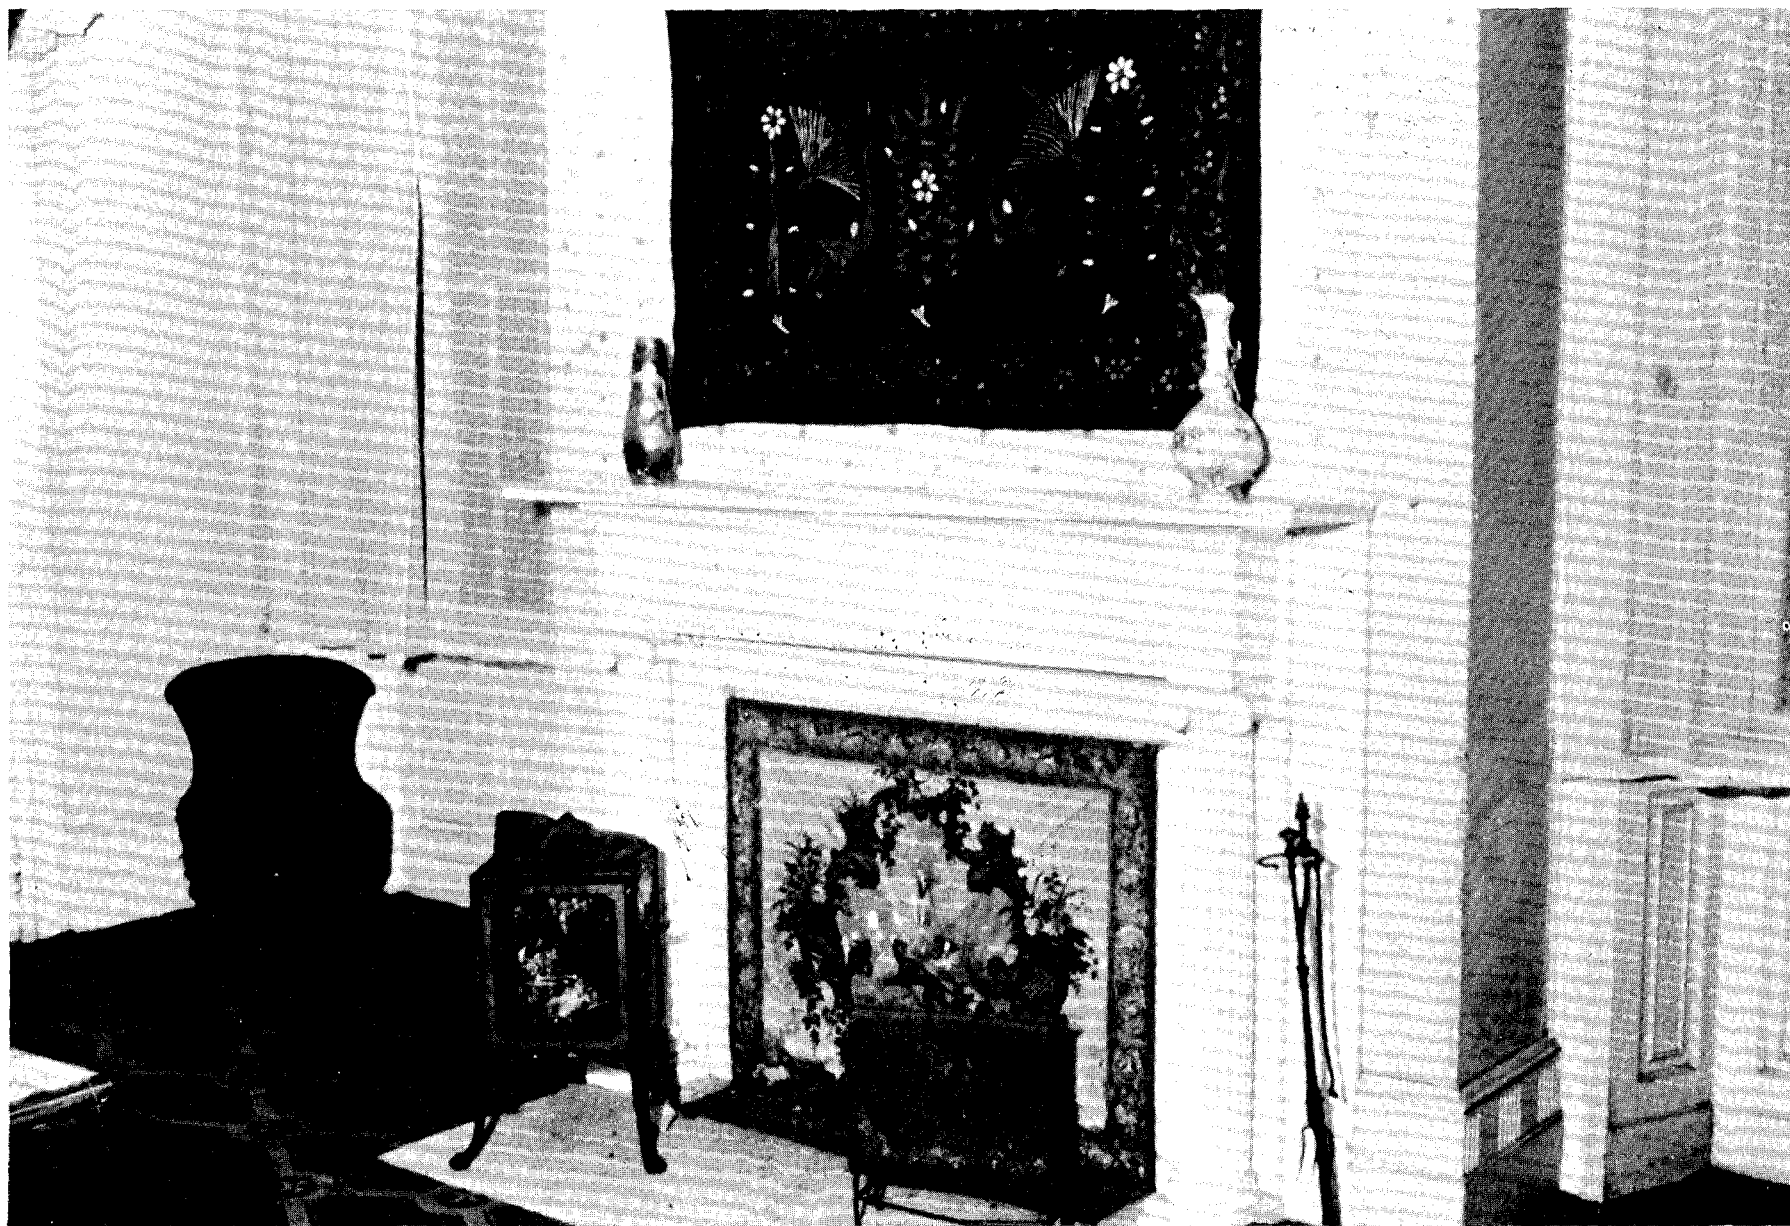
HP39. Room 106, ca. 1936-1957. This photograph is associated with HP38 and HP40 and assigned a date of ca. 1936-1957 on the basis of circumstantial evidence presented with HP38. The following details should be noted:

pier mirror

furniture

electric lamp

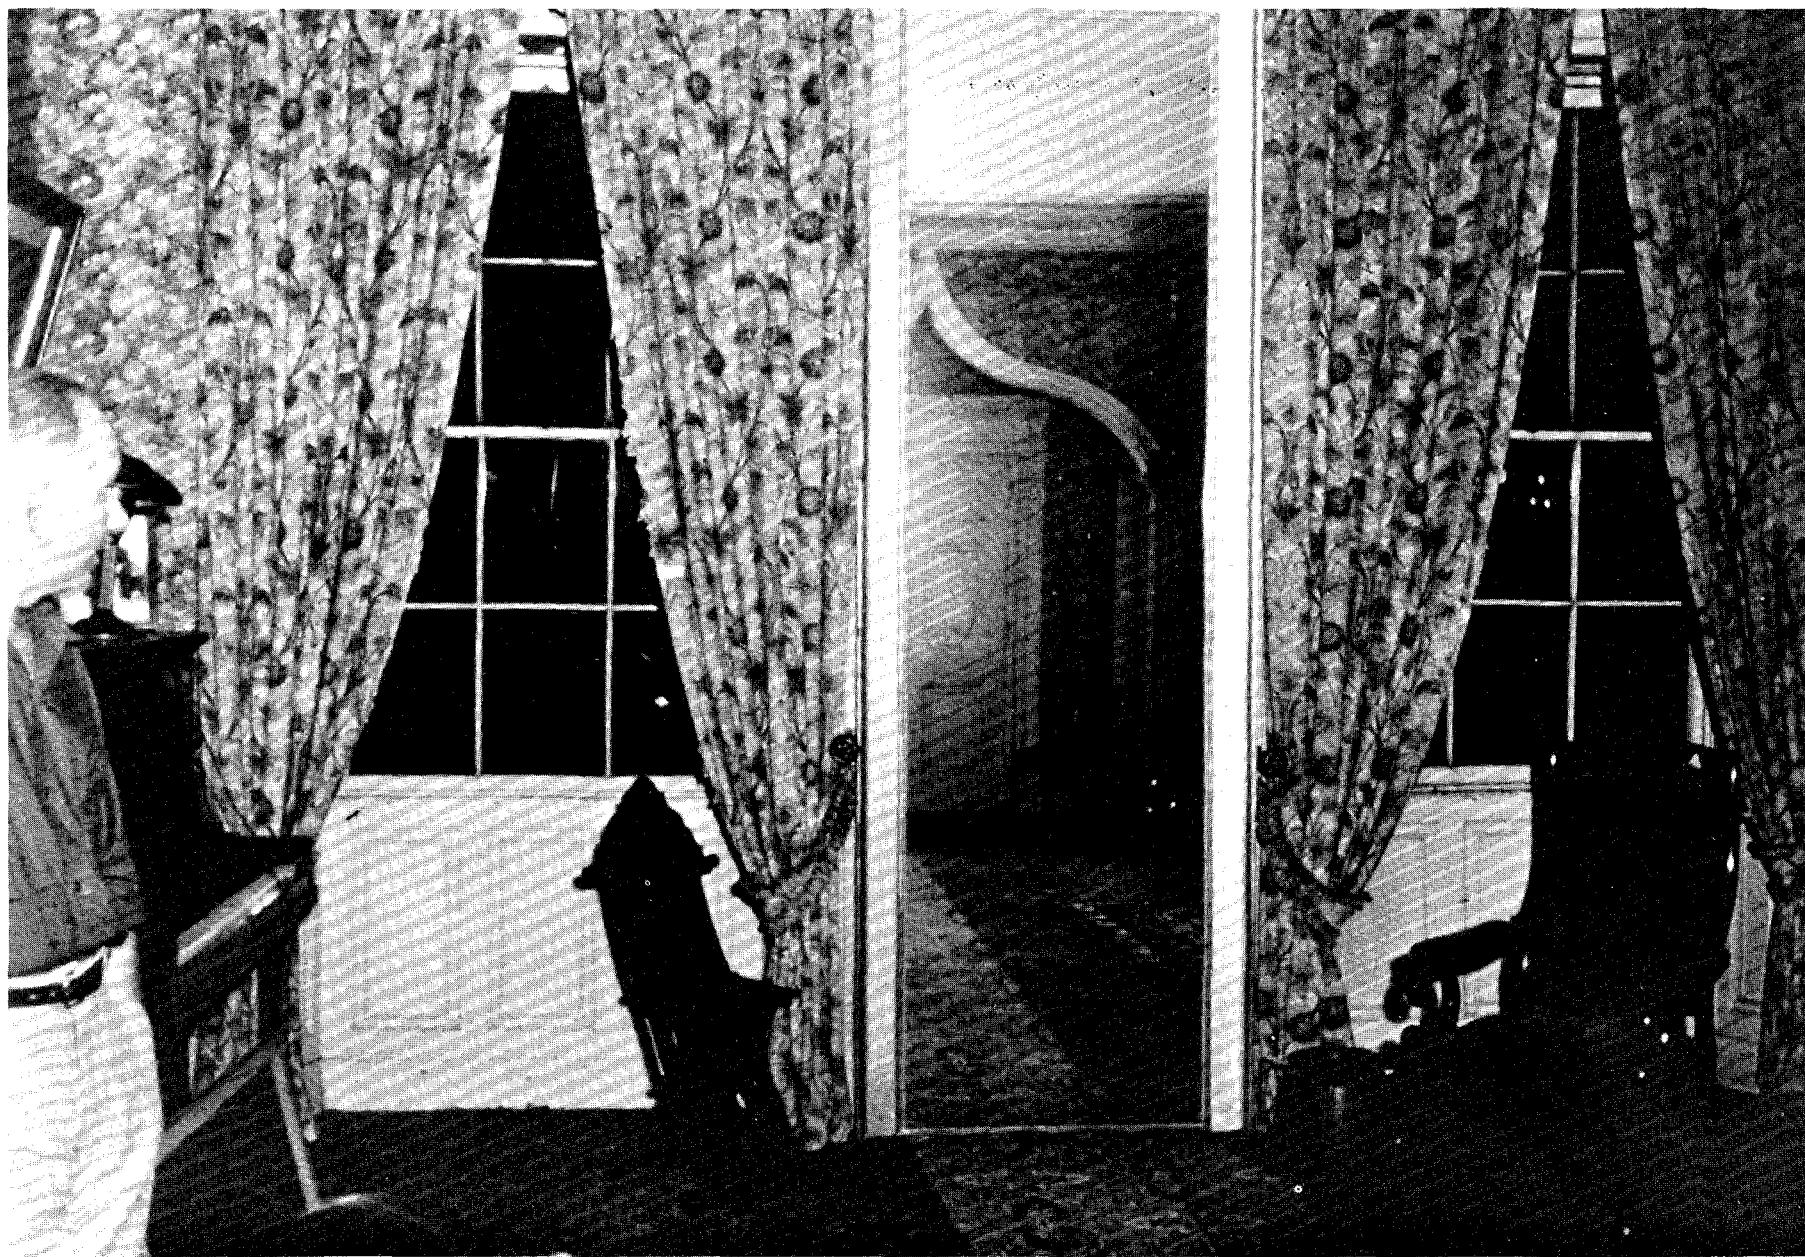
HP40. Room 106, ca. 1936-1957. This photograph is associated with HP38 and HP39 and assigned a date of ca. 1936-1957 on the basis of circumstantial evidence presented with HP38. The following details should be noted:

wallpaper

astragal molding on wall above ogee arch

electrical convenience outlet adjacent to card table

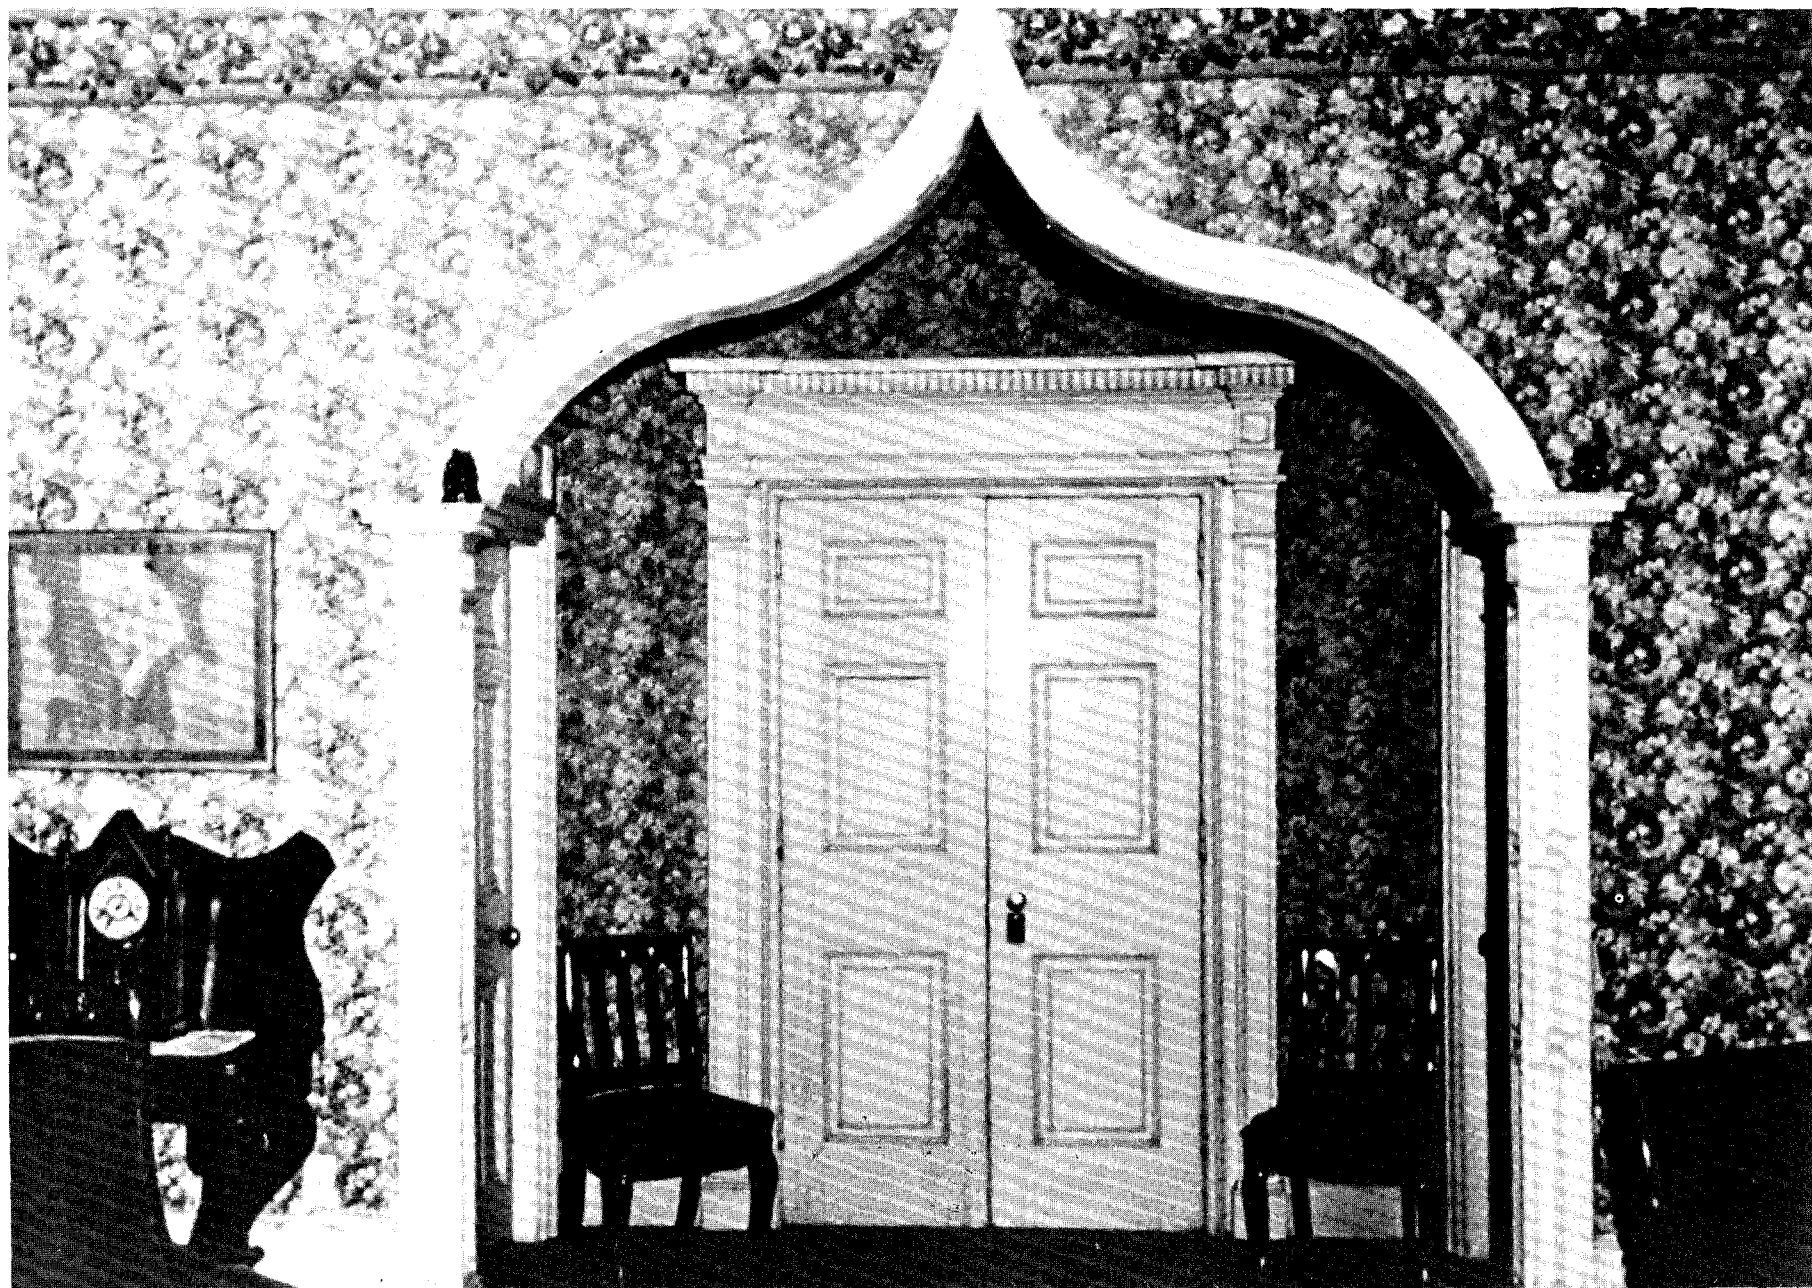
HP41. Lindenwald, ca. 1946-1950. This color photograph of the south and east facades of Lindenwald was donated to the National Park Service by the DeProsse family. It has been assigned a date between ca. 1946 and ca. 1950 on the basis of two DeProsse family recollections (W.N. Jackson, "Oral History Report," September 5, 1979). The painting of windows and doors is reported to have been done in 1946. The front porch is reported to have been removed in 1950. The following details should be noted:

repairs to tower roof

missing scrolls on north dormer

condition of porch roof

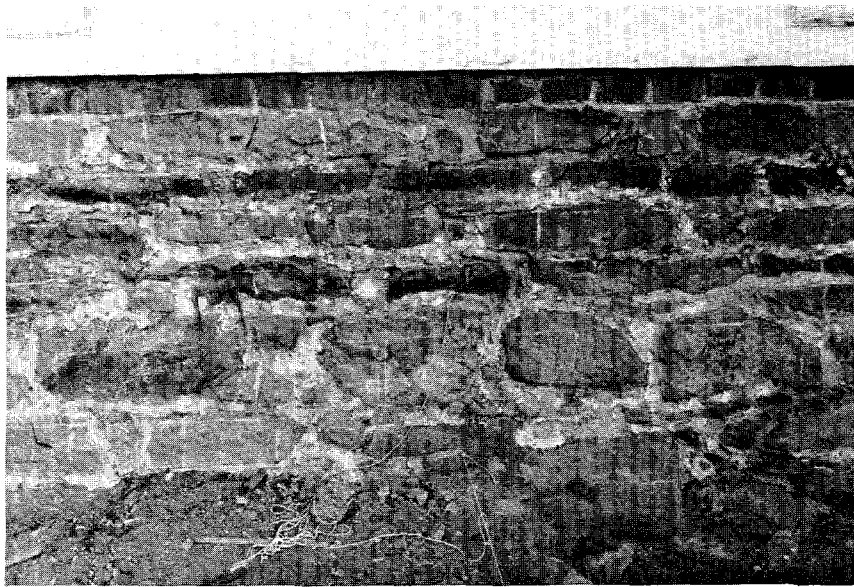
IP001, N002-04. Ca. 1797 foundation below door 101.

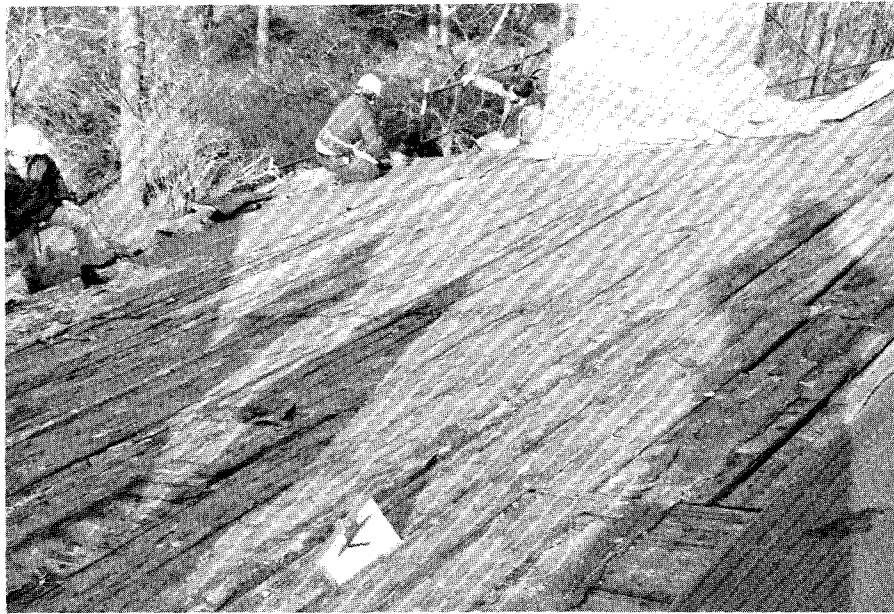
IP003, N039-01. Main roof, northwest corner looking northwest. Note hatch infill in foreground.

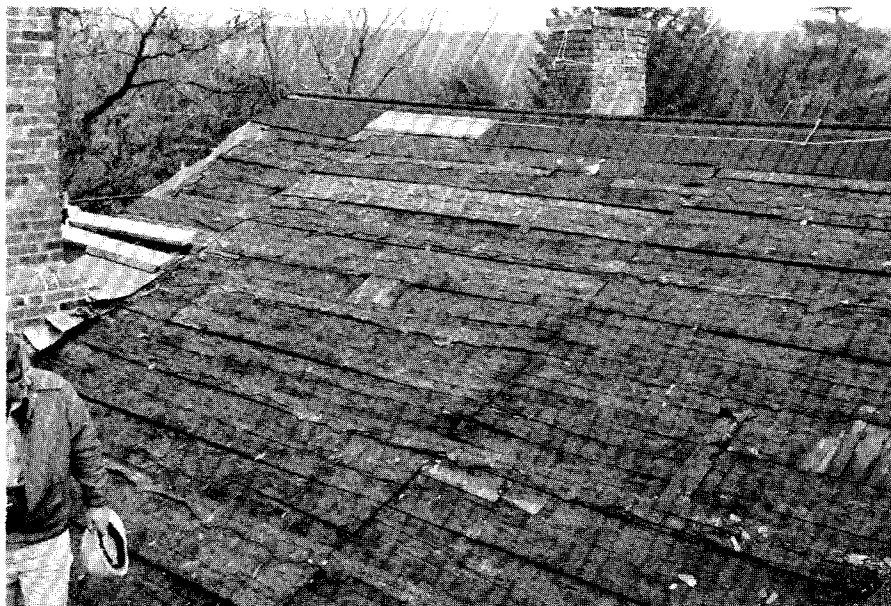
IP004, N039-07. Main roof, northwest corner looking northeast. Note shingle shims.

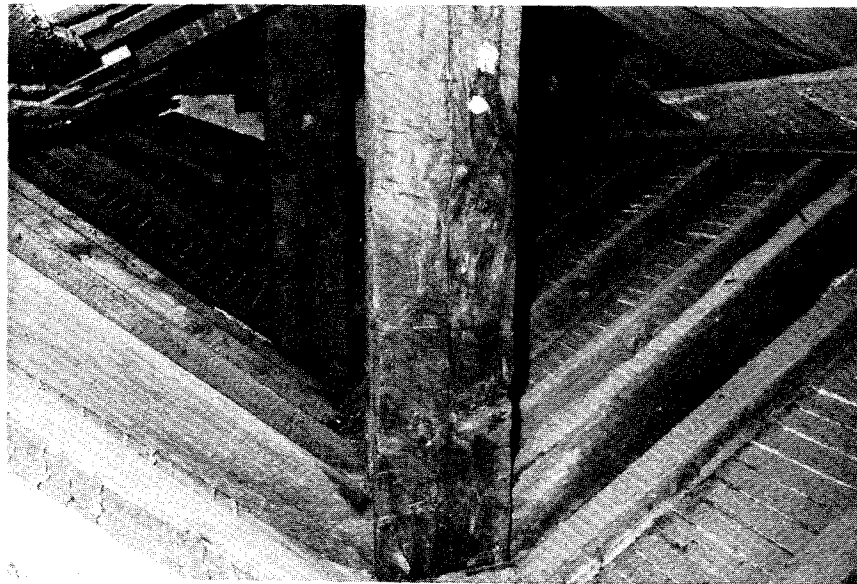
IP005, N002-11. Kingposts above ca. 1849 ceiling. Note plaster on end wall.

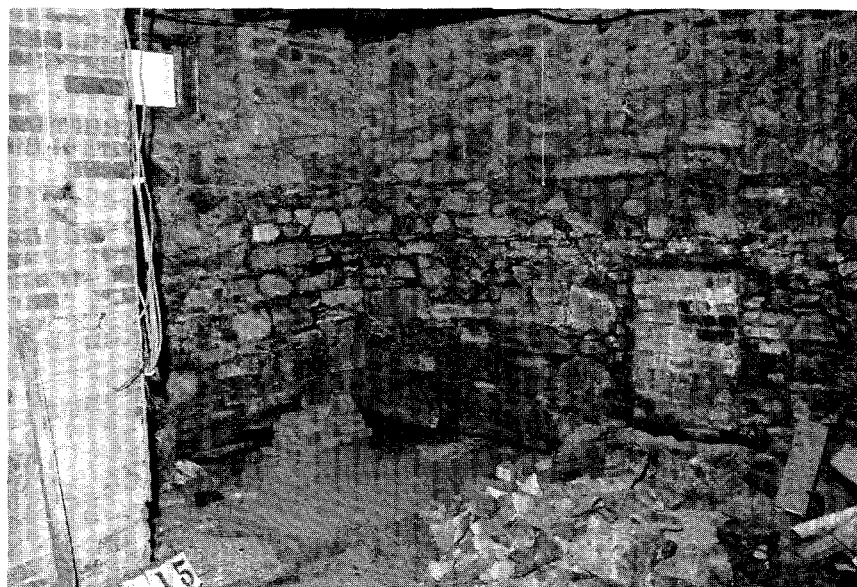
IP011, N016-12. Room 015. Note bricked-in coal chute opening.

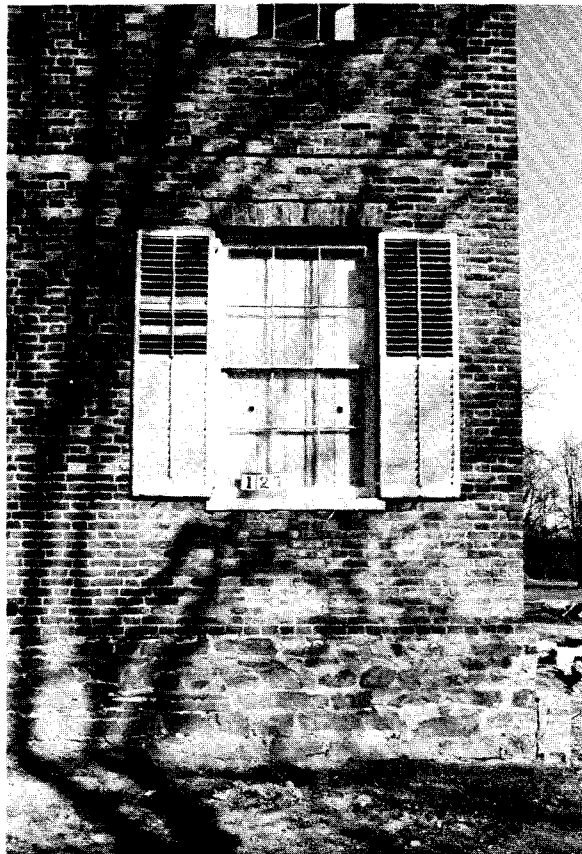
IP012, N012-08. Window 127, typical ca. 1797 window with ca. 1840 sash and shutter blinds.
