historic structure report
architectural data section
volume 2: appendixes

MARTIN VAN BUREN

NATIONAL HISTORIC SITE / NEW YORK

LINDENWALD

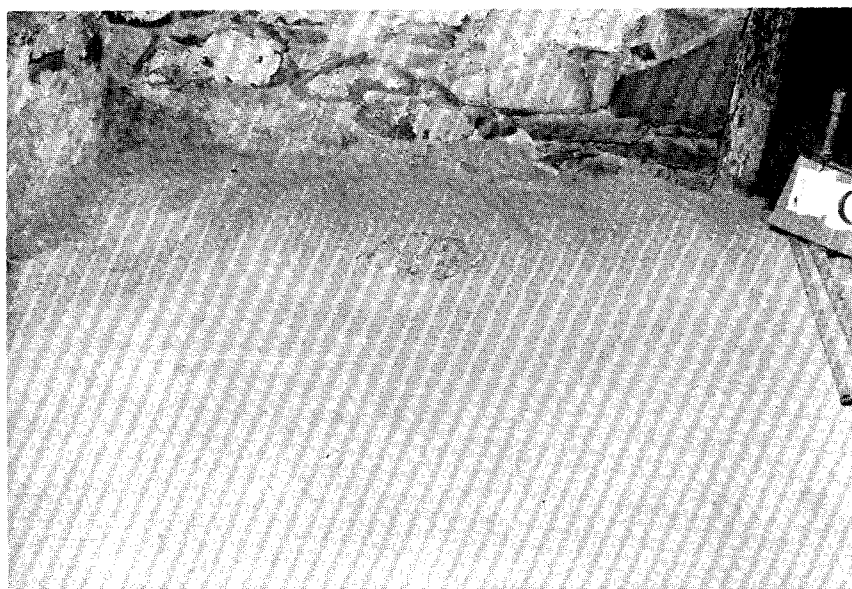
IP018, N008-37. Unidentified feature in floor of room 002.

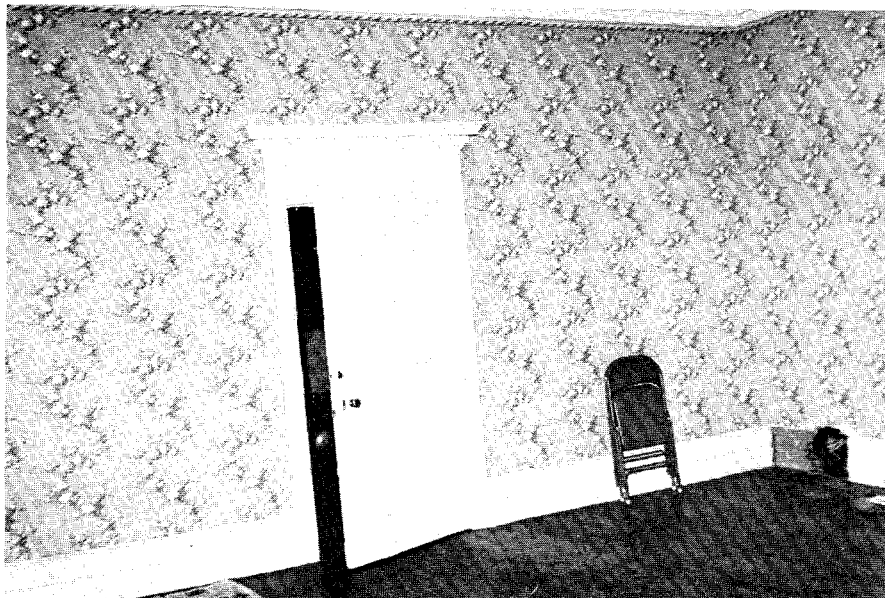
IP026, N022-29. Room 104, south wall and door 102. Note register opening in southwest corner.

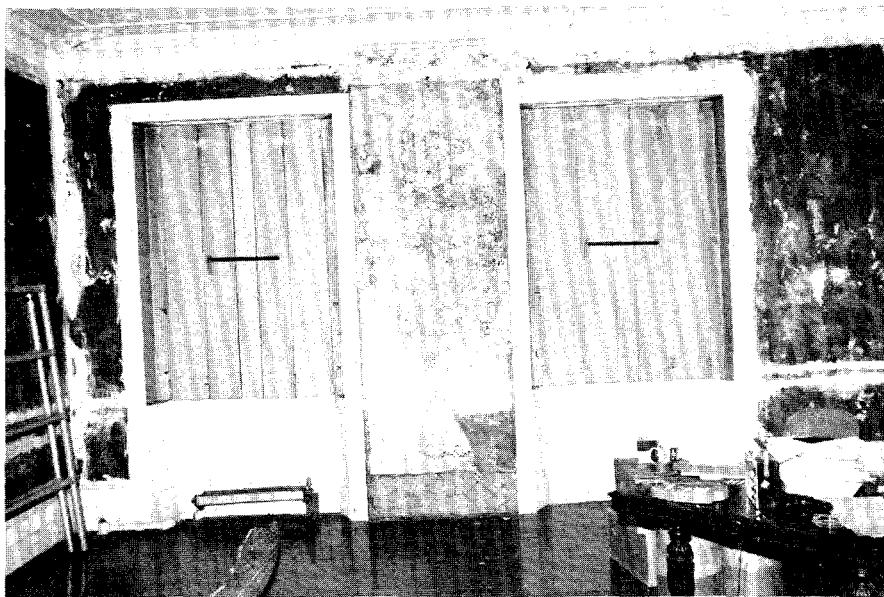
IP030, N023-24. Room 106, east wall. Note historic wallpaper revealed by removal of mirror between windows 101 and 102.

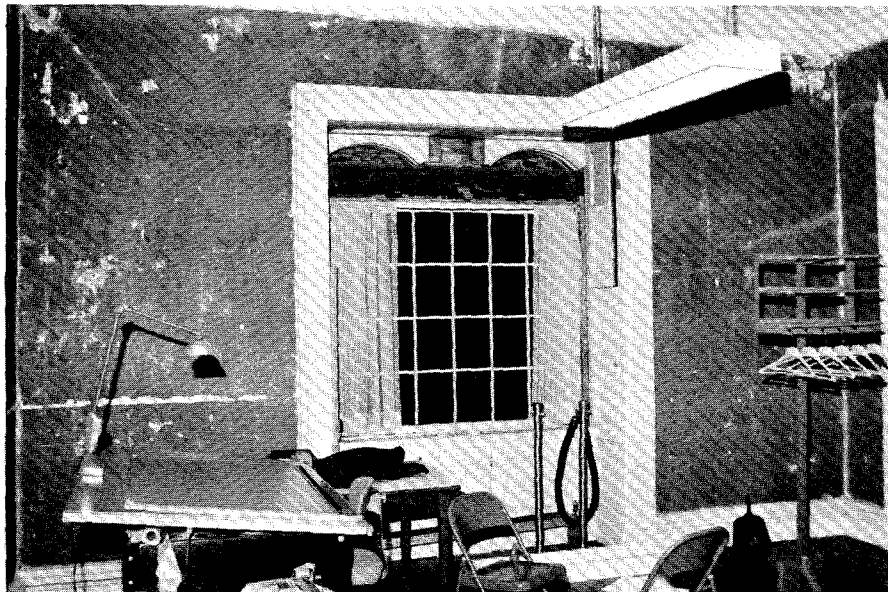
IP034, N023-29. Room 111, south wall, windows 122 and 123. Note arched window heads.

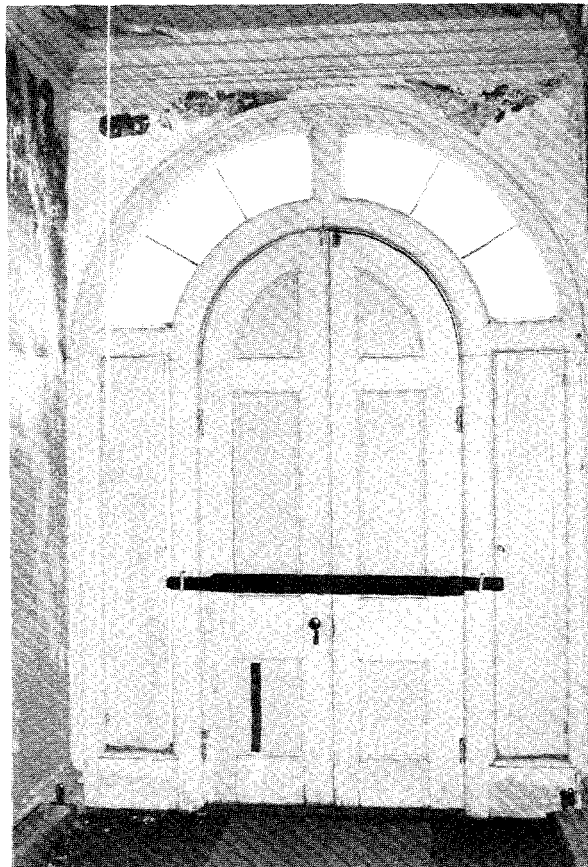
IP039, N021-14.
Room 119, looking
north to door 109.

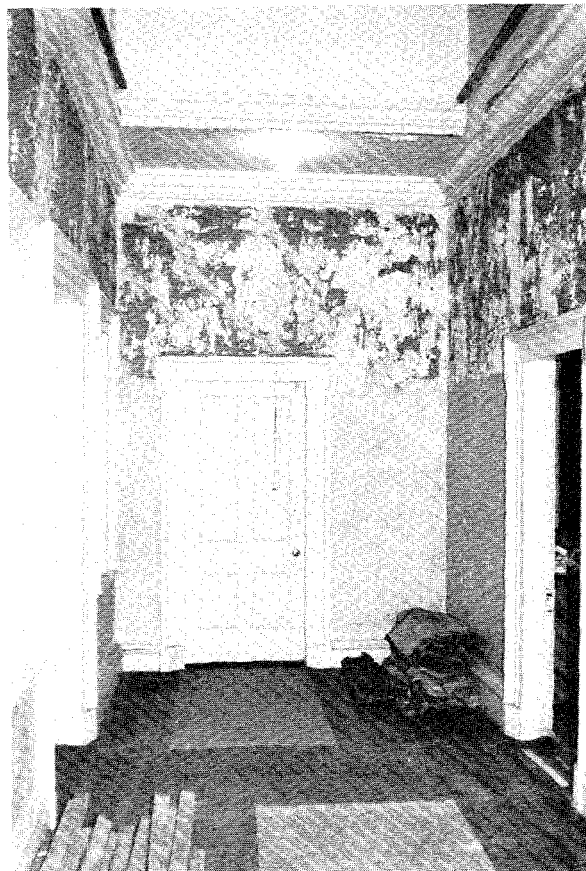
IP040, N021-15.
Room 119, looking south
to door 118, door 115 to the
right and door 108 to the left.
Note skylight opening above.

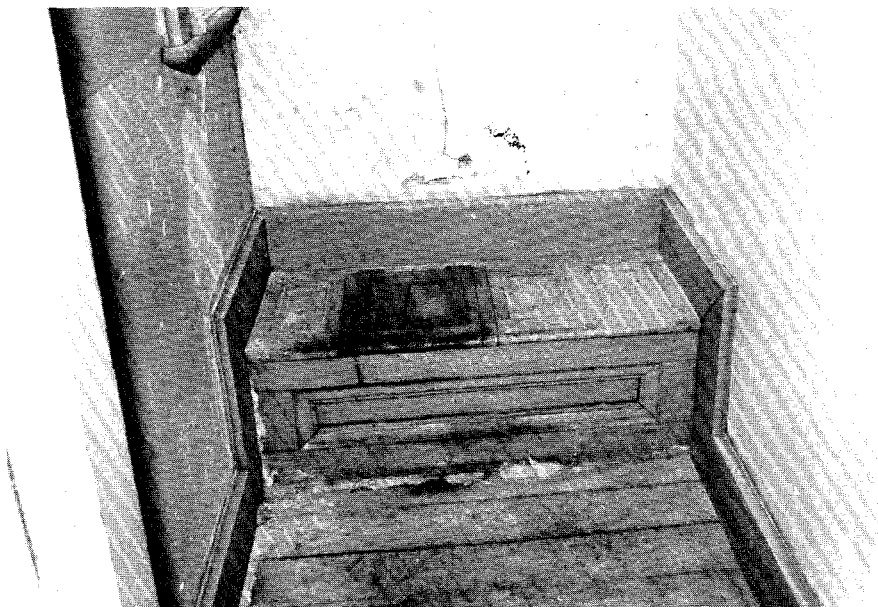
IP041, N023-02. Room 121. Note similarity to water closet (IP034).

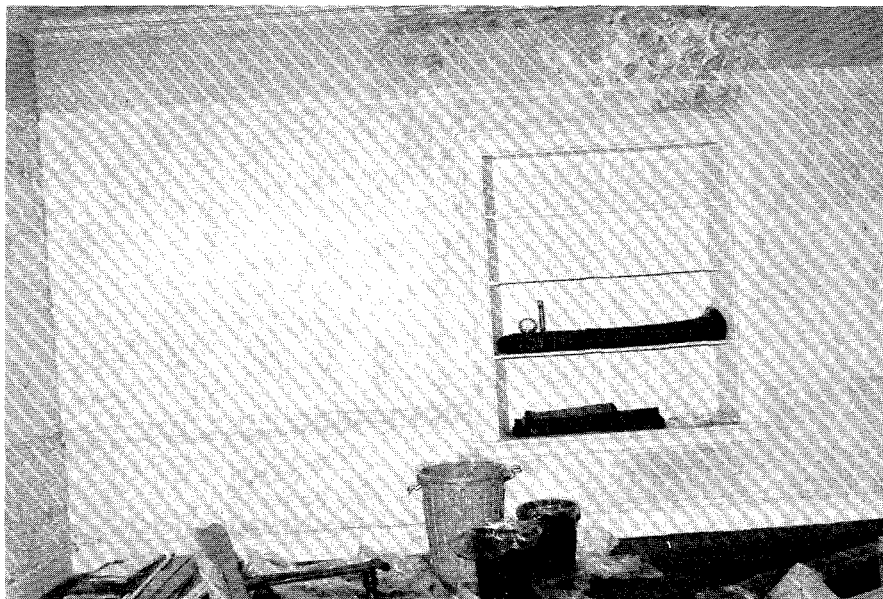
IP042, N030-37. Room 201 west wall. Note shelves in former window opening.

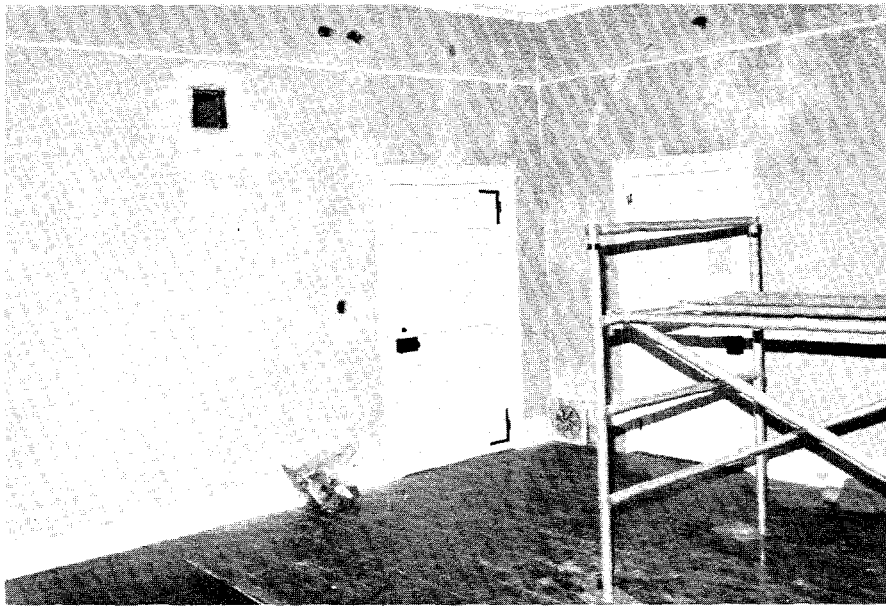
IP043, N030-31. Room 205, south and west walls. Note outline of former door opening (door 219) on south wall and ventilation opening above.

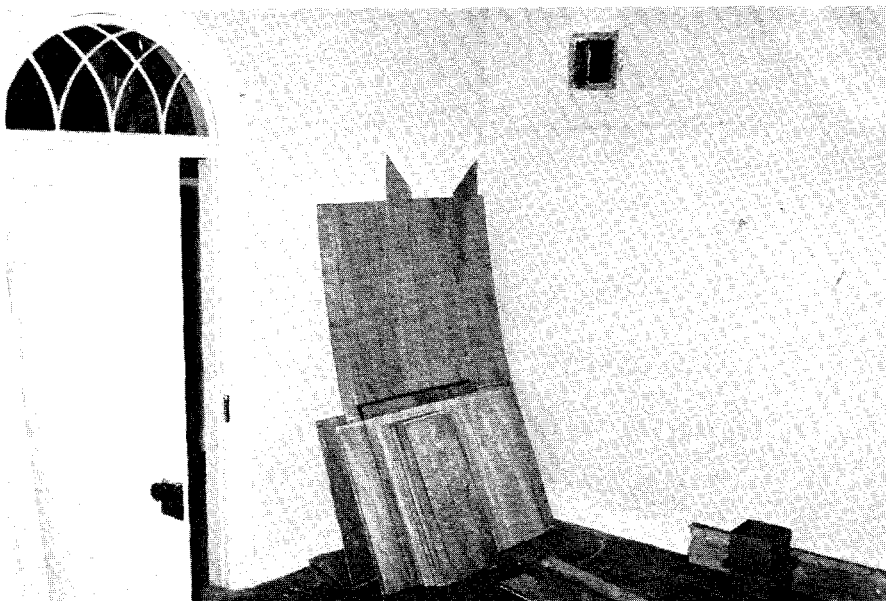
IP044, N030-23. Room 208, northwest corner. Note faint outline of former door opening (door 219) on north wall below ventilation opening and patch of chair rail across door opening.

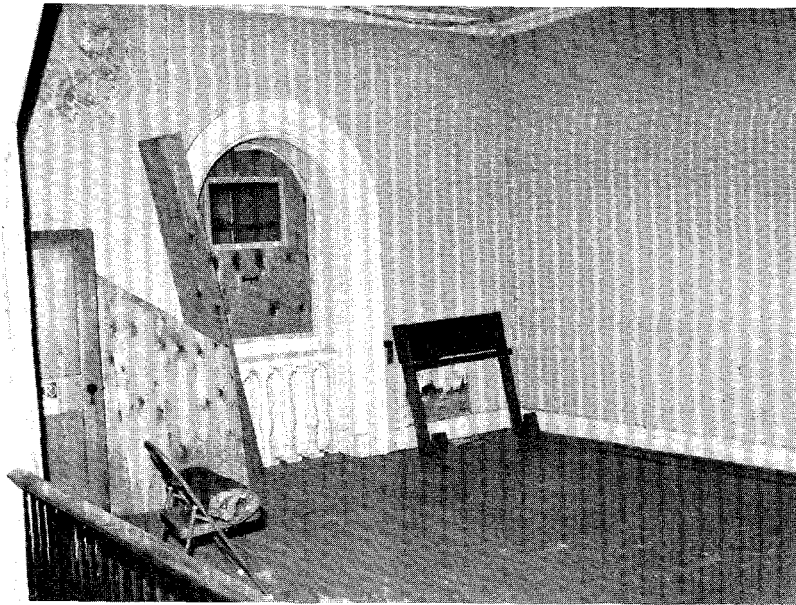
IP045, N029-36. Room 206, west and north walls. Note window 213 and balustrade.

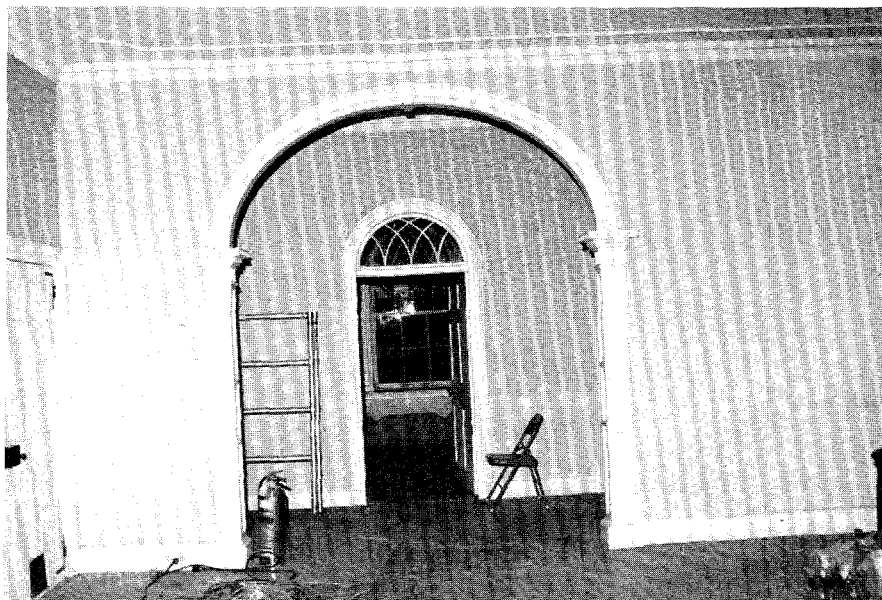
IP046, N030-03. Room 206, looking east into rooms 207 and 208 through doors 218 and 202. Note vertical line at former location of south wall near right edge.

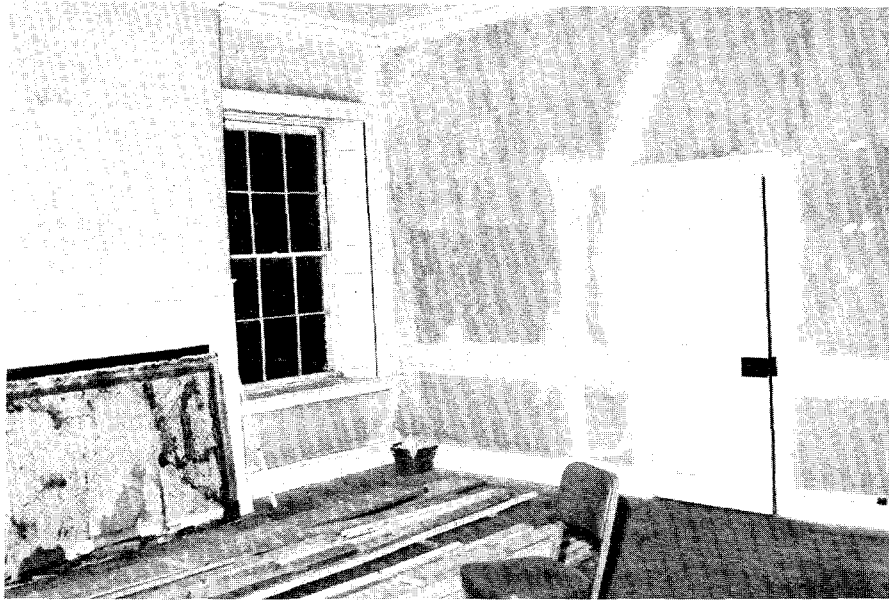
IP047, N030-15. Room 209, south and west walls. Note door 216 and its former location.

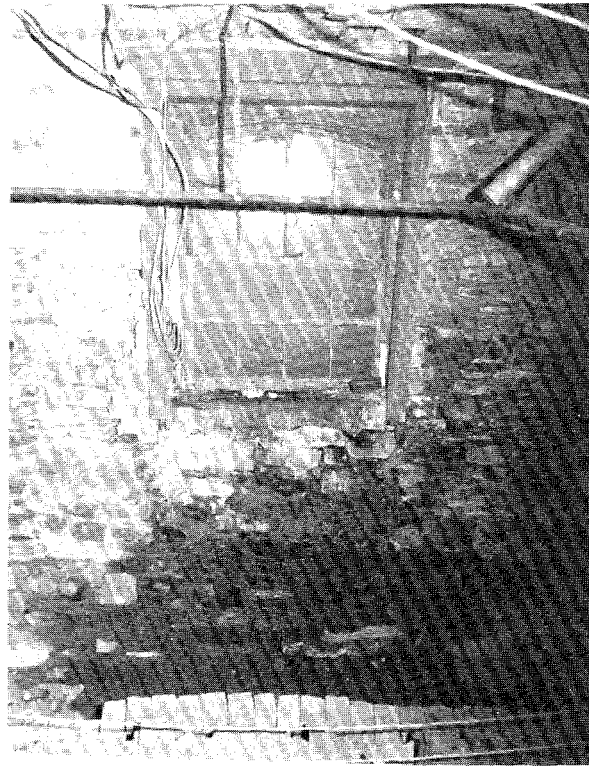
IP072, N028-35. Window 011. Note water penetration and dislodged masonry at lower left corner.

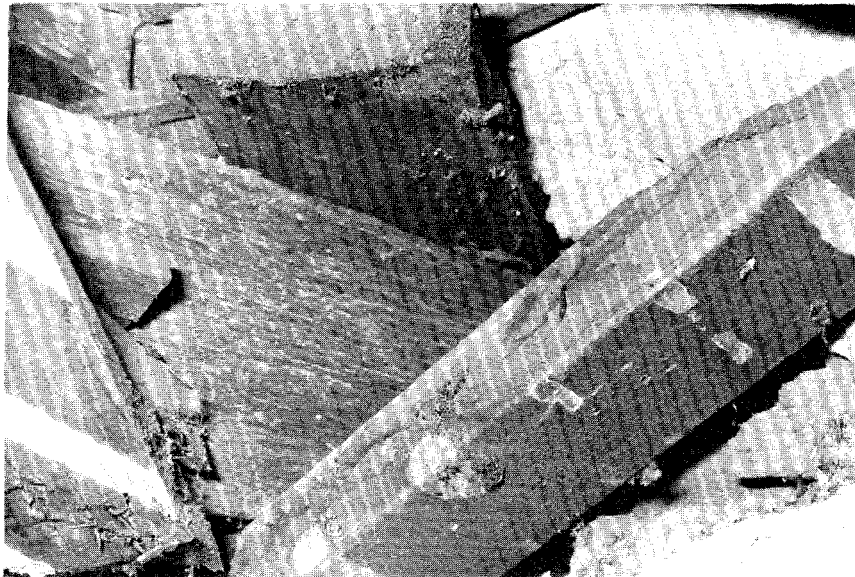
IP073, N041-12. Typical condition of cantilever joist wedged into masonry pocket.

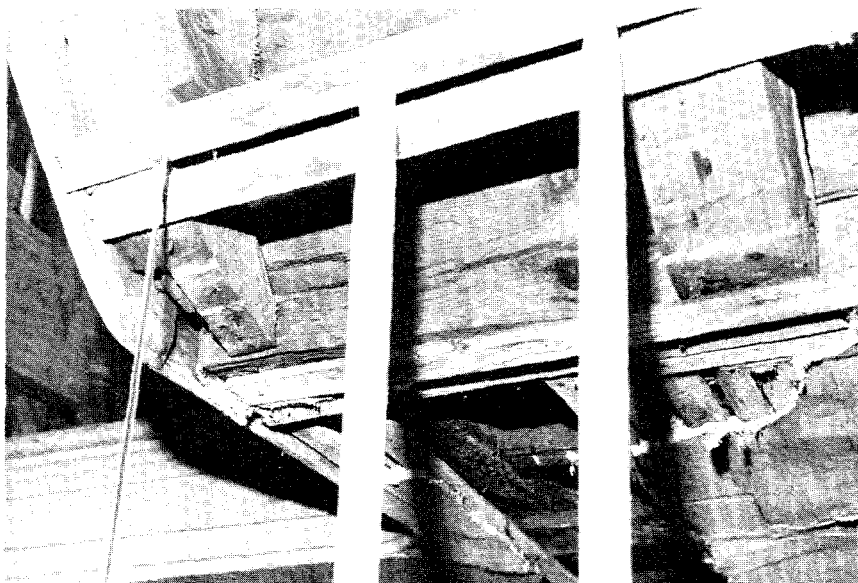
IP075, N041-06. Same area as IP069 (above), looking northwest and slightly up. Note stair stringers at top of picture. Horizontal joist is cantilevered from east wall. Tenon of previously mentioned stub joist appears at west end of cantilever above stair stringer.

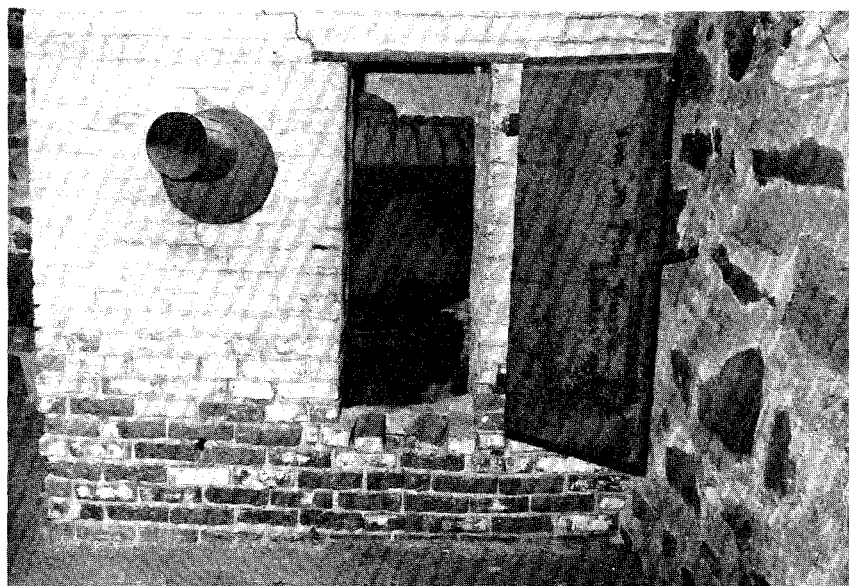
IP081, N010-05. North wall of furnace enclosure. Note inscription on door.

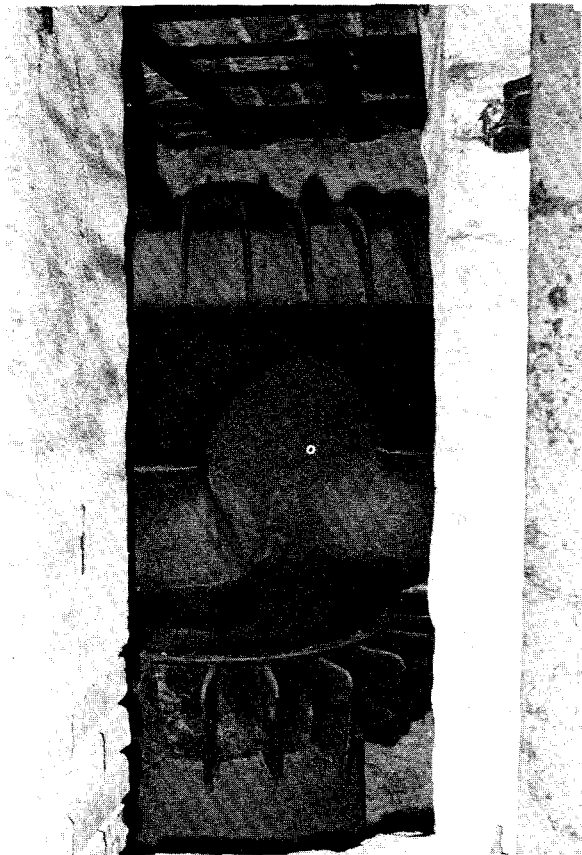
IP082, N010-07. Boynton's patent cast-iron furnace.

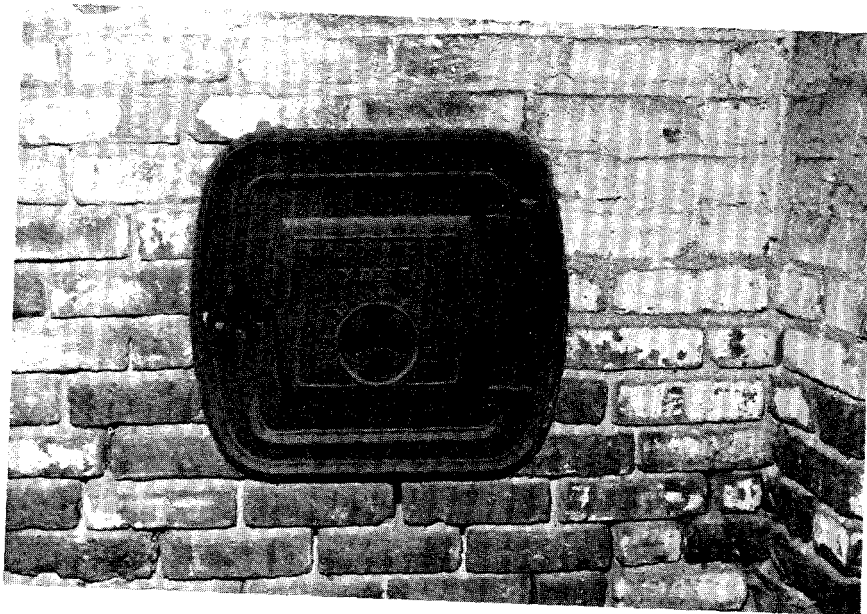
IP083, N010-04. Cast-iron fuel door with patent data.

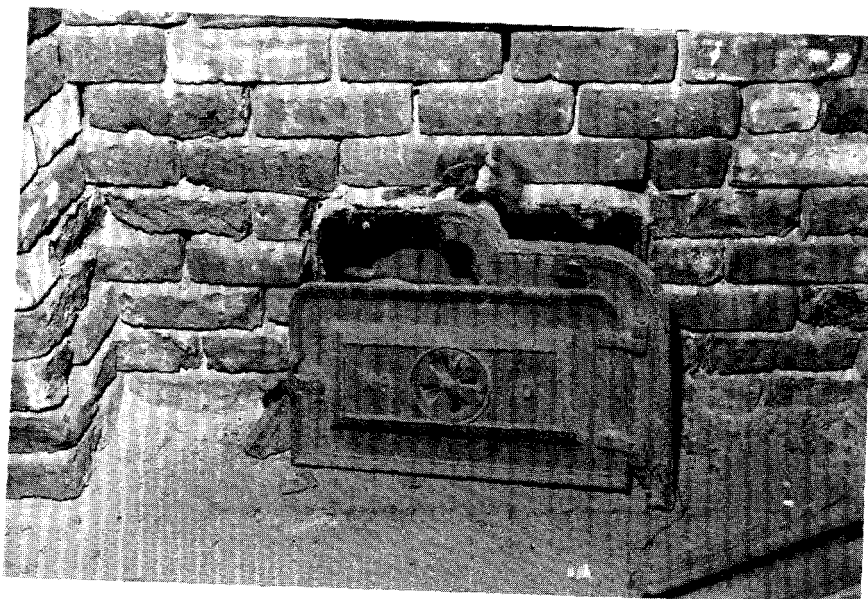
IP084, N010-10. Cast-iron ash cleanout door.

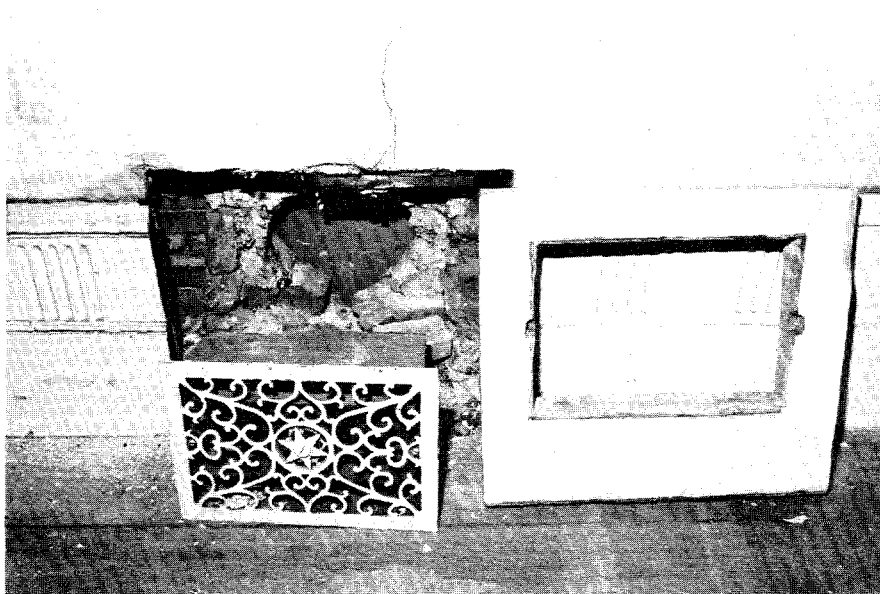
IP085, N022-22. Culver's patent register and marble frame, room 105, north wall.

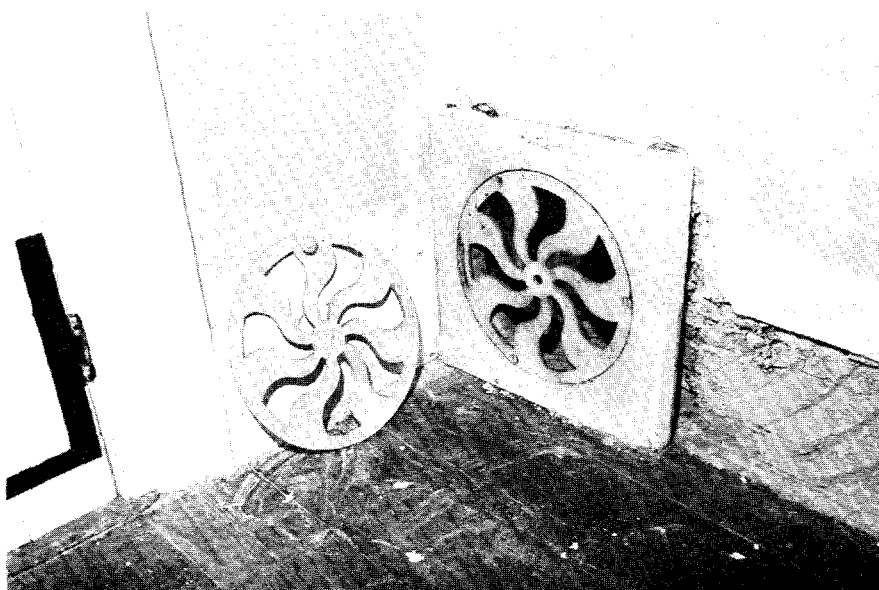
IP086, N031-11. Circular "sunflower" type register and frame, room 205.

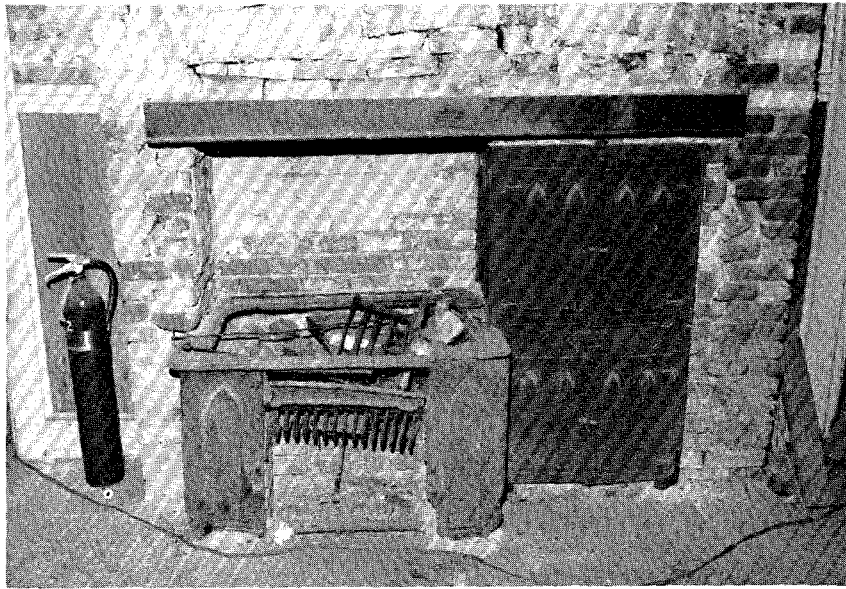
IP087, N017-22. Cook stove, room 006, north wall.

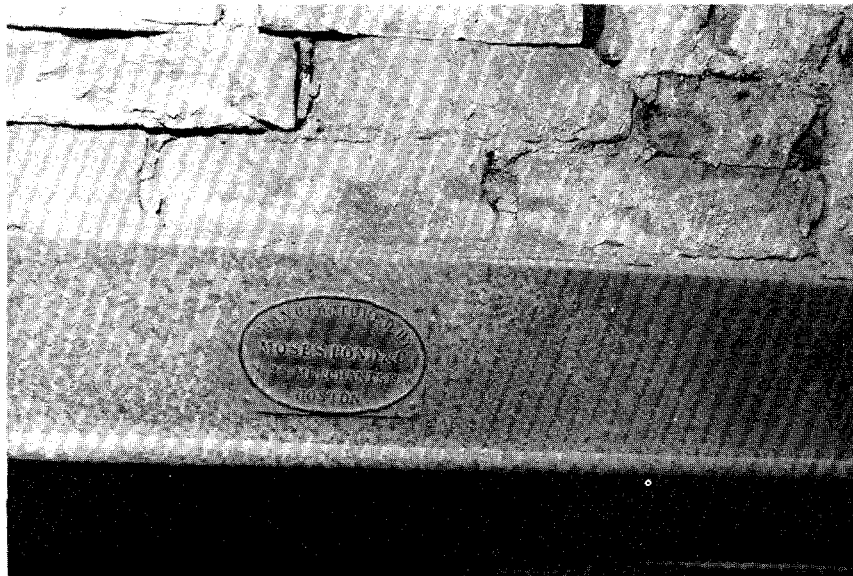
IP088, N017-23. Manufacturers label on hood over cook stove.

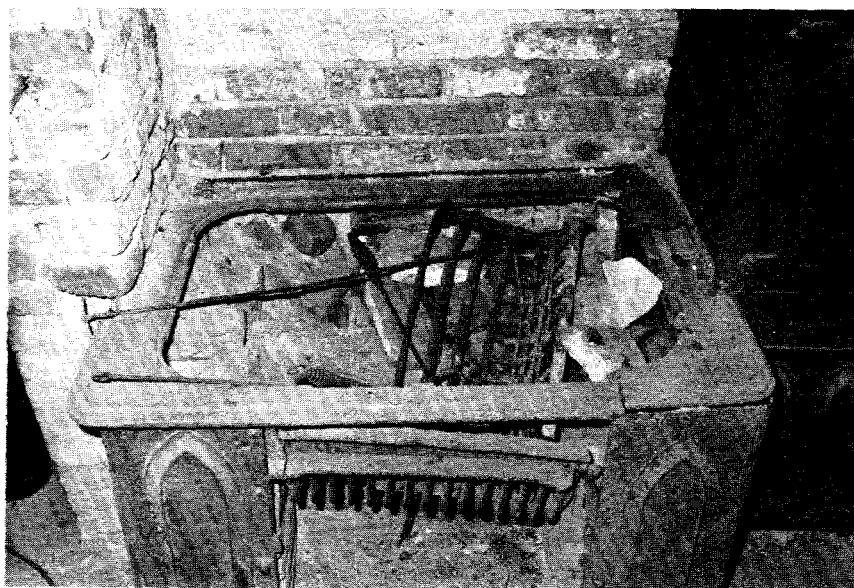
IP089, N017-26. Cooking surface.

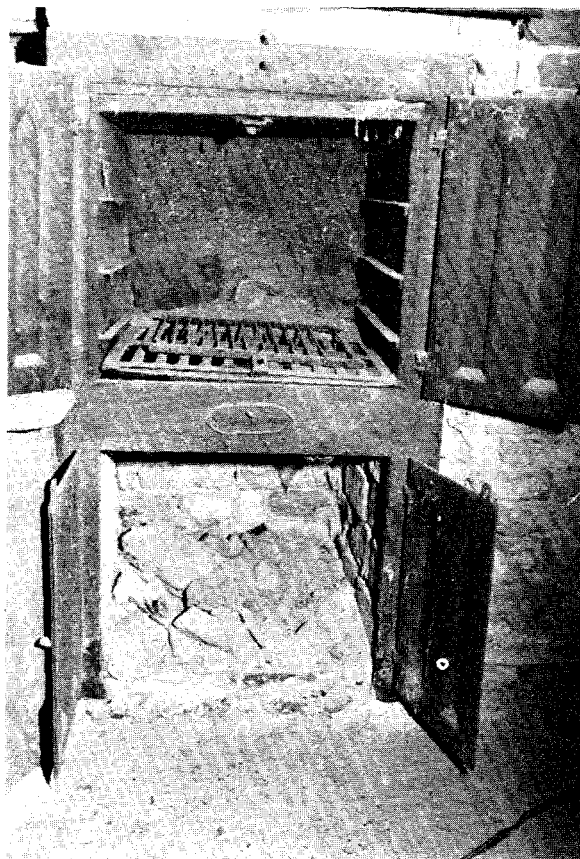
IP090, N017-28. Ovens.

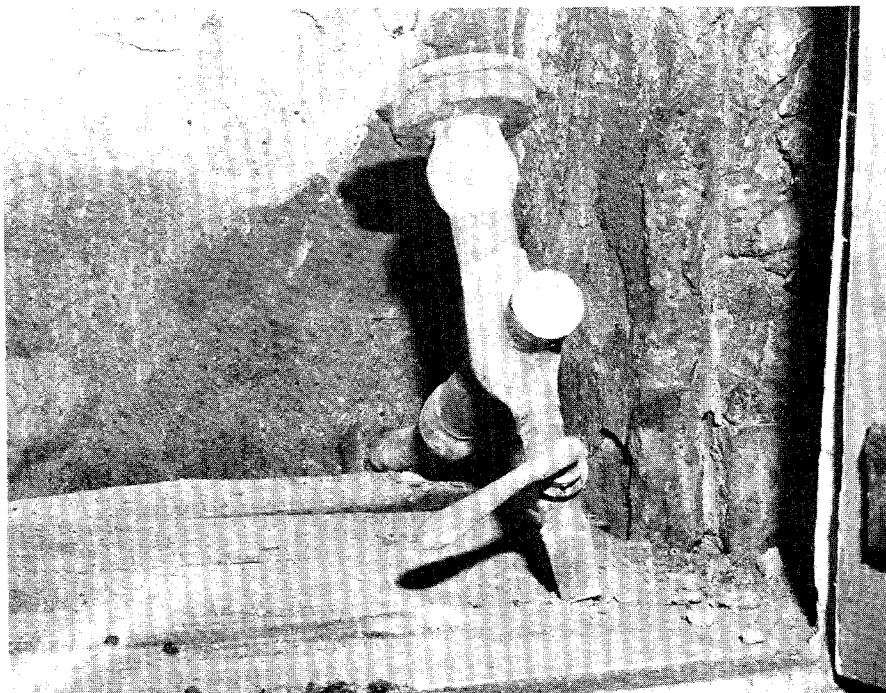
IP091, N038-01. Probable water supply to force pump, room 006, southwest corner at floor level.

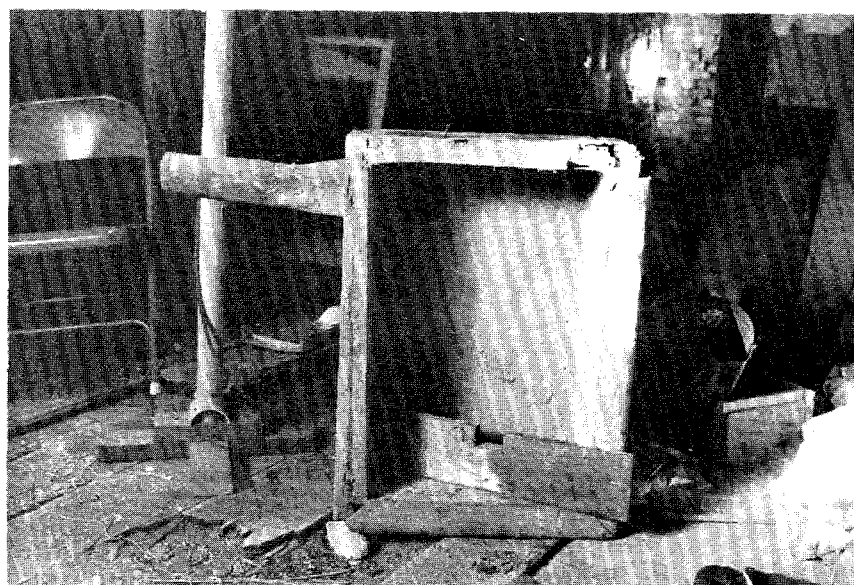
IP092, N001-08. Laundry room, room 007, sink.

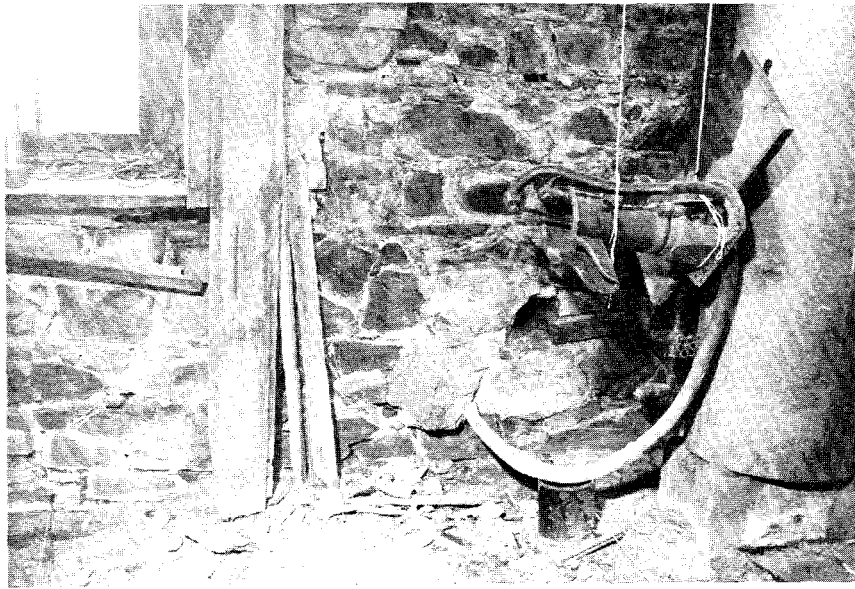
IP093, N001-09. Hand pump for laundry sink, room 007. Note hole in wall for drain.

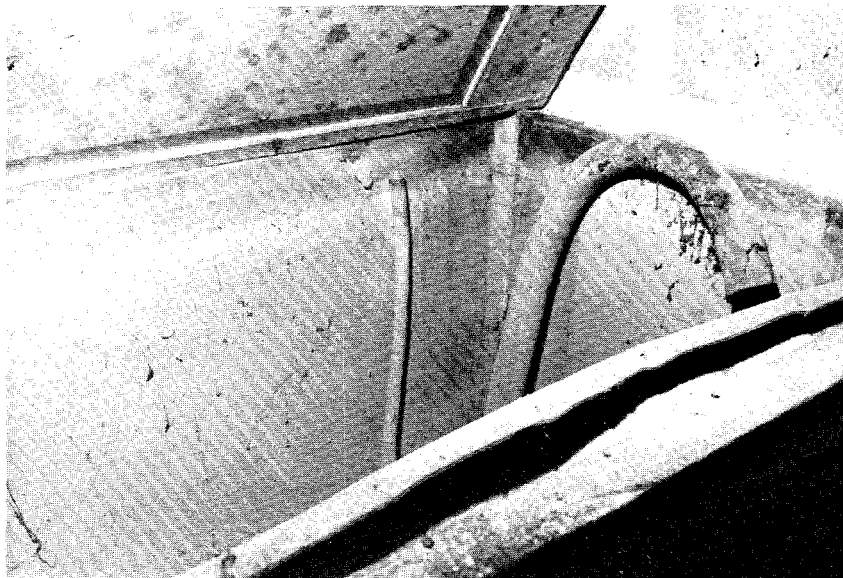
IP094, N018-17. Water tank, room 115, filler and overflow pipes.

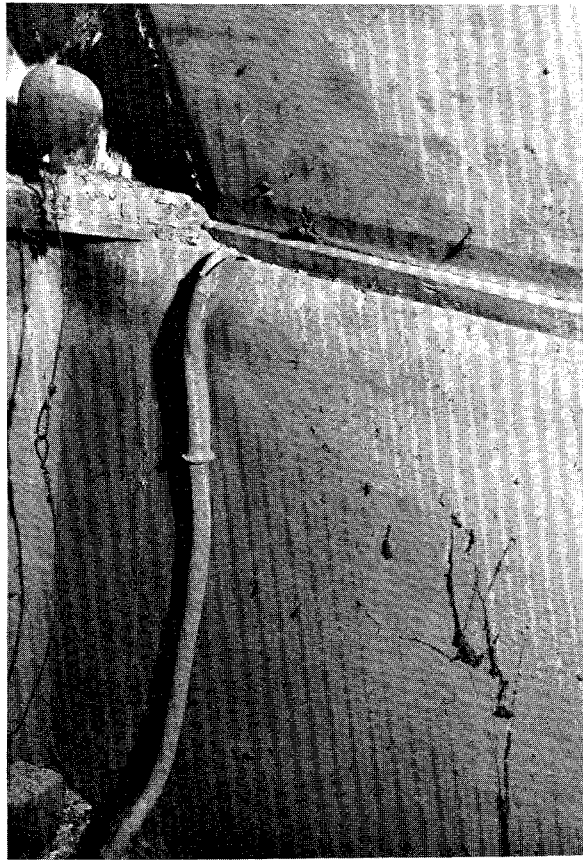
IP095, N018-18. Water tank, room 115, stopper lever and vacuum breaker pipe.

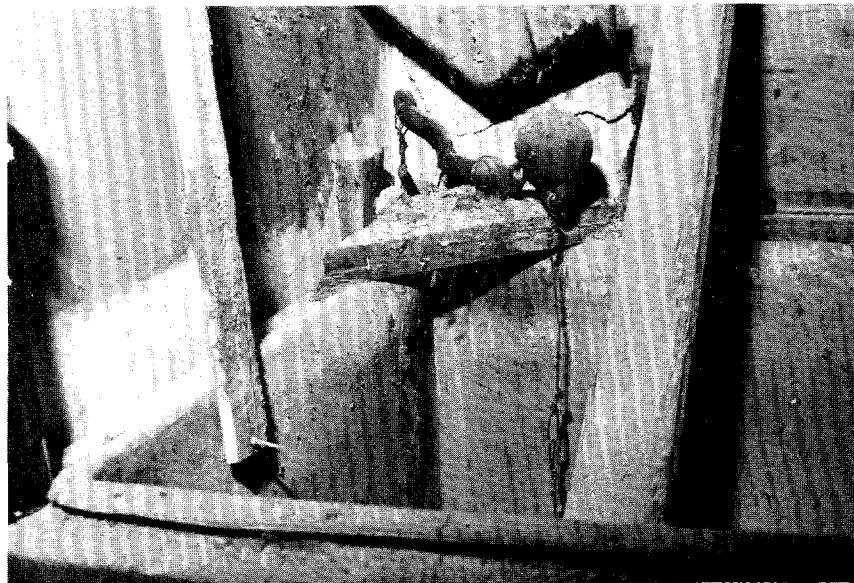
IP096, N018-16. Water tank, room 115, stopper lever.

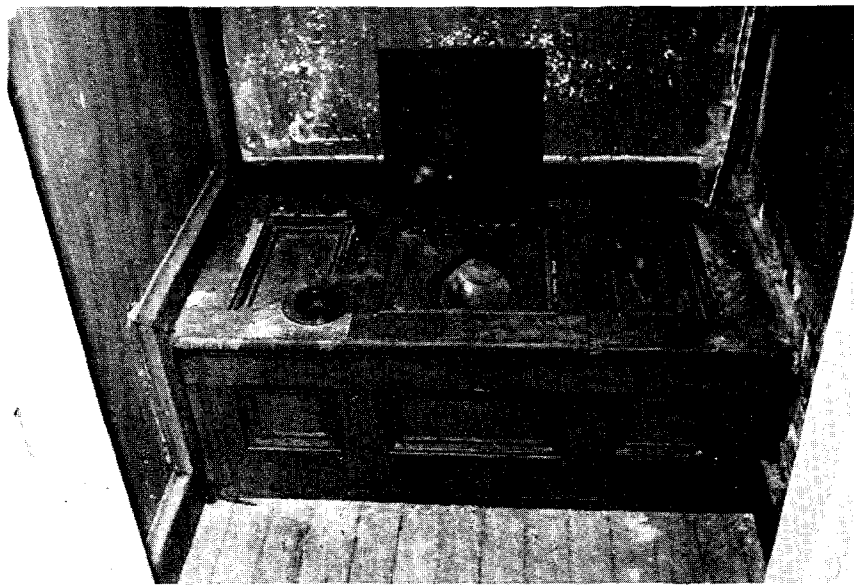
IP097, N018-20. Room 115 water closet and enclosure.

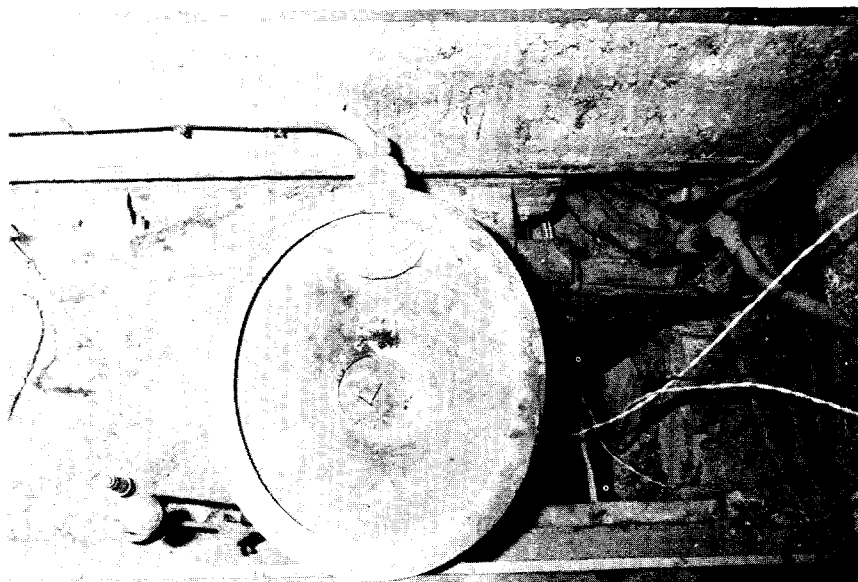
IP098, N036-03. Water closet with top removed.

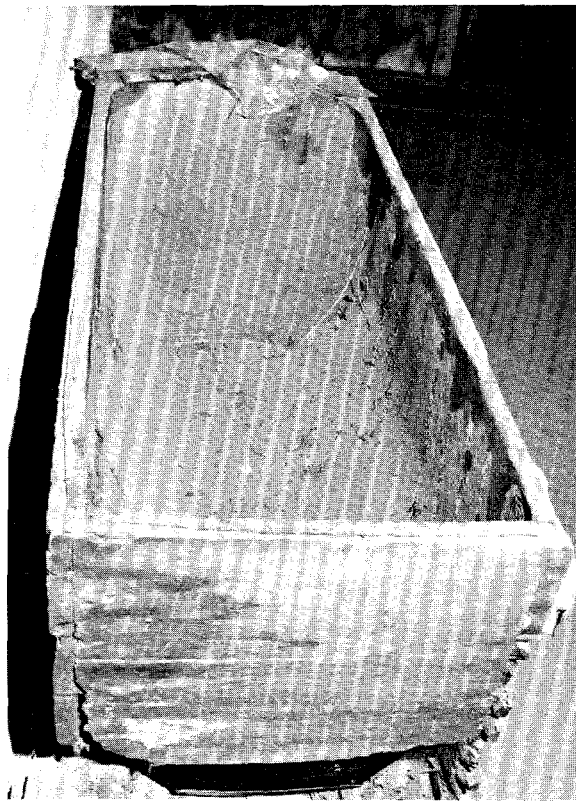
IP099, N007-26. Historic bathtub and case. Note dovetailed joints.

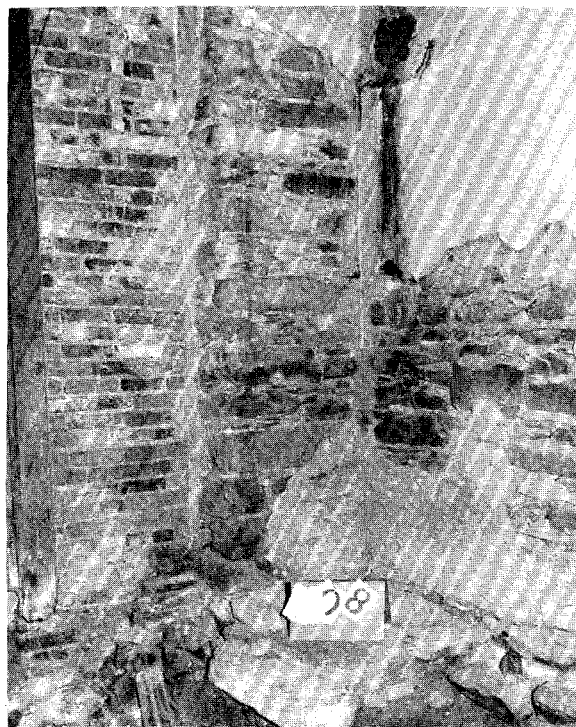
IP100, N009-18. Room 009, brick platform at southeast corner and stovepipe hole above.

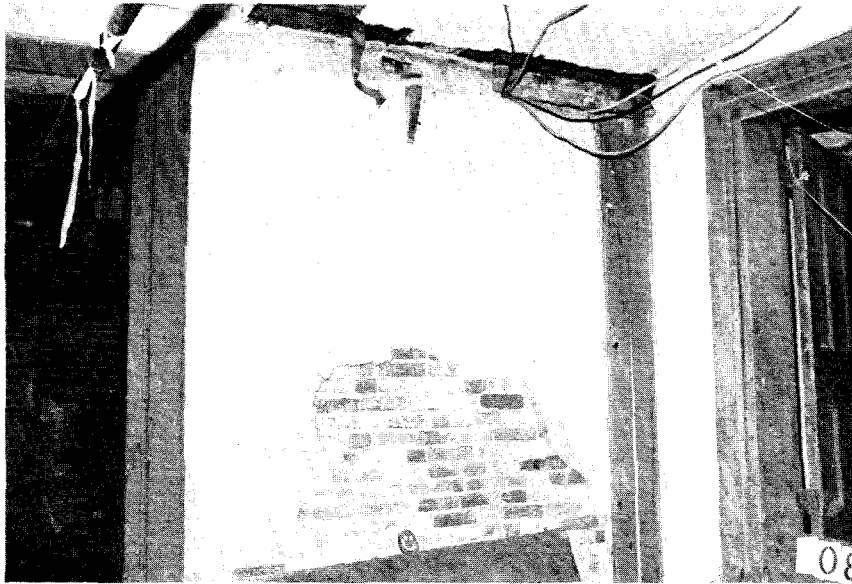
IP101, N009-20. Room 009, northeast corner. Note remains of wooden pipe chase.

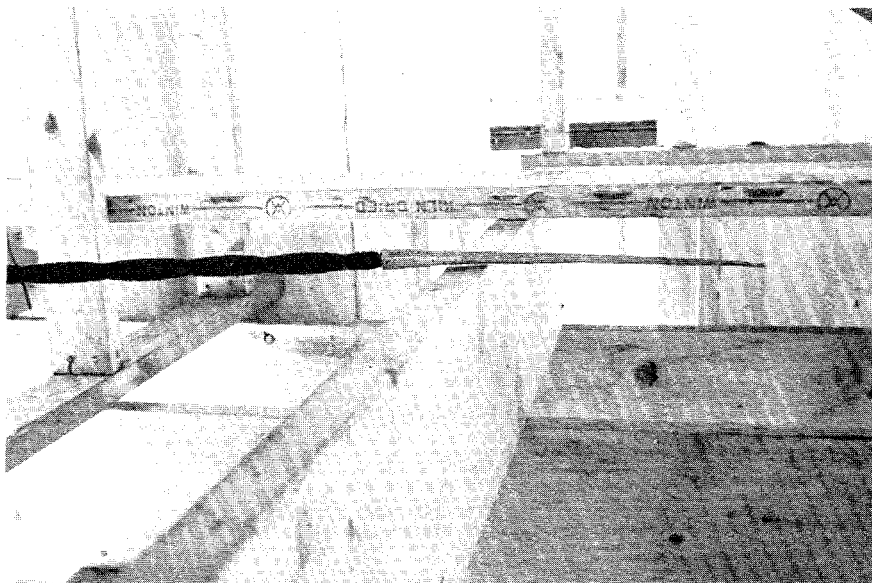
IP102, N031-36. Copper point attached to spiral fluted iron lightning rod.

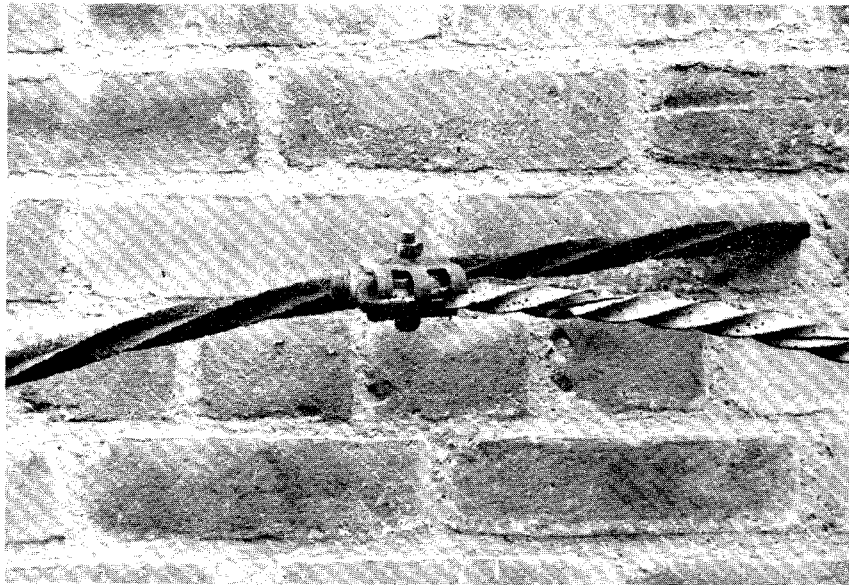
IP103, N050-12. Detail of iron lightning rod.

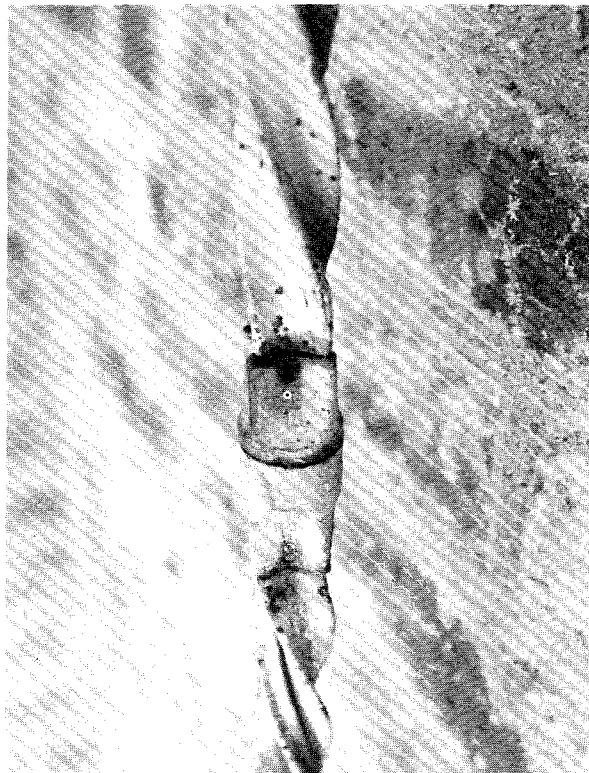
IP104, N034-9. Detail of more recent sheet copper spiral fluted rod with brass connectors marked "RHCO."

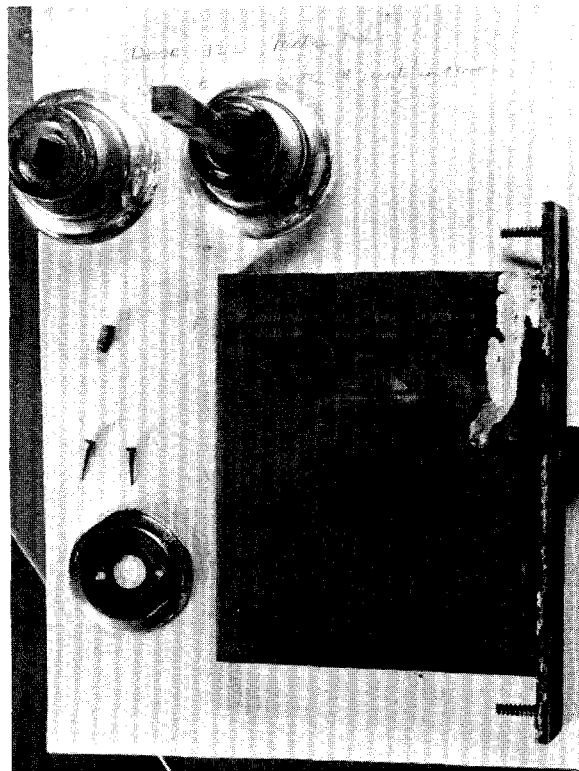
IP123, N037-33. Lock 136, with tumbler removed.

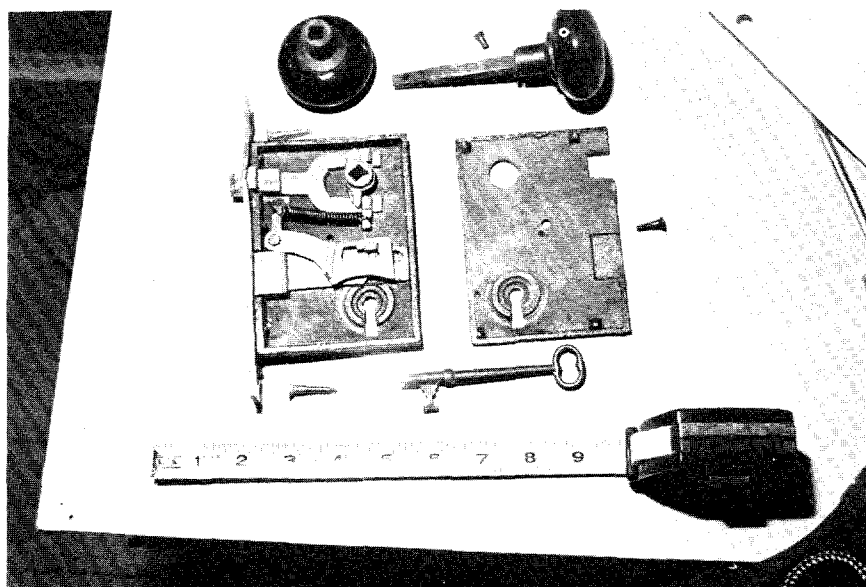
IP125, N016-21. Lock 133, with cover removed.

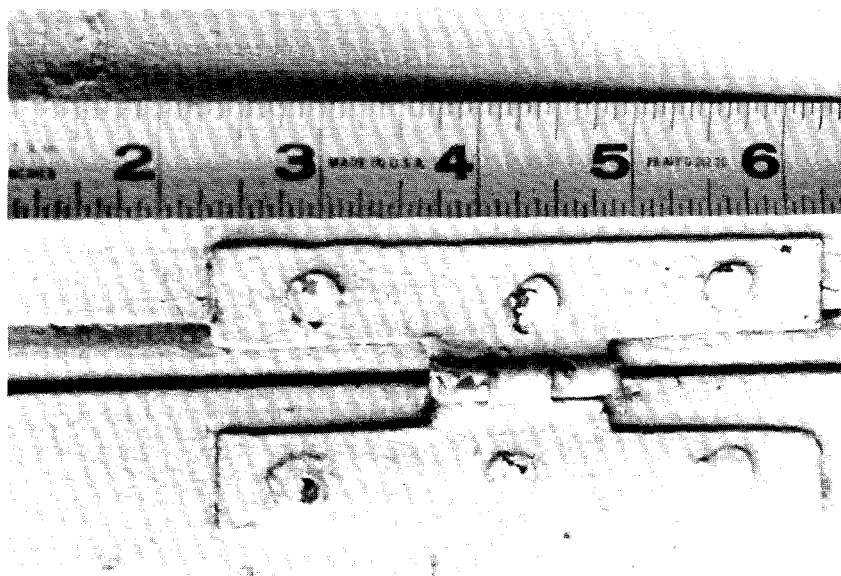
IP127, N027-25. Wrought-iron strap hinge typical for ca. 1797 basement board-and-batten doors.

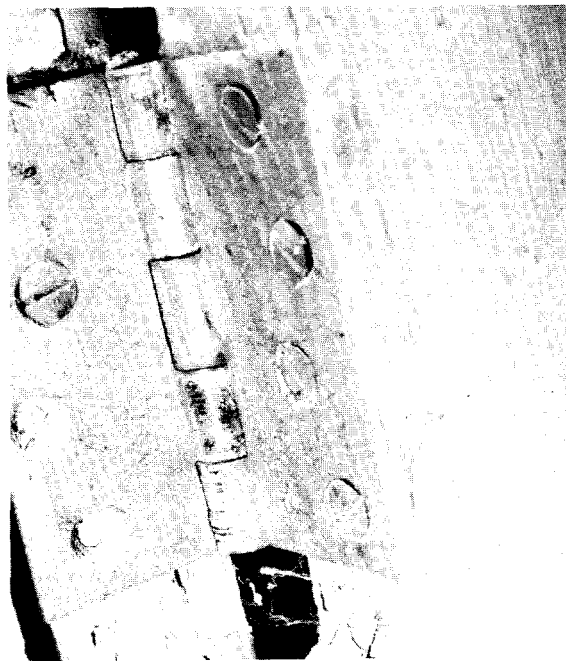
IP129, N030-06. Door 210, typical mounting of HL hinges on ca. 1797 door.
