historic structure report
architectural data section
volume 2: appendixes

MARTIN VAN BUREN

NATIONAL HISTORIC SITE / NEW YORK

LINDENWALD

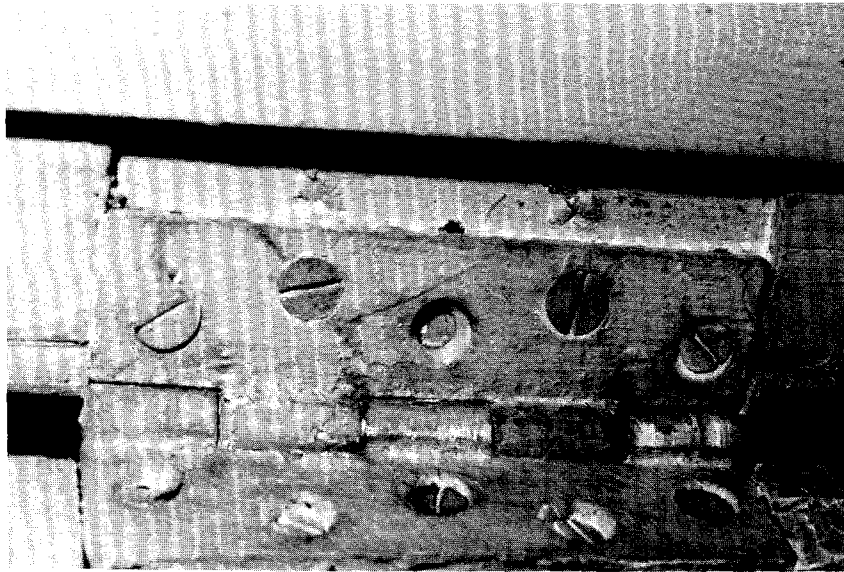
IP130, N037-28. 4" by 4" five-knuckle, eight-hole cast-iron butt hinge.

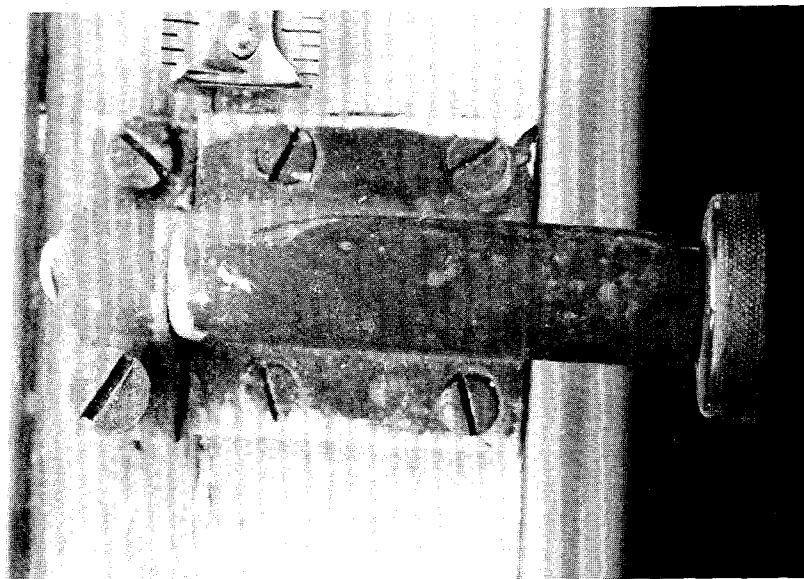
IP131, N037-27. 5" by 3" five-knuckle, ten-hole cast-iron butt hinge.

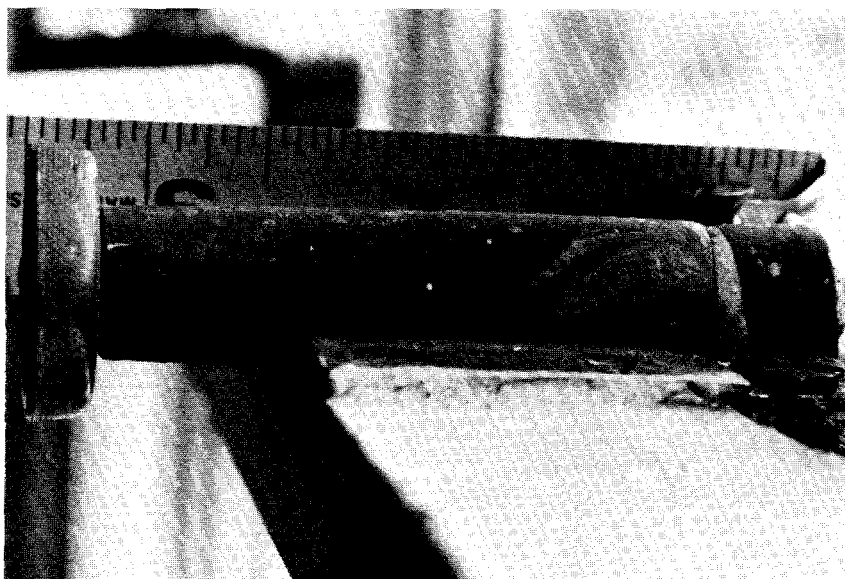
IP132, N036-28. Ca. 1840 sash lock.

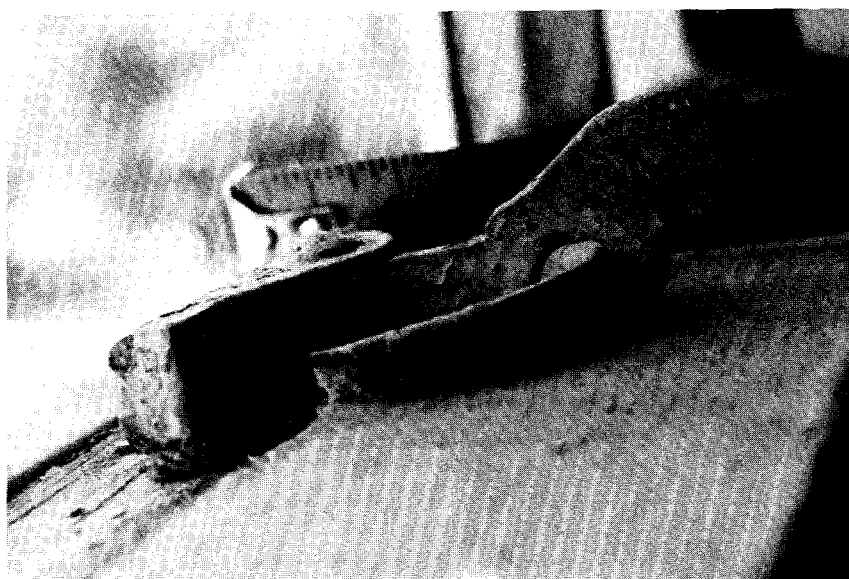
IP133, N036-40. Ca. 1840 sash lock.

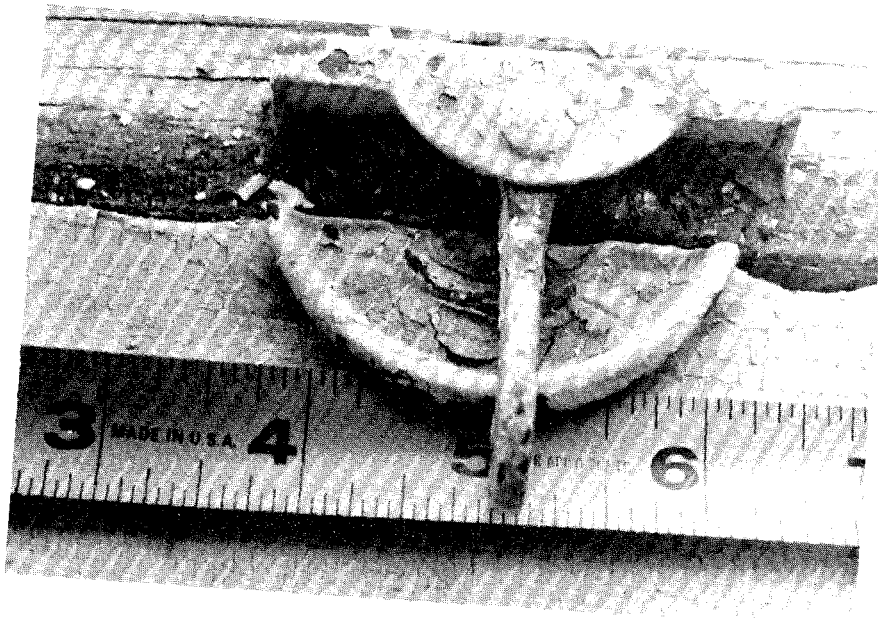
IP134, N036-27. Ca. 1850 sash lock.

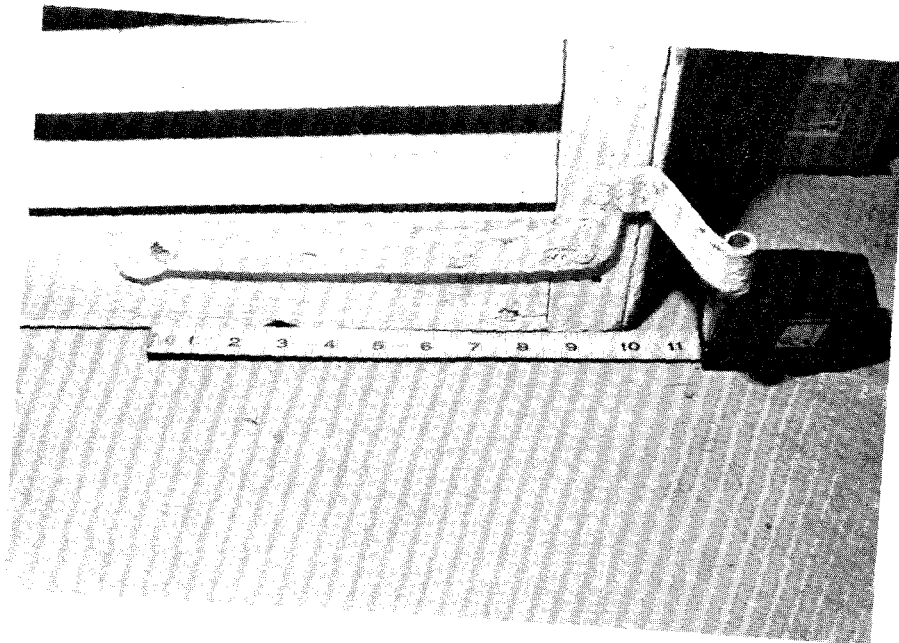
IP135, N036-26. Ca. 1850 sash lock.

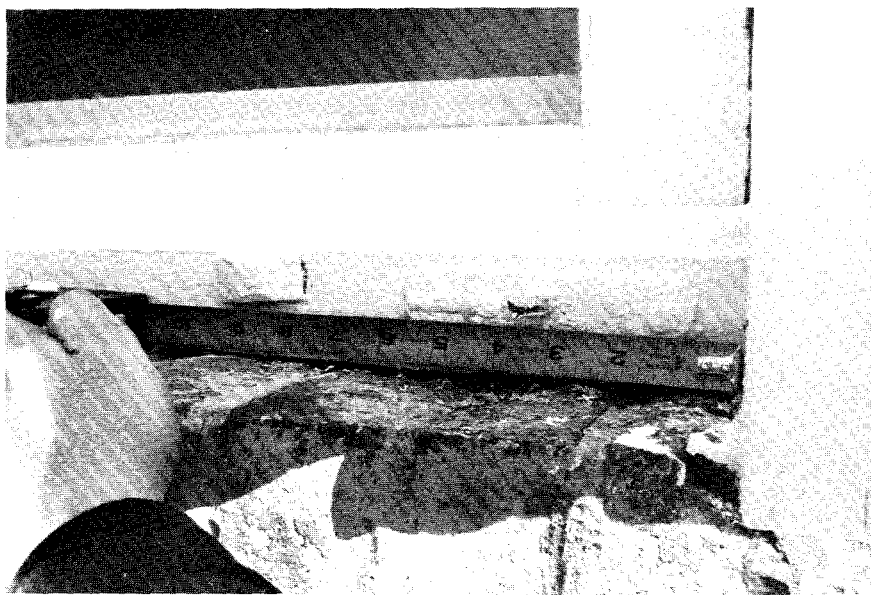
IP136, N033-16. Wrought-iron hinge for exterior shutter blind.

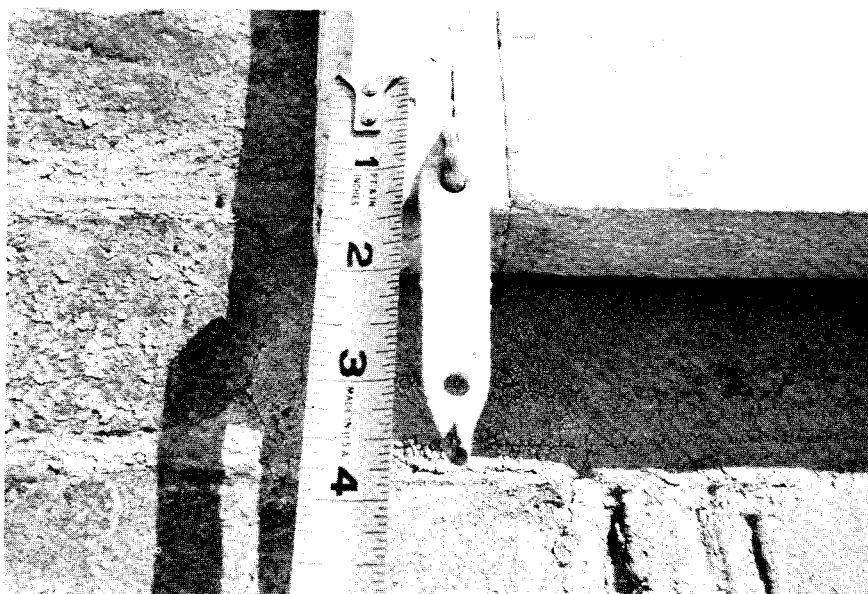
IP137, N034-04. Wrought-iron pintle for exterior shutter blinds.

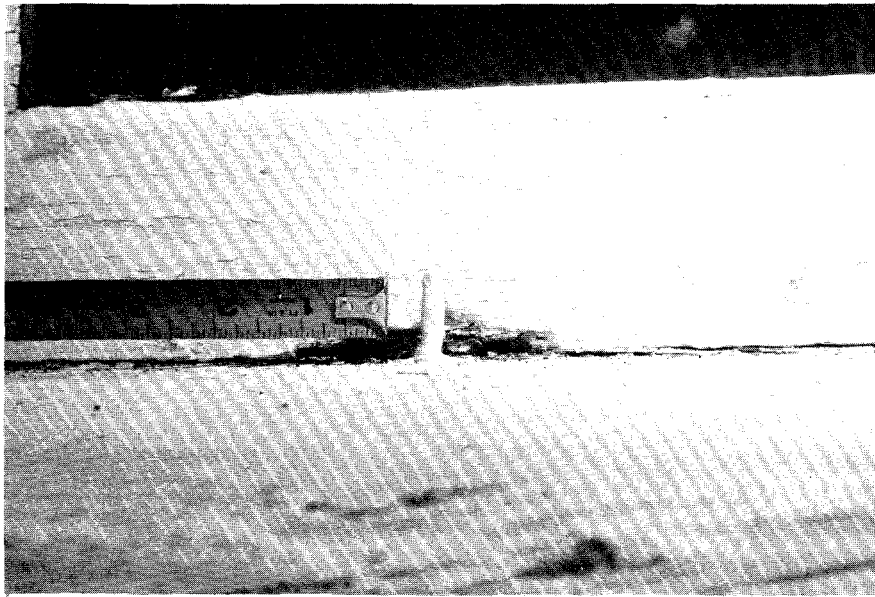
IP138, N033-17. Fastener for exterior shutter blinds.

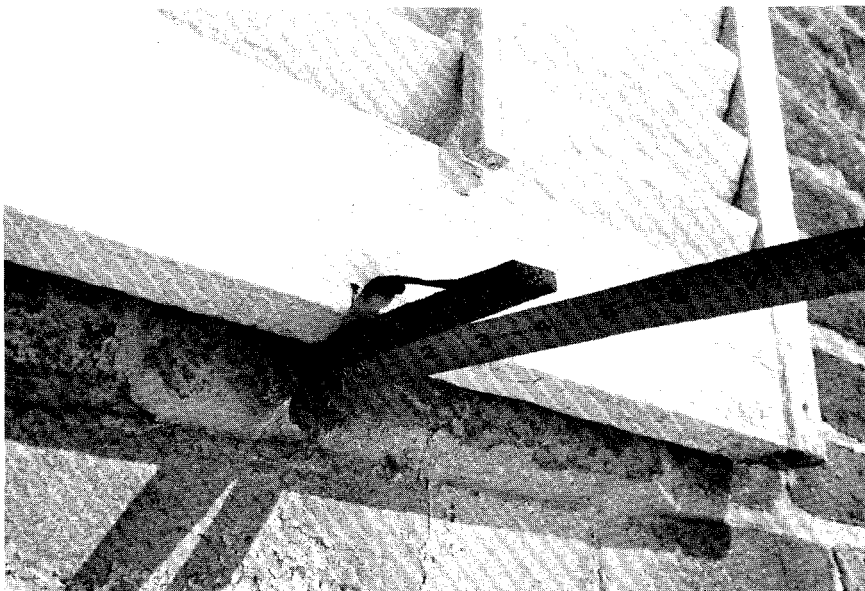
IP139, N033-19. Post for above fastener.

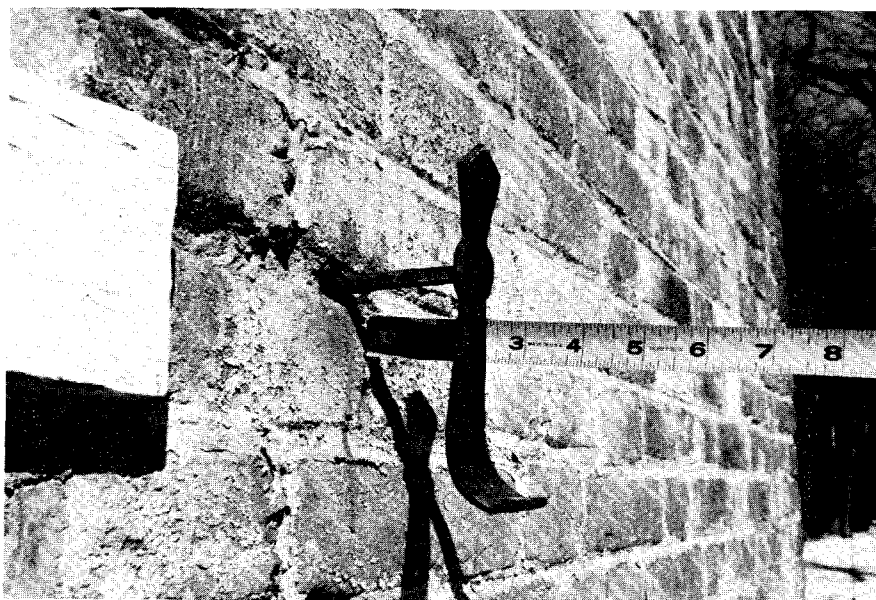
IP140, N033-18. Spring-type shutter holdback.

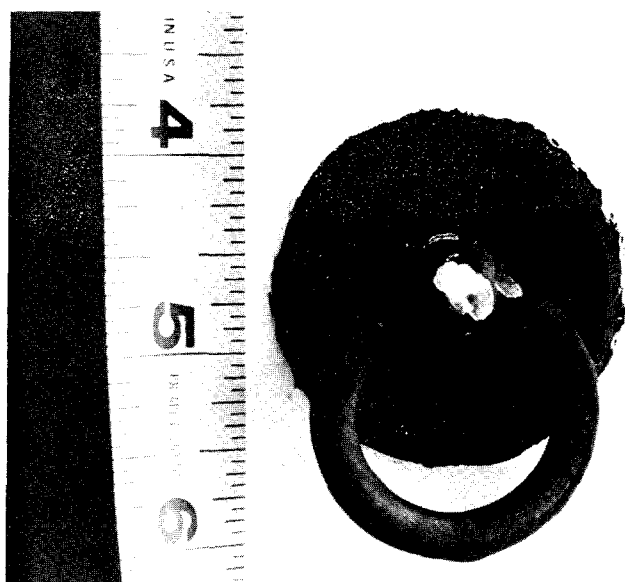
IP141, N034-03. Propeller-type shutter holdback.

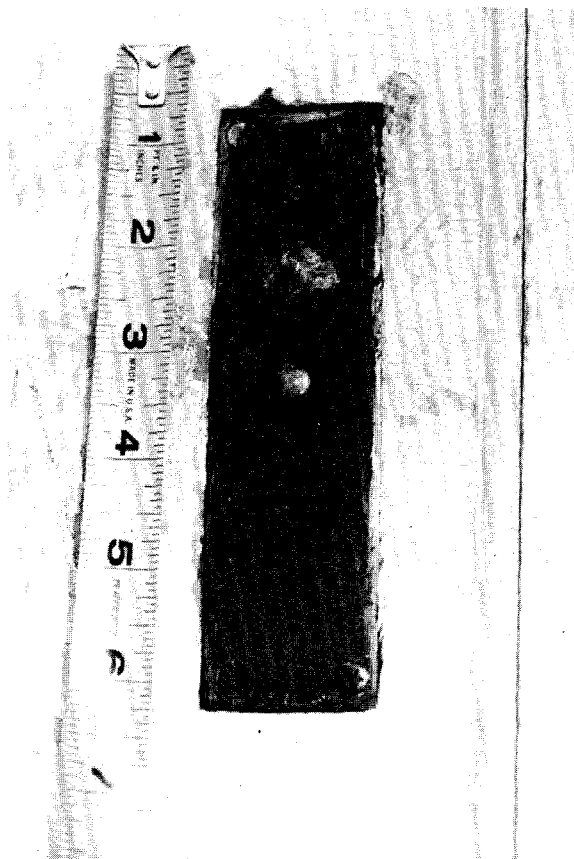
IP143, N036-34. Bar hardware for ca. 1797 interior shutters.

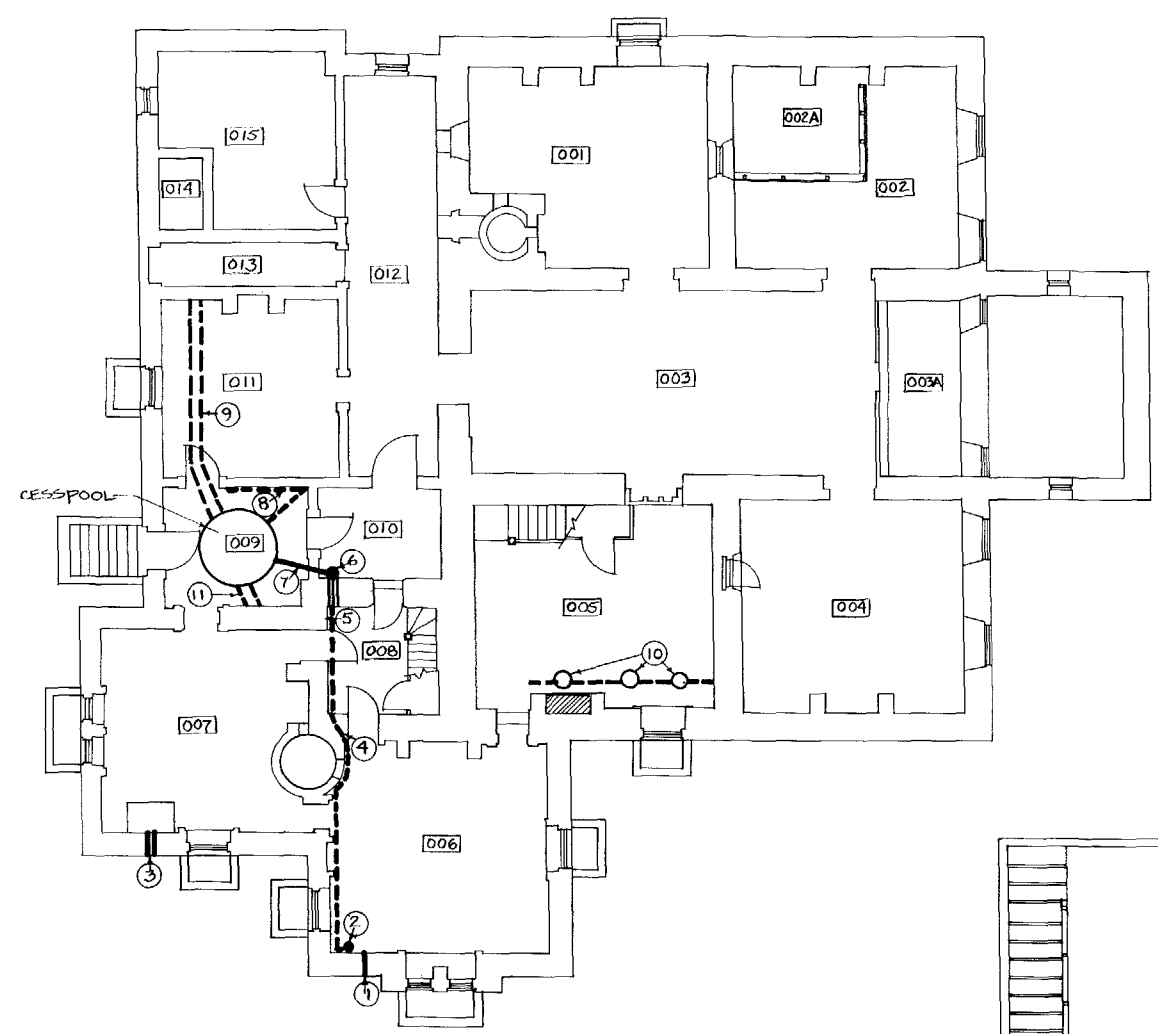
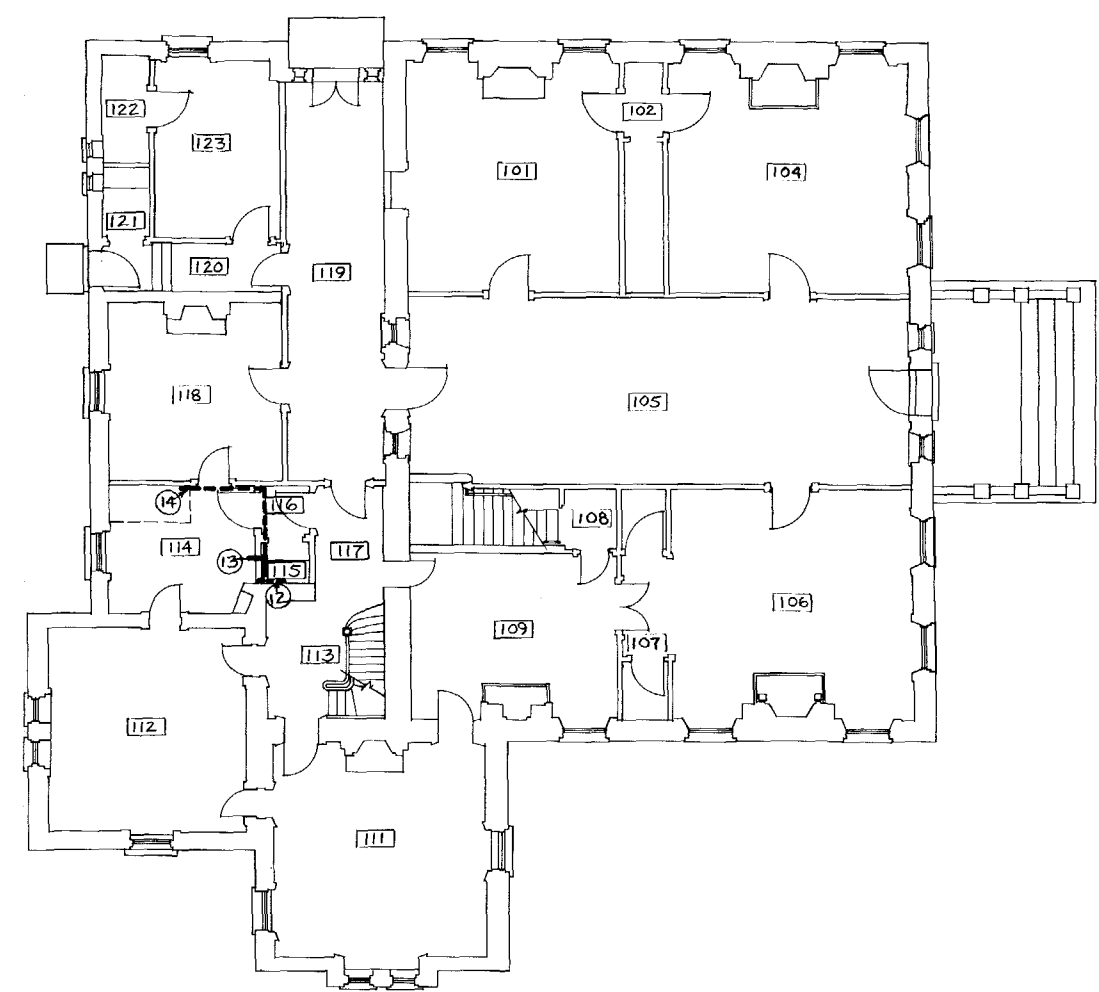
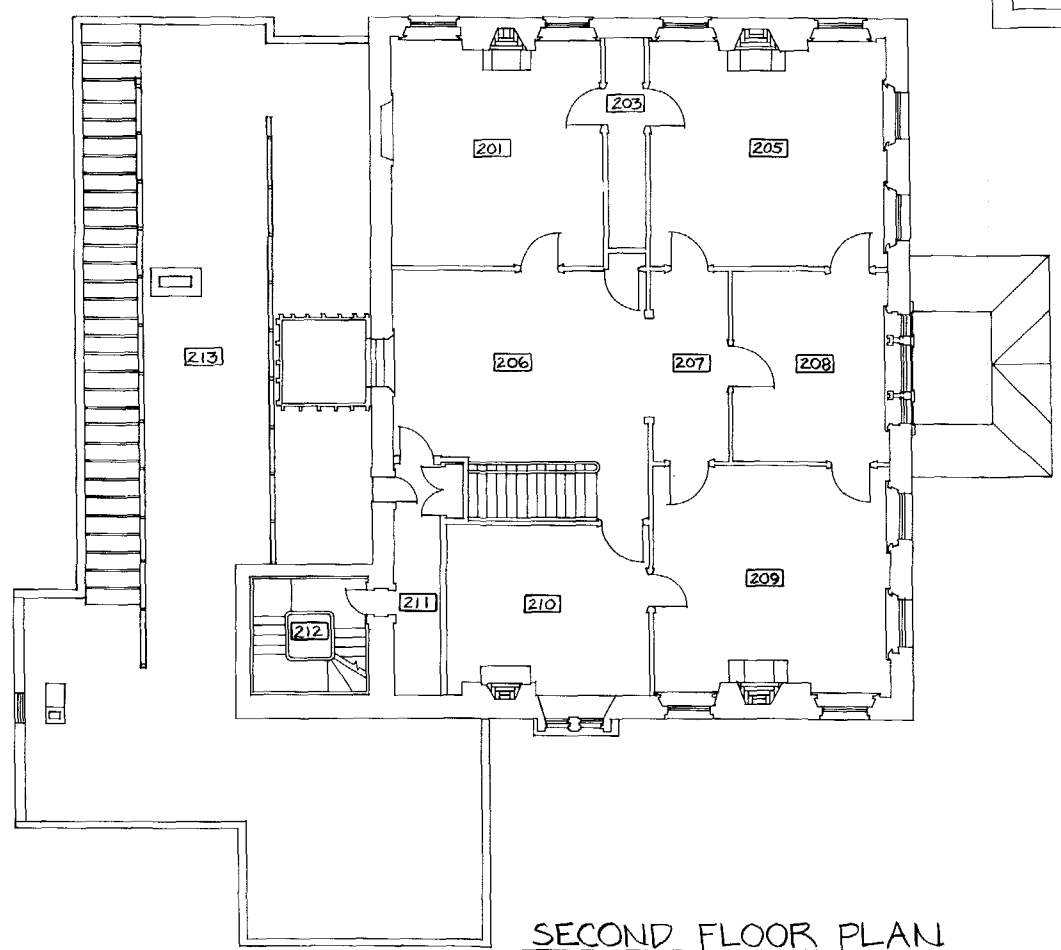
- ⑫ THREE (3) PIPES FROM BASEMENT THAT RUN INTO WATER TANK
- ⑬ SUPPLY PIPE FROM WATER TANK TO SINK (PIPE STILL IN PLACE)
- ⑭ SUPPLY PIPE FROM WATER TANK TO BATHTUB. THIS PIPE RUNS OUT OF THE LOWER WEST SIDE OF THE WATER TANK. IT HAS BEEN CUT OFF. PIPE CLIPS AT HOLE IN THE WALL BETWEEN ROOMS 114 AND 116, AND A PAINT ANALYSIS INDICATES THE ROUTE OF THE PIPE.

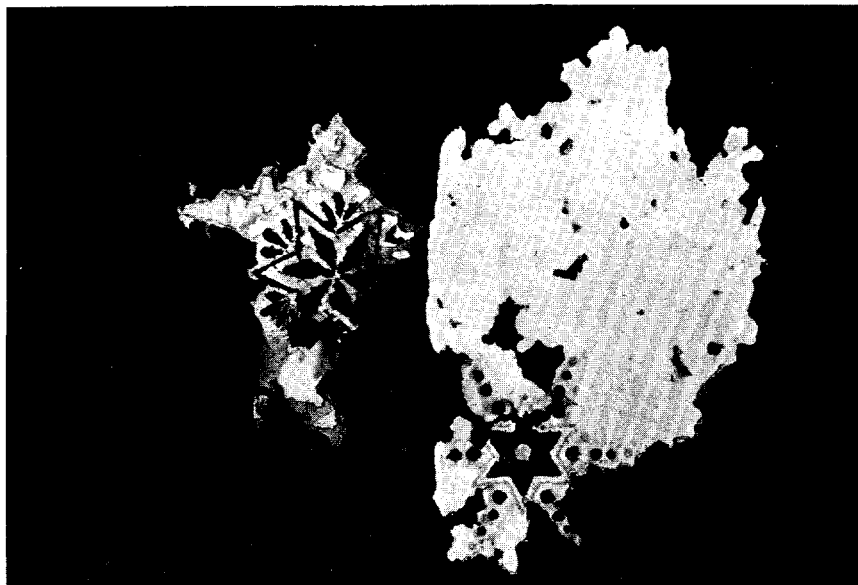
Sample No: MAVA 01 WP003
Location: Room 104 (east wall)
Substrate: Plaster

Comments: A full panel of this wallpaper was found on the east wall of room 104 when the pier mirror between the windows were removed. The wallpaper is lined with the green print lining paper used in room 105.

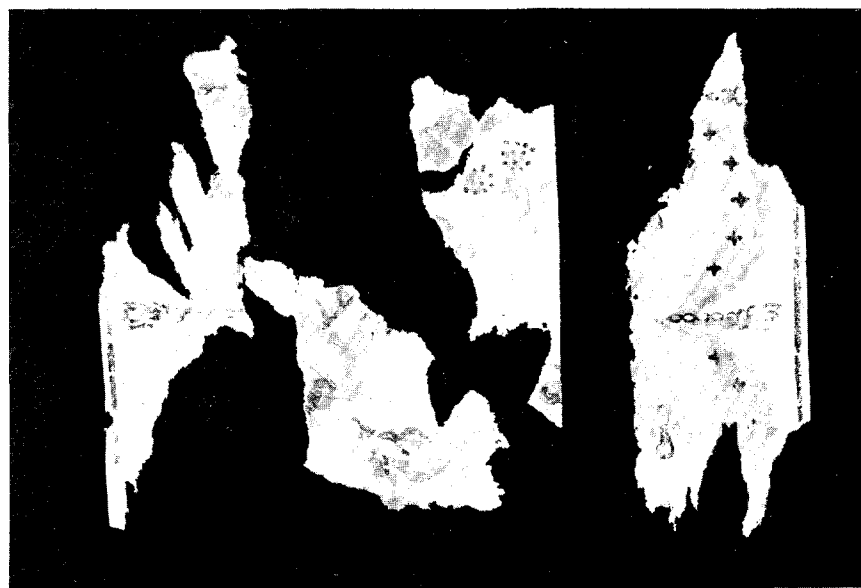
Sample No: MAVA 01 WP004
Location: Room 106
Substrate: Plaster

Comments: This paper was found on the east wall of room 106, behind the pier mirror that hung between the windows. It was covered by two later layers of wallpaper before the pier mirror was hung. The wallpaper does not extend across the chair rail area. The border ran down the sides of the windows as well as at the cornice. The paper has horizontal seams, indicating that it was handmade. A portion of this wallpaper is still on the walls and should be conserved.

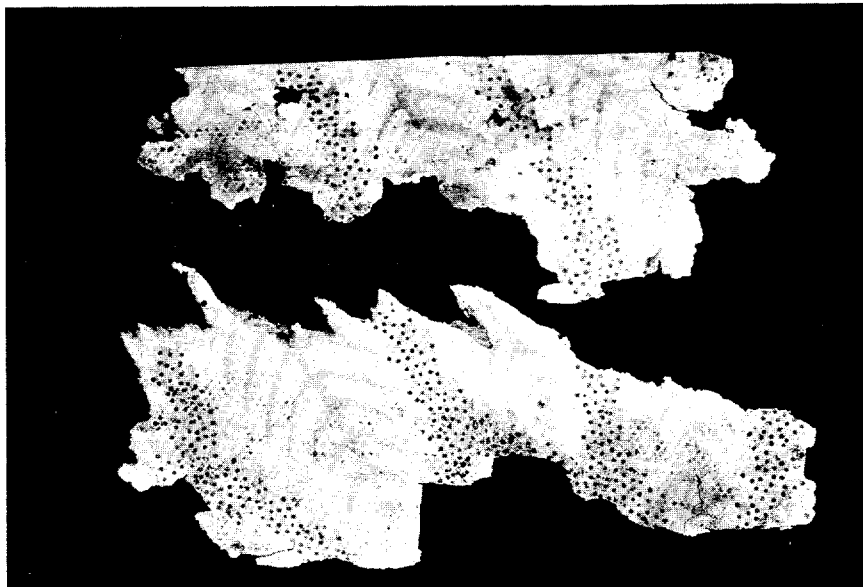
Sample No: MAVA 01 WP 005
Location: Room 106 (east wall)
Substrate: Plaster

Comments: This is the second layer of wallpaper (counting up from the plaster) found under the pier mirror in room 106. It does not extend across the area from which the chair rail was removed, indicating that it predates Van Buren. Part of a strip of this wallpaper is still on the walls and should be conserved.

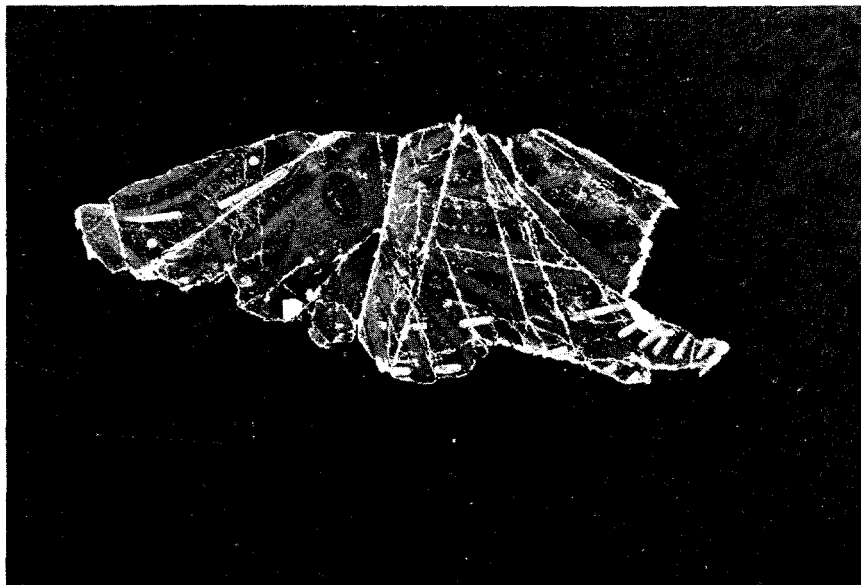
Sample No: MAVA 01 WP009
Location: Room 109 (north wall
under stair platform)
Substrate: Plaster

Comments: This sample was found under the stair platform of room 109. It was loose and therefore cannot be positively identified as having come from this room. The fragment is too small to be used as the basis for a reproduction wallpaper.

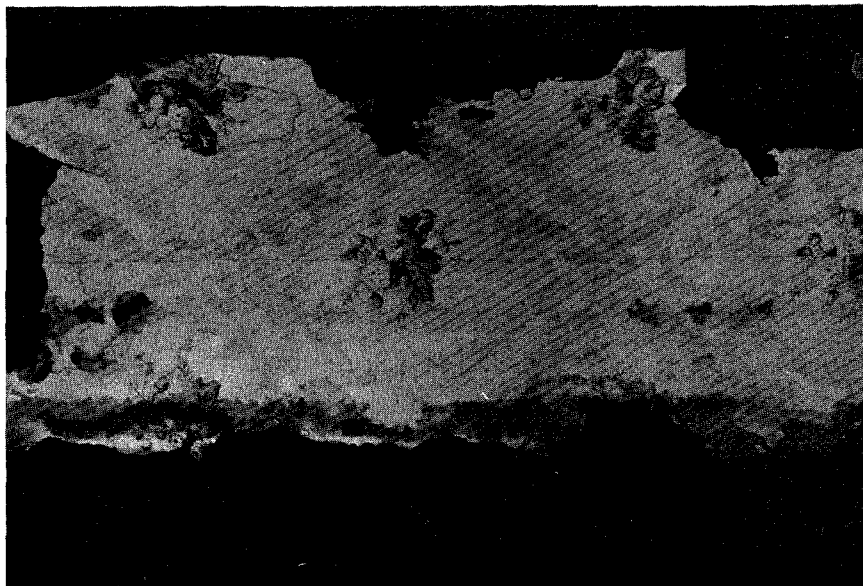
Sample No: MAVA 01 WP012
Location: Room 112 (behind door
124 casing)
Substrate: Plaster

Comments: This sample is the second layer of wallpaper (counting up from the plaster) found under the casing of door 124.

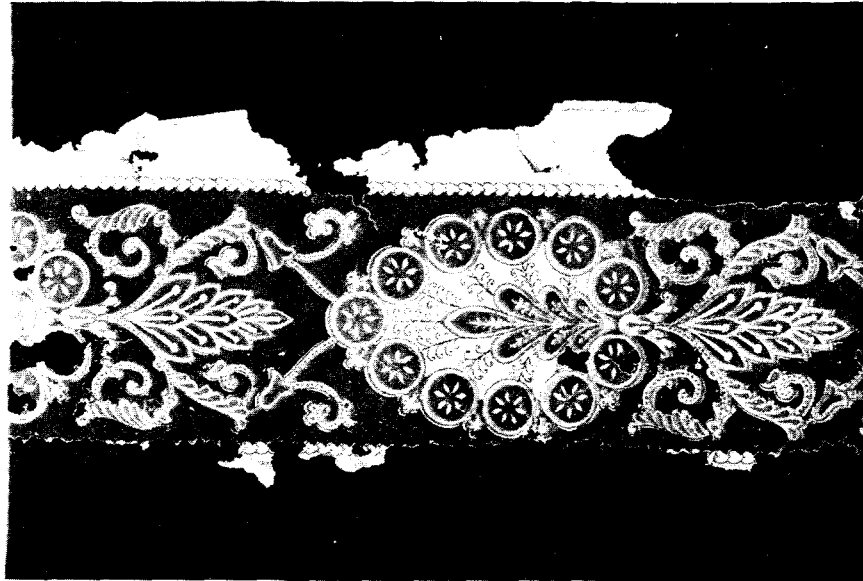
Sample No: MAVA 01 WP013
Location: Room 112 (behind door
124 casing)
Substrate: Plaster

Comments: This sample is the third layer of wallpaper (counting up from the plaster) found under the casing of door 124.

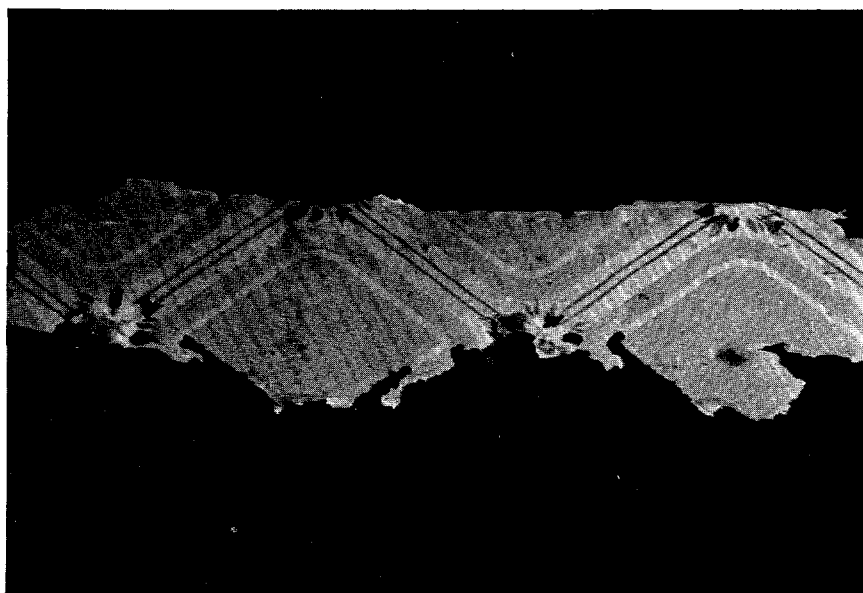
Sample No: MAVA 01 WP014
Location: Room 118 - behind
door 116 casing)
Substrate: Plaster

Comments: This wallpaper sample was found under the casing of door 116. Physical evidence found in rooms 114 and 118 indicate that this alteration was made in the latter part of the 19th century.

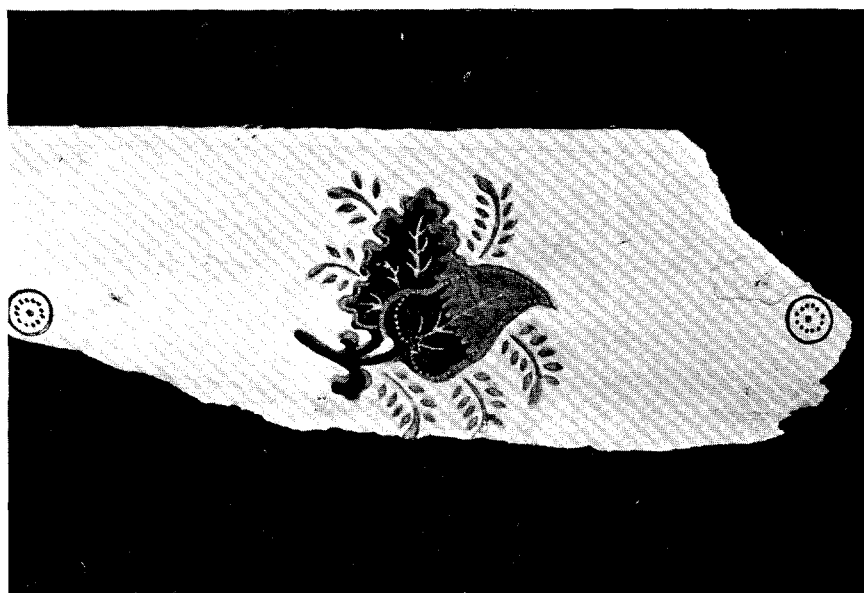
Sample No: MAVA 01 WP018
Location: Room 205 (behind
door 206 casing)
Substrate: Plaster

Comments: This sample was found behind the casing of door 206 in room 205. This door was moved roughly 2' to the north of its original location ca. 1850 (see description of room 205). A second sample of this paper was found in room 105, sandwiched between the green lining paper and the Zuber scenic. The Zuber scenic was hung in 1841.
