# SAGAMORE HILL HOME OF THEODORE ROOSEVELT

Sagamore Hill National Historic Site  
Oyster Bay, New York

Historic Structure Report

Marie L. Carden  
with  
Richard C. Crisson

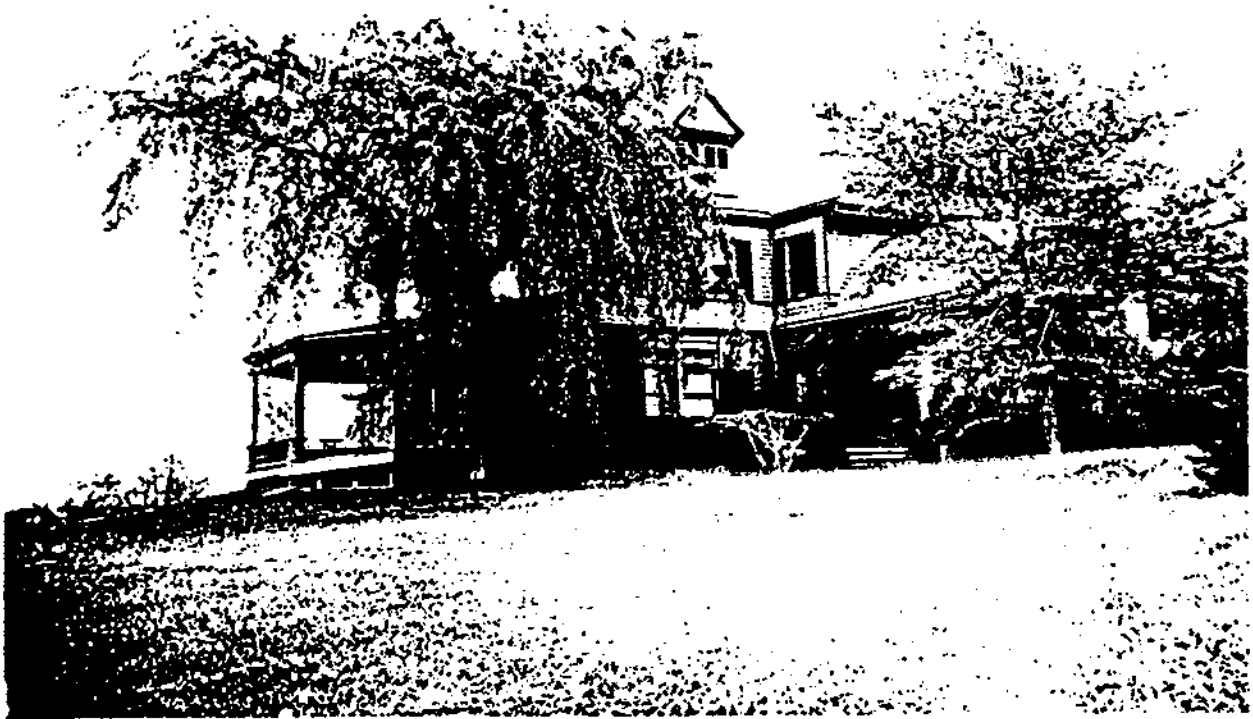
1. Sagamore Hill - c.1905

House had a polychromatic color scheme.

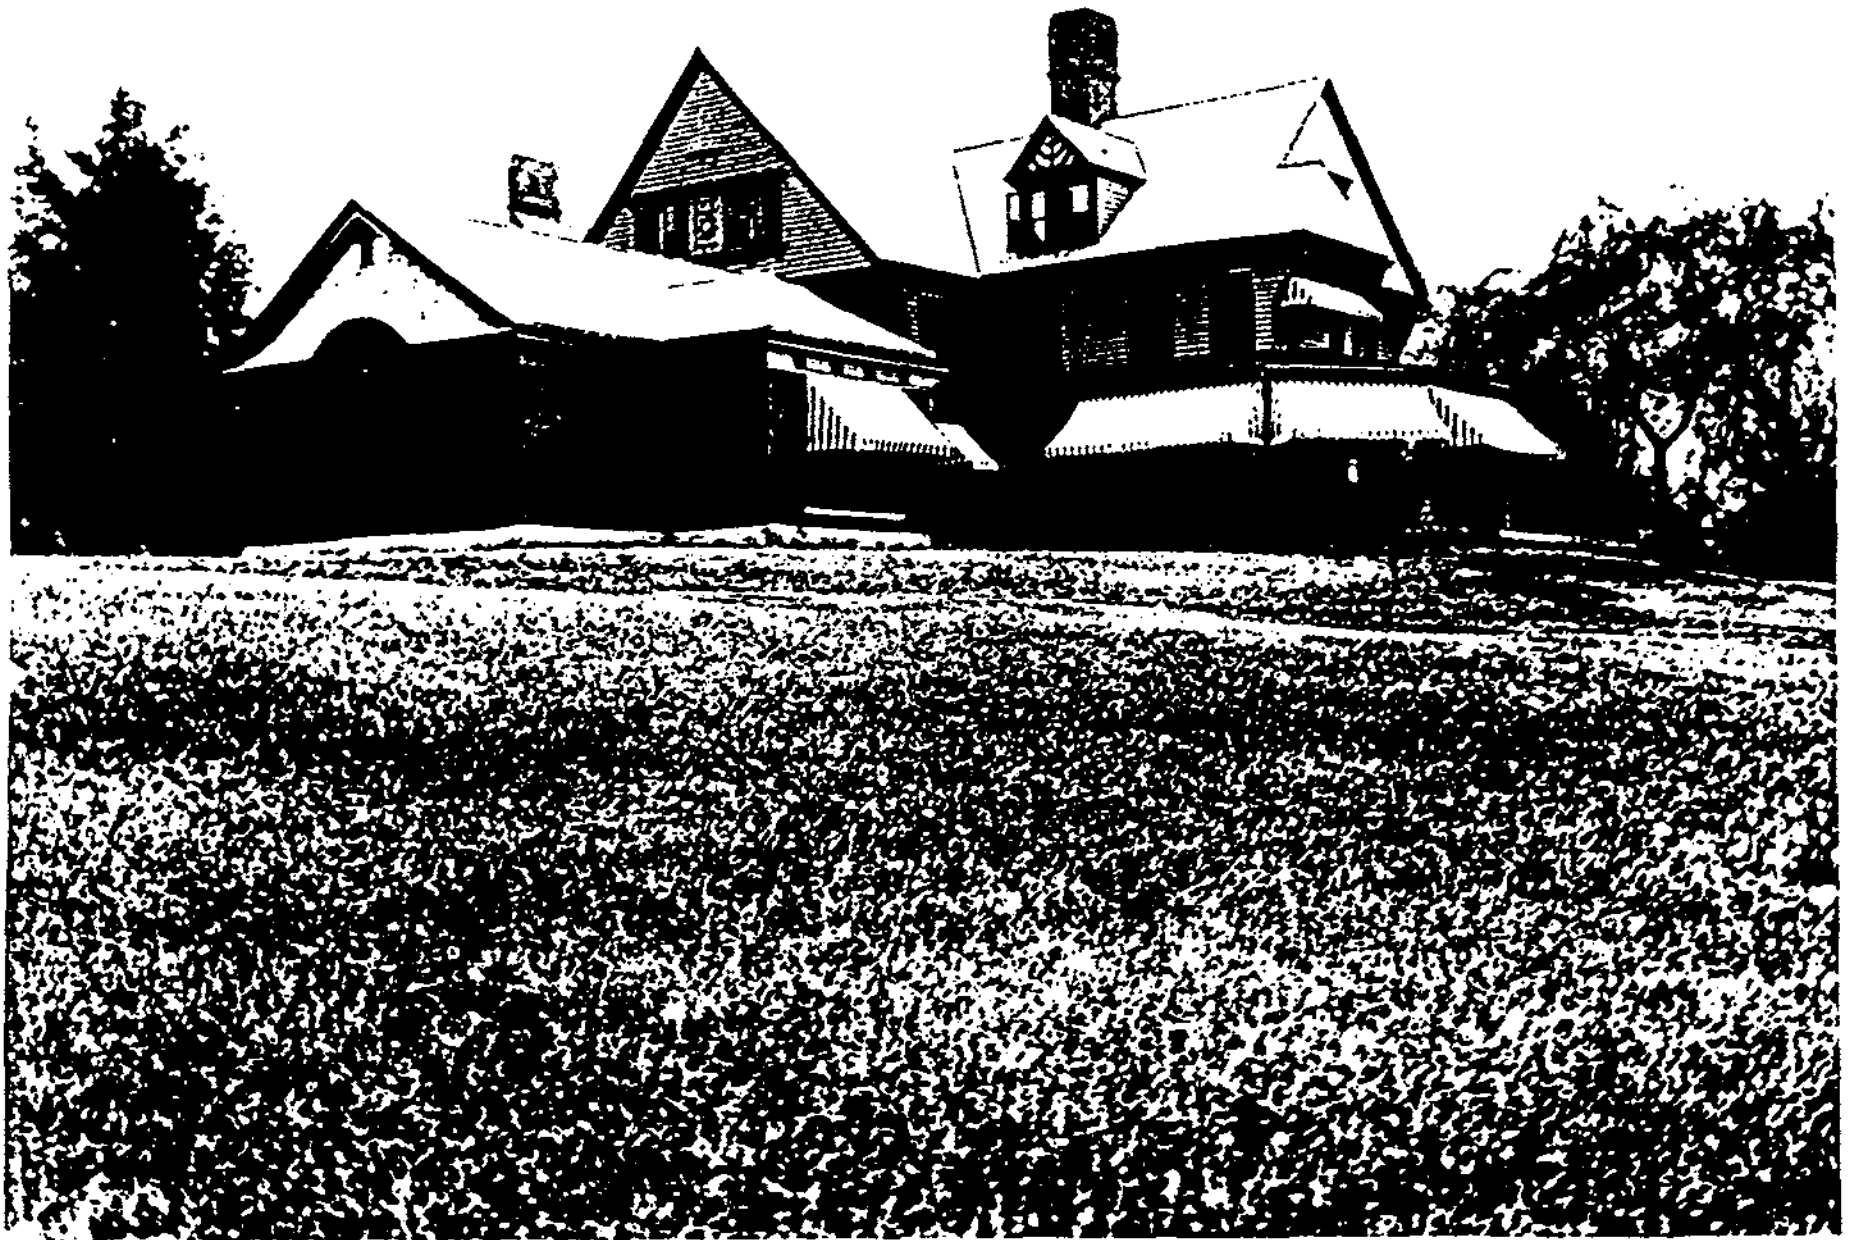
2. Sagamore Hill - c.1905

Trophy Room has been built. The shingles at the north end of the Trophy Room and the brick wall appear to be unpainted. The wood trim is painted a dark color. The c.1884 portico of the house has a polychromatic color scheme probably the brown and dark green.

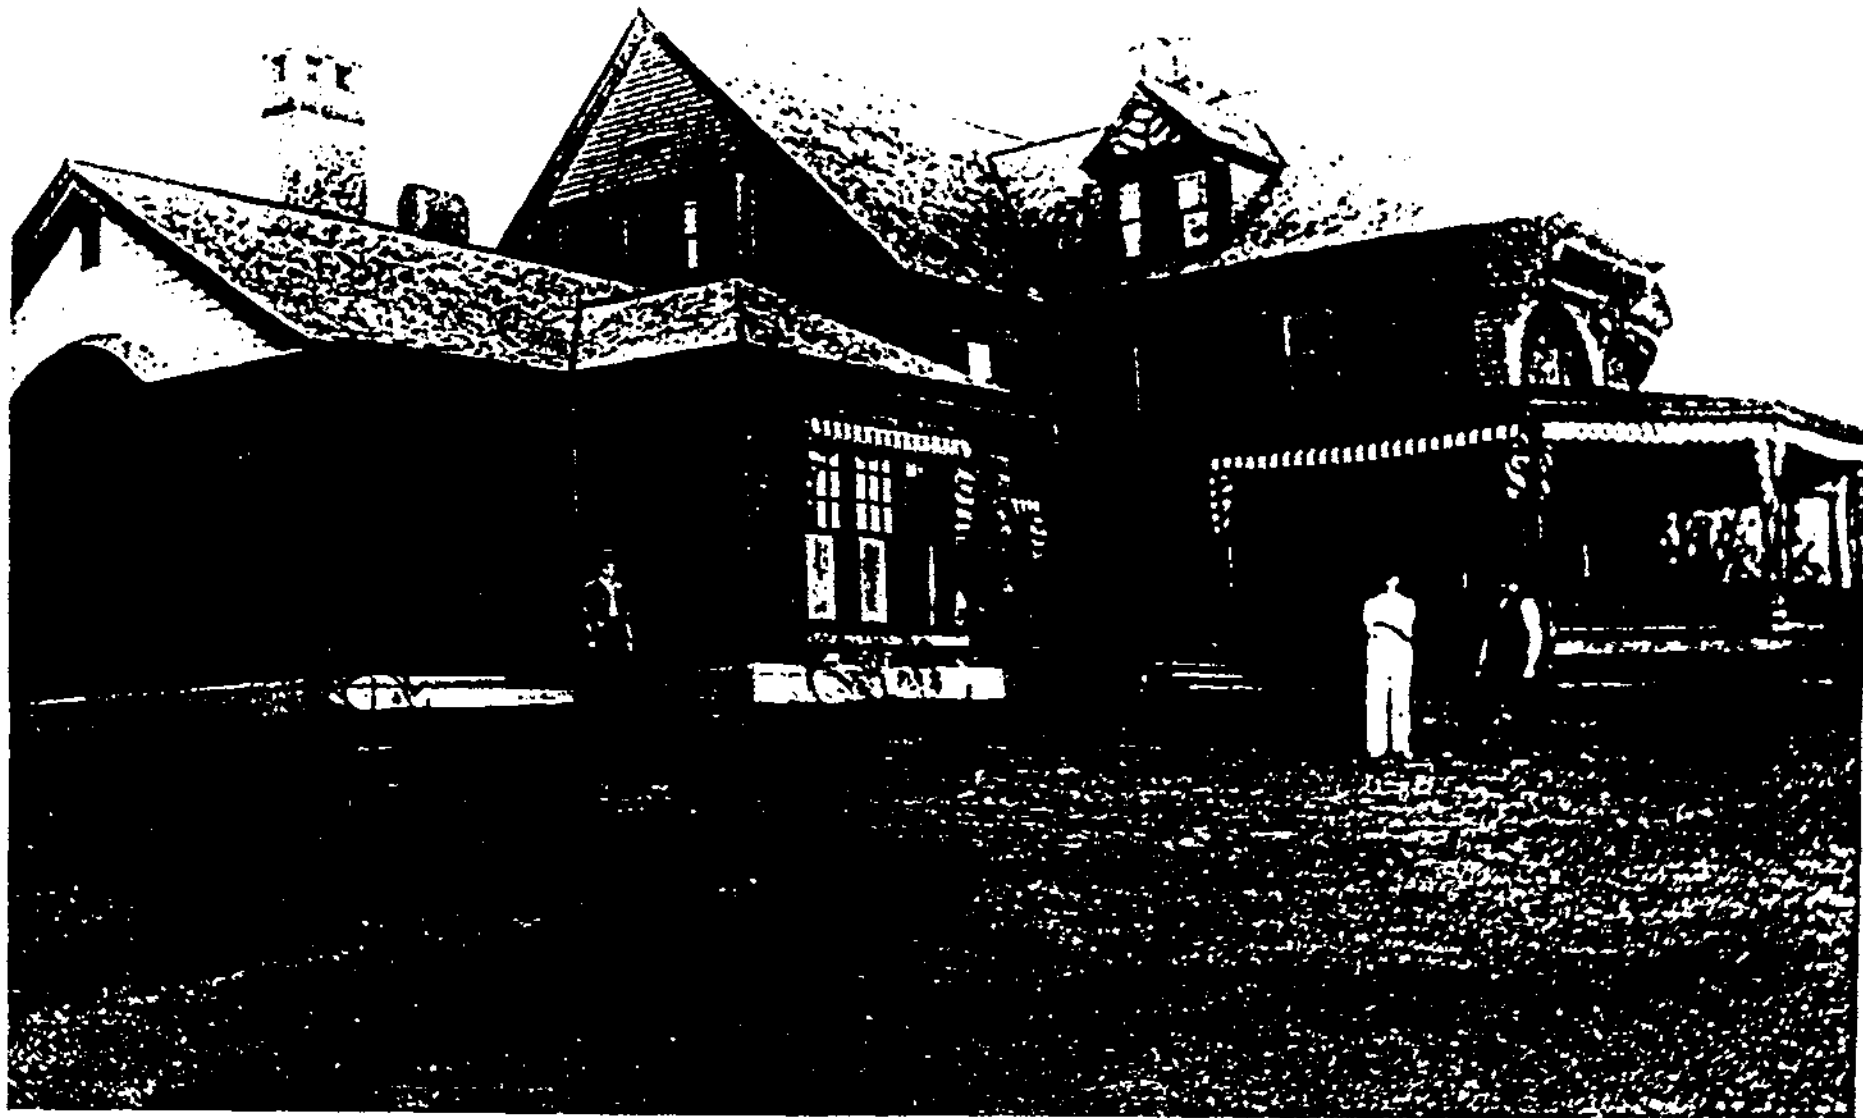
3. Sagamore Hill - c. 1905

Trophy Room has been built. The shingles at the north end of the Trophy Room and the brick walls appear to be unpainted. The wood trim is painted a dark color. The c.1884 portion of the house has a...

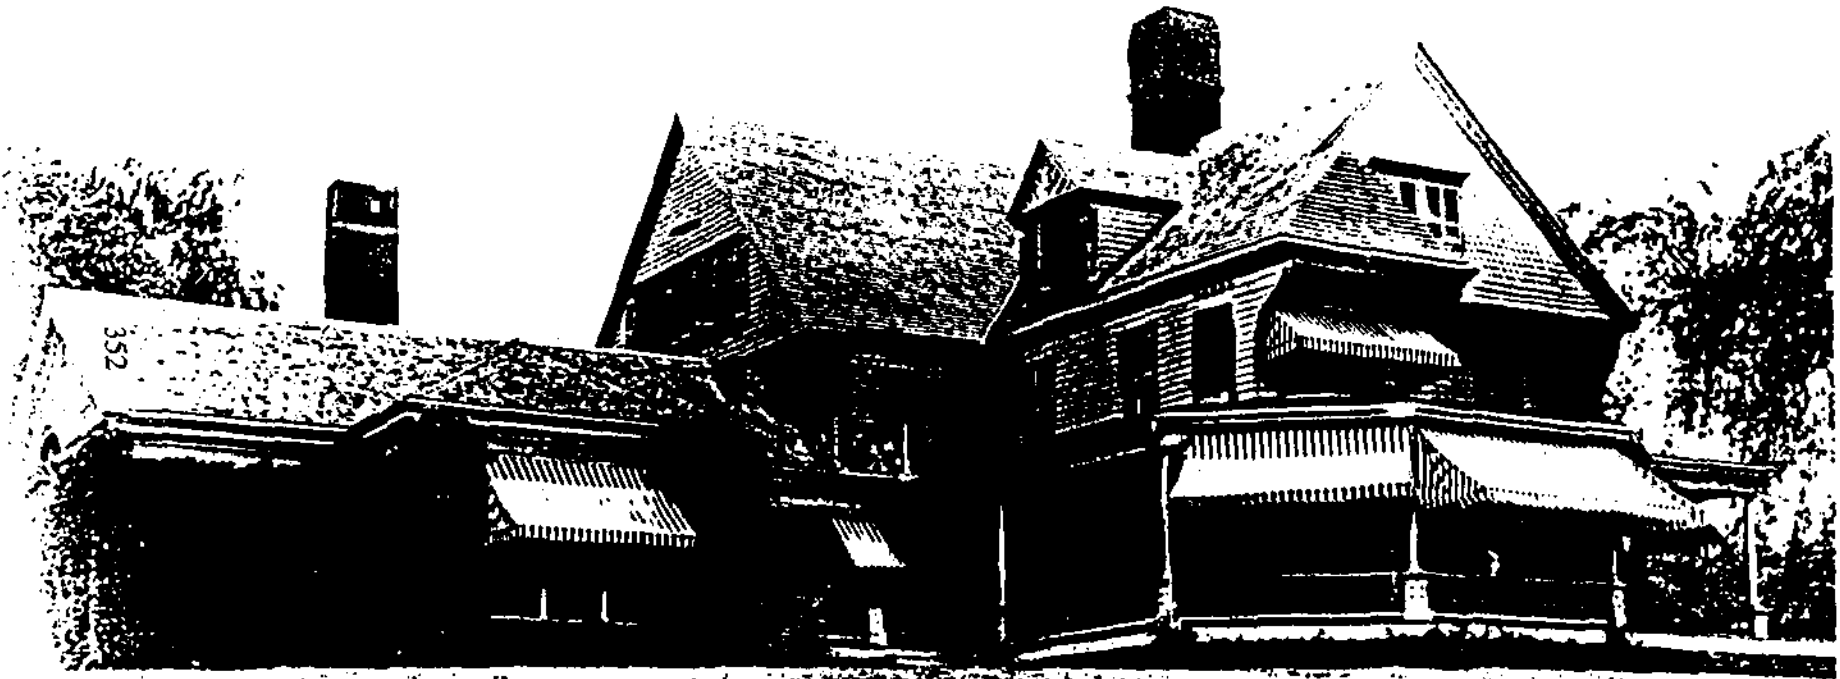
4. Sagamore Hill - c.1907  
House appears to have the monochromatic gray color scheme.

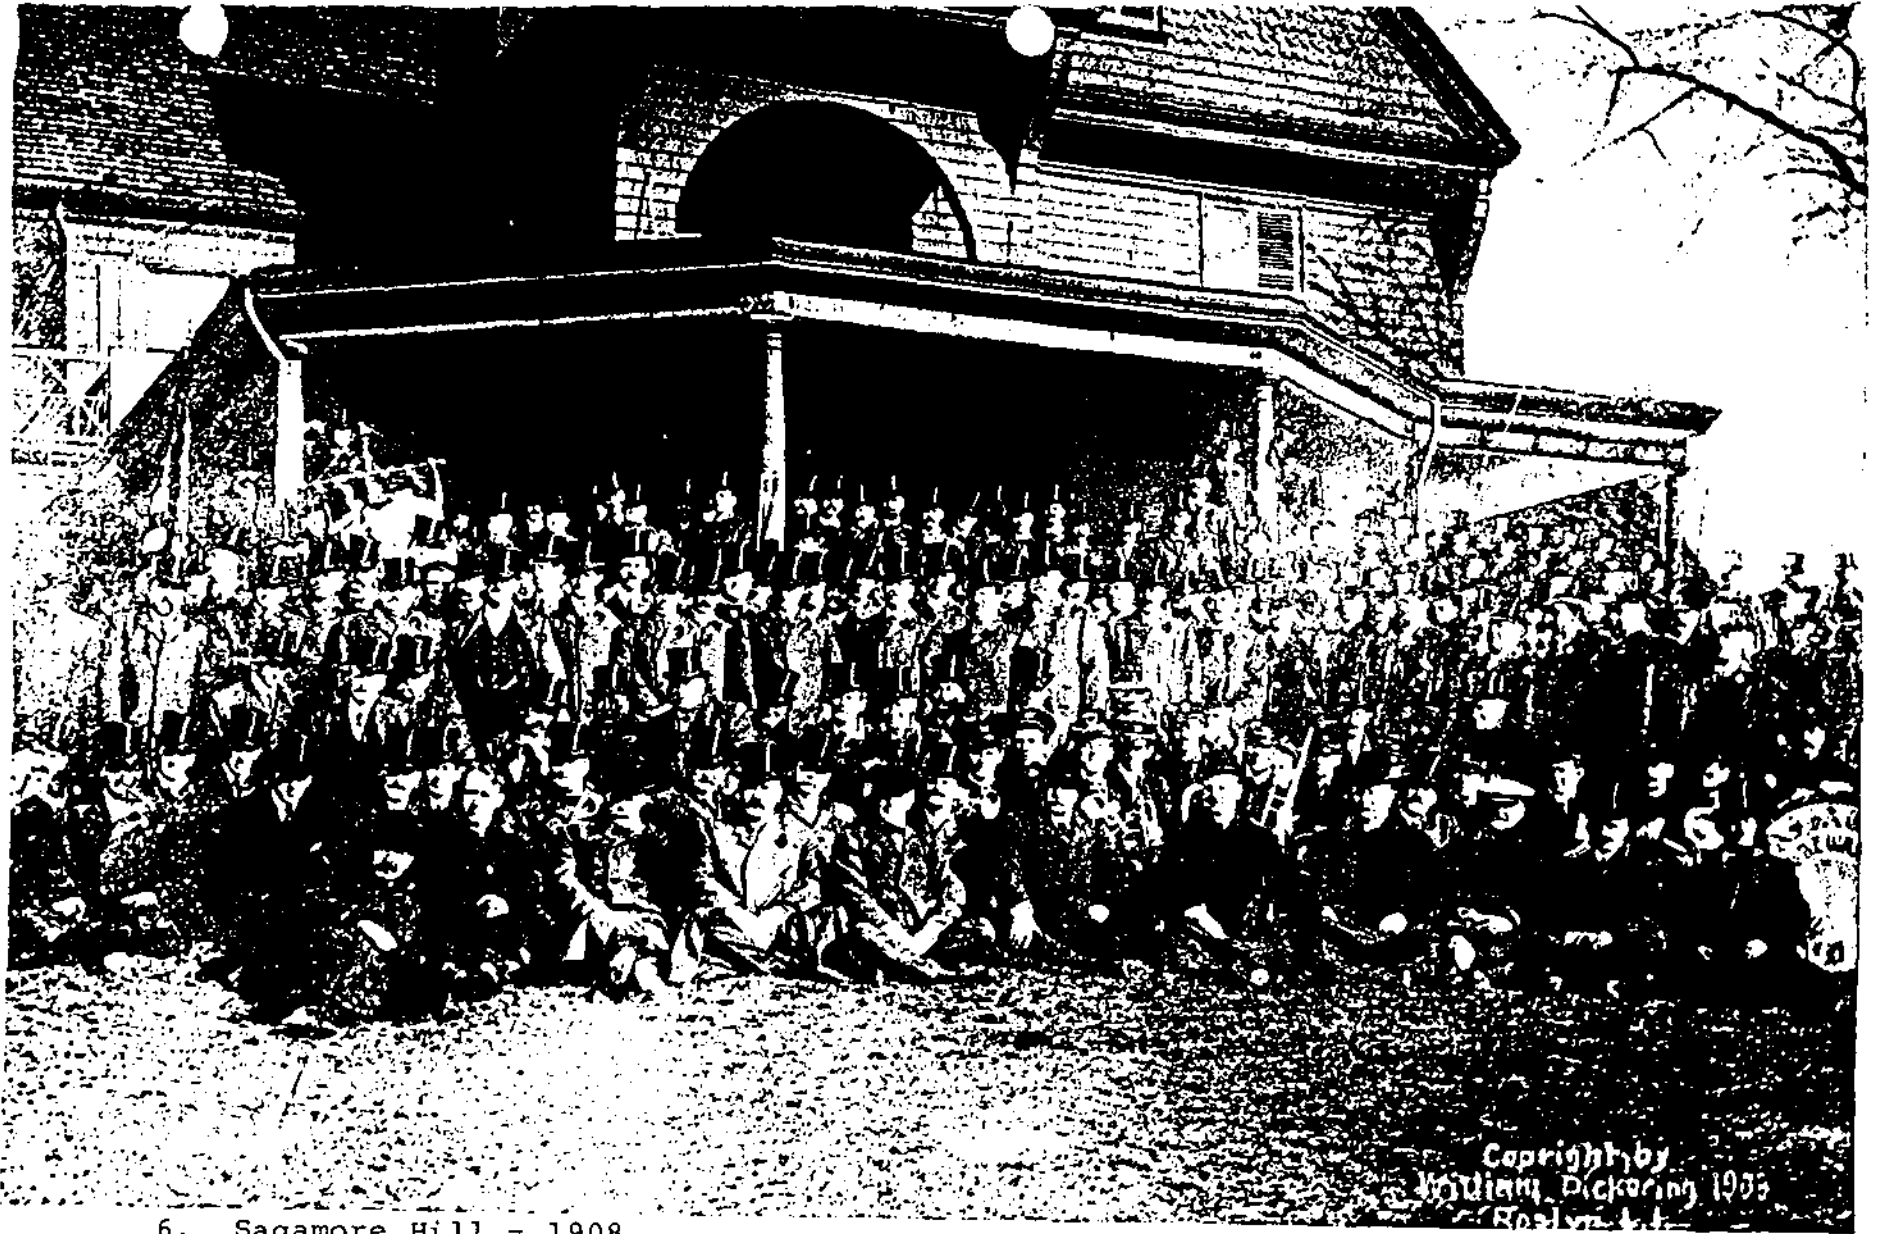
6. Sagamore Hill - 1908

House appears to have the monochromatic gray colorscheme.

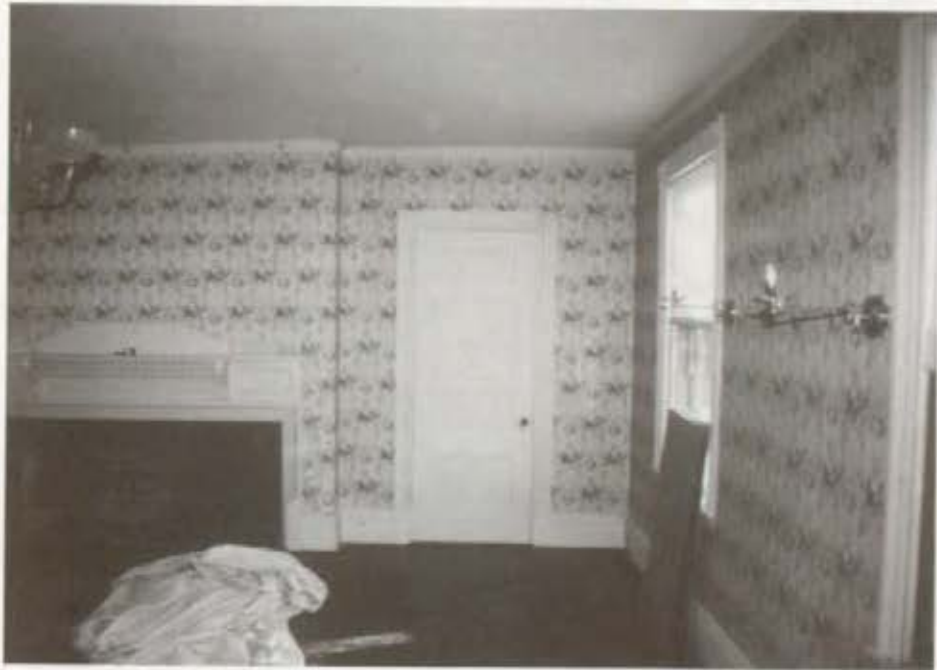
**South Bedroom: Before Restoration**

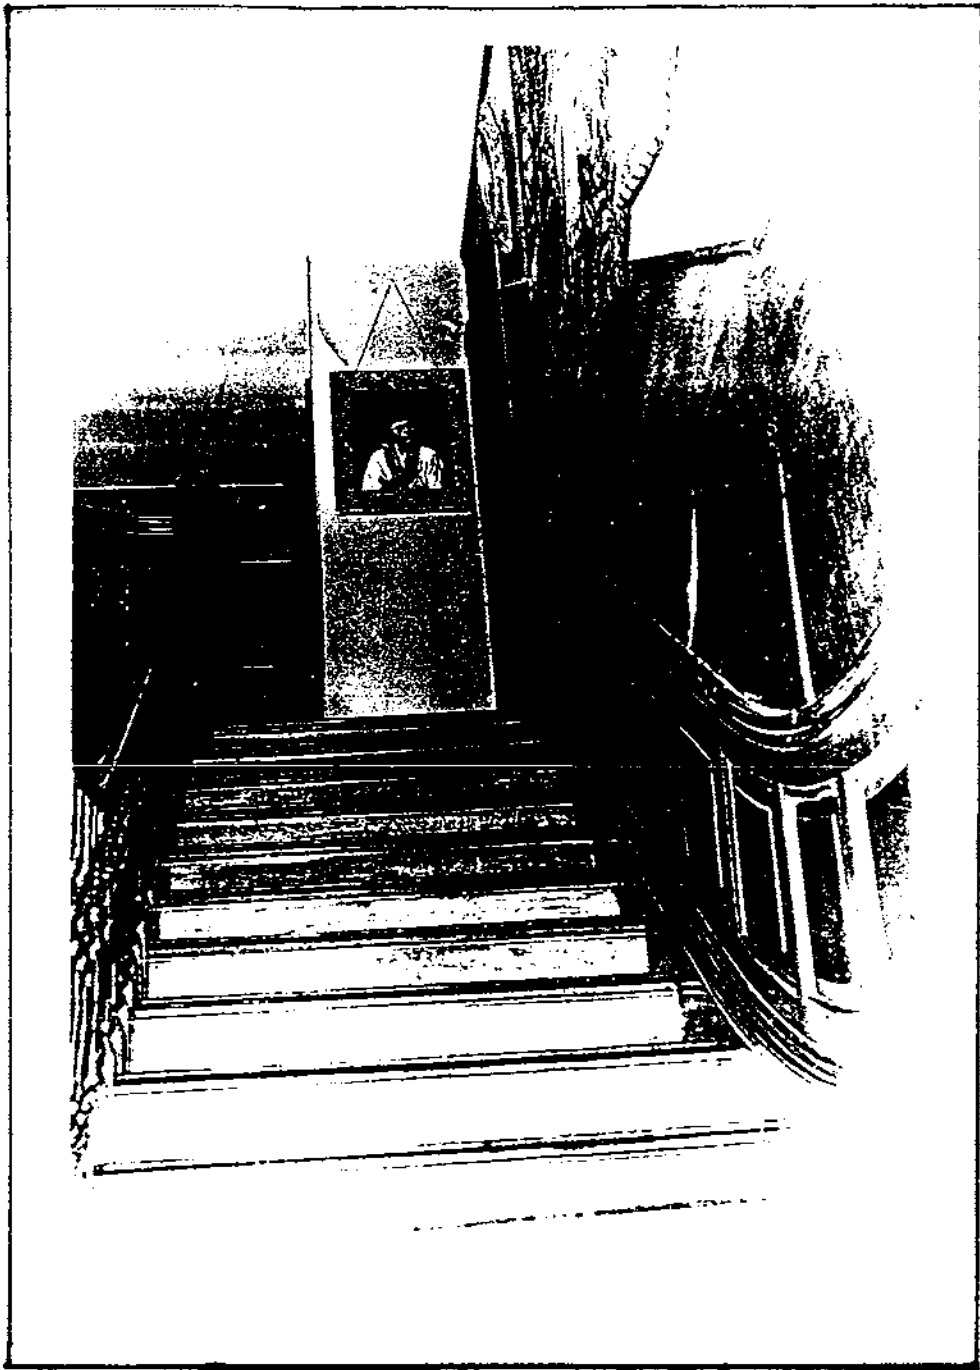
photograph of the second floor hall this wall is seen as rectangular in shape (fig. 1). Archways were indicated in the original Lamb and Rich drawings by dotted lines. However, this particular one did not have the word "arch" written across it, as the others did (see Appendix A, second floor plan), further indicating that the opening was not built as an arch.

Fig. 1. Main staircase; Front Hall  
(Room 101) looking east, 1948.  
Photographic collection, SAHI NHS.  
After 1948, the rectangular wall at the top  
of the stairs was changed to an arch.
